# Technical Memorandum

To: Steve Wall, City of Camas  
From: Dawn Chapel and Dan Matlock, Pacific Groundwater Group  
Re: Updated Environmental Review for Select Facilities at the Port of Camas-Washougal Industrial Park  
Date: August 6, 2015

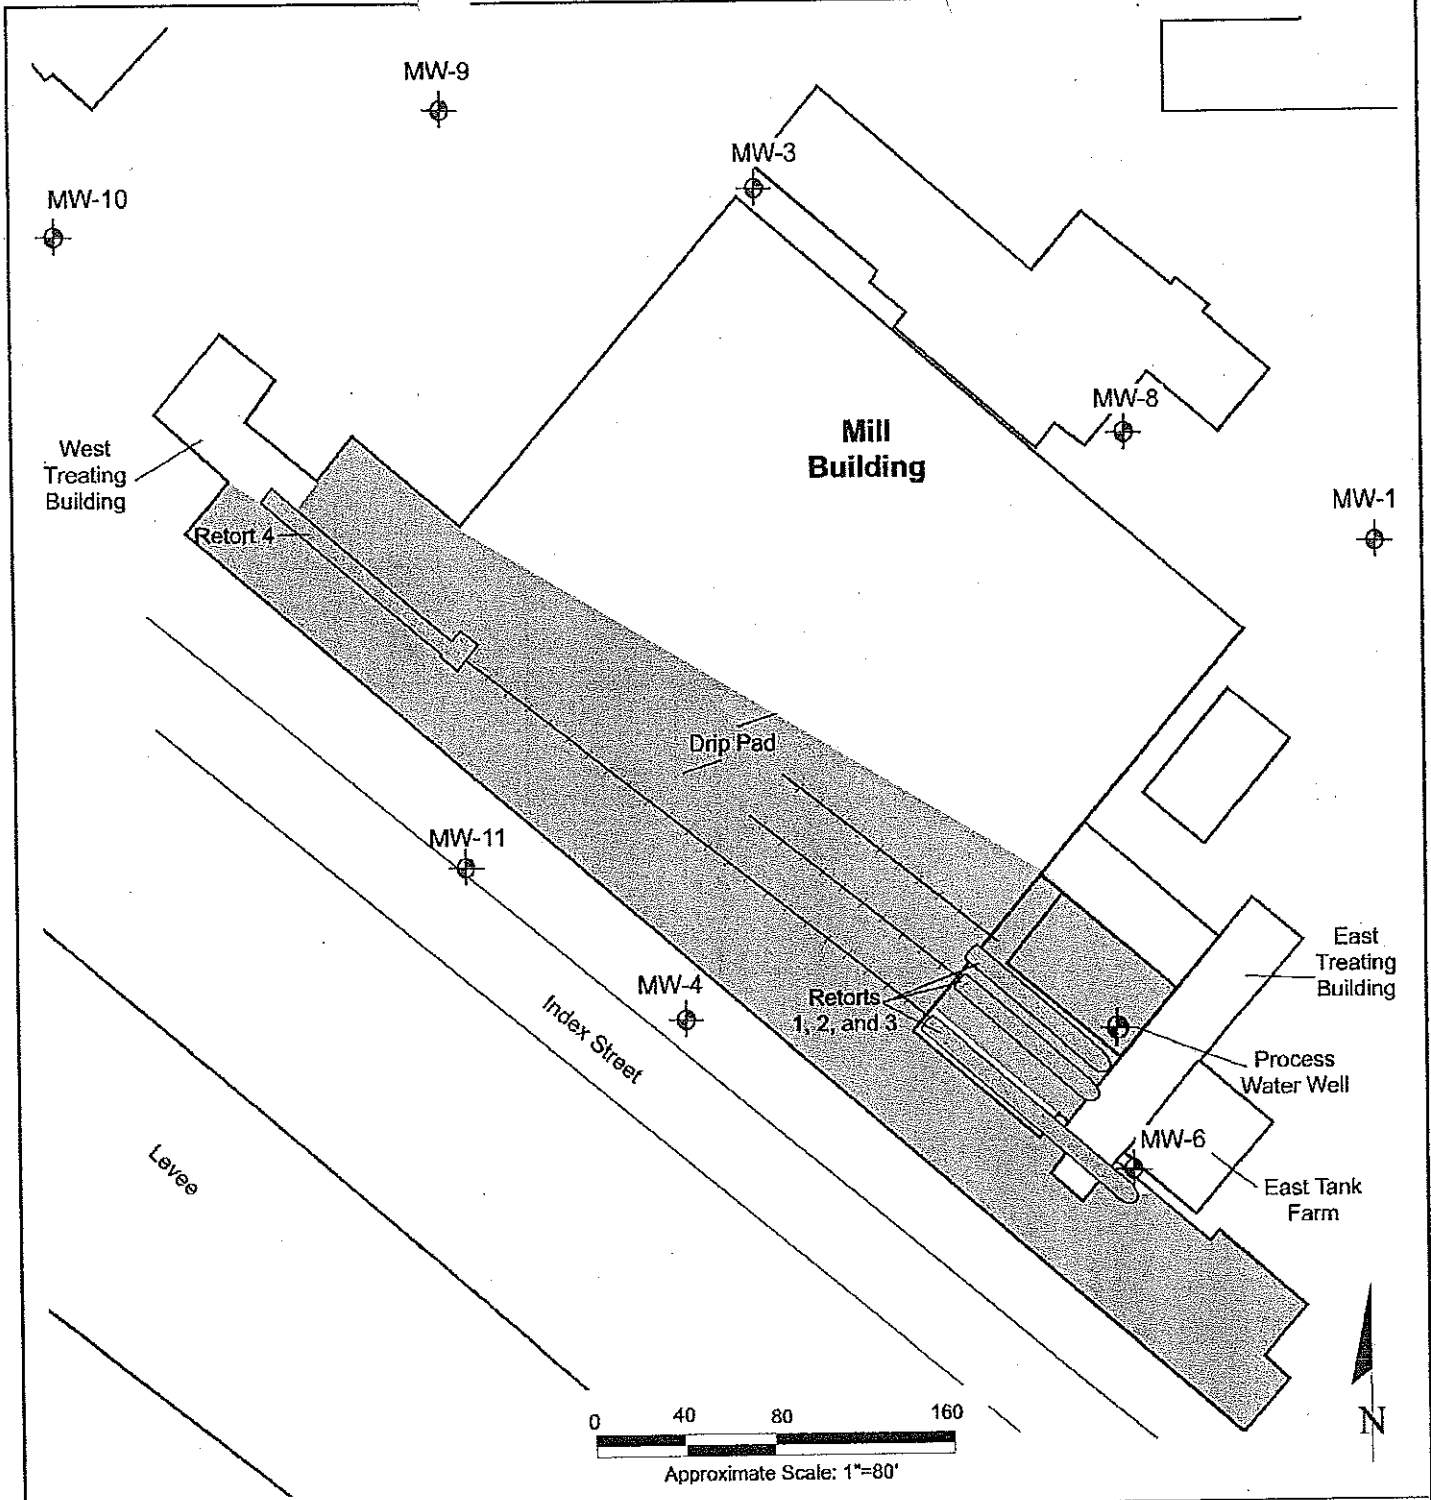
**Figure 1  
 Drip Pad and Monitoring Well Locations**

Groundwater concentrations in onsite wells *downgradient* of the drip pad (towards the north) have remained relatively stable since monitoring first began and are either non-detected or at concentrations below MTCA (MW-3, MW-8, and MW-10). A recent elevated detection of chromium and copper (9.23 ug/L and 30.6 ug/L respectively) was reported in downgradient well MW-9 during the March 2011 sampling event; however, these elevated detections are still below MTCA cleanup levels. Previous concentrations of chromium and copper (since 1997) in well MW-9 are generally less than 2 ug/L. It is unknown if the March 2011 results are indicative of a new increasing trend in this well.

Elevated concentrations of arsenic, chromium, and copper are generally observed in one or more onsite wells immediately *upgradient* of the drip pad (MW-4 and MW-11) and along the east side of the property (MW-1 and MW-6). MW-6 is located adjacent to a portion of the drip pad where some of the highest chromium concentrations in soil were observed prior to excavation. Concentrations and trends observed in these wells are as follows:

- MW-4: Historically arsenic exceeded MTCA Method-A in this well with concentrations as high as 63.6 ug/L (1999); however concentrations have generally *decreased* since 2000 and since 2009 have been below MTCA Method-A. The most recent arsenic concentration in March 2011 was 1.11 ug/L. Concentrations of chromium and copper have been somewhat variable in this well but always below MTCA values. The most recent chromium and copper concentrations were < 2 ug/L (undetected) and 5.84 ug/L respectively.

- MW-11: Arsenic has exceeded MTCA Method-A in this well since 1997, with relatively stable concentrations (though somewhat variable between sampling events). A maximum concentration of 83.9 ug/L was observed in September 2009 and the most recent concentration in March 2011 was 45 ug/L. Concentrations of chromium and copper are much lower (typically less than 2 ug/L).

- MW-1: Arsenic concentrations have generally *increased* in this well over time and have consistently exceeded the MTCA Method-A level since 2005. The most recent arsenic concentration in March 2011 was 67 ug/L. Chromium concentrations are generally less than 5 ug/L, except for a single elevated concentration of 33.8 ug/L in March 2010. Copper concentrations are typically less than 10 ug/L, but more recent concentrations in 2010 and 2011 have been higher (as high as 26.9 ug/L in March 2010). It is not clear if the recent 2010 and 2011 elevated copper results are indicative of a new increasing trend in this well.

- MW-6: Chromium concentrations in this well have *increased* from values typically less than 5 ug/L prior to 2005 to a maximum of 149 ug/L recently measured in March 2011 (above MTCA Method-A). Chromium concentrations in this well display sig-

nificant variability from one sampling event to the next. For example the concentration of chromium measured in September 2009, December 2009, March 2010 and June 2010 was < 2 ug/L, 112 ug/L, 7.26 ug/L and 88.5 ug/L respectively. The large variability in chromium concentrations from one sampling event to the next suggests fluctuating groundwater elevations may be remobilizing residual contaminants in site soils; although changes in redox conditions may also play a role in mobilizing metals. As mentioned above, MW-6 is located adjacent to a portion of the drip pad where some of the highest chromium concentrations in soil were observed prior to excavation. Arsenic and copper concentrations in this well are typically less than 5 ug/L (below MTCA levels) and have been somewhat more stable over time.

Along the northeast corner of the property (downgradient of MW-1 and MW-6) the concentrations of arsenic, chromium, and copper are relatively low (generally less than 2 ug/L) and well below MTCA levels.

Recommendations in the Saga 2011 report was to continue monitoring of arsenic and chromium on a quarterly basis for the next year to evaluate trends over time, after which the frequency of monitoring would be reassessed. It was recommended that the frequency of copper analysis be reduced to annual events. The Saga 2011 report also recommended that the facility's water supply well be sampled during the next sampling event. Sampling results were not found in Ecology's files; however, PGG is currently in contact with Ecology to address investigation of potential vertical migration during their ongoing negotiations with this site.

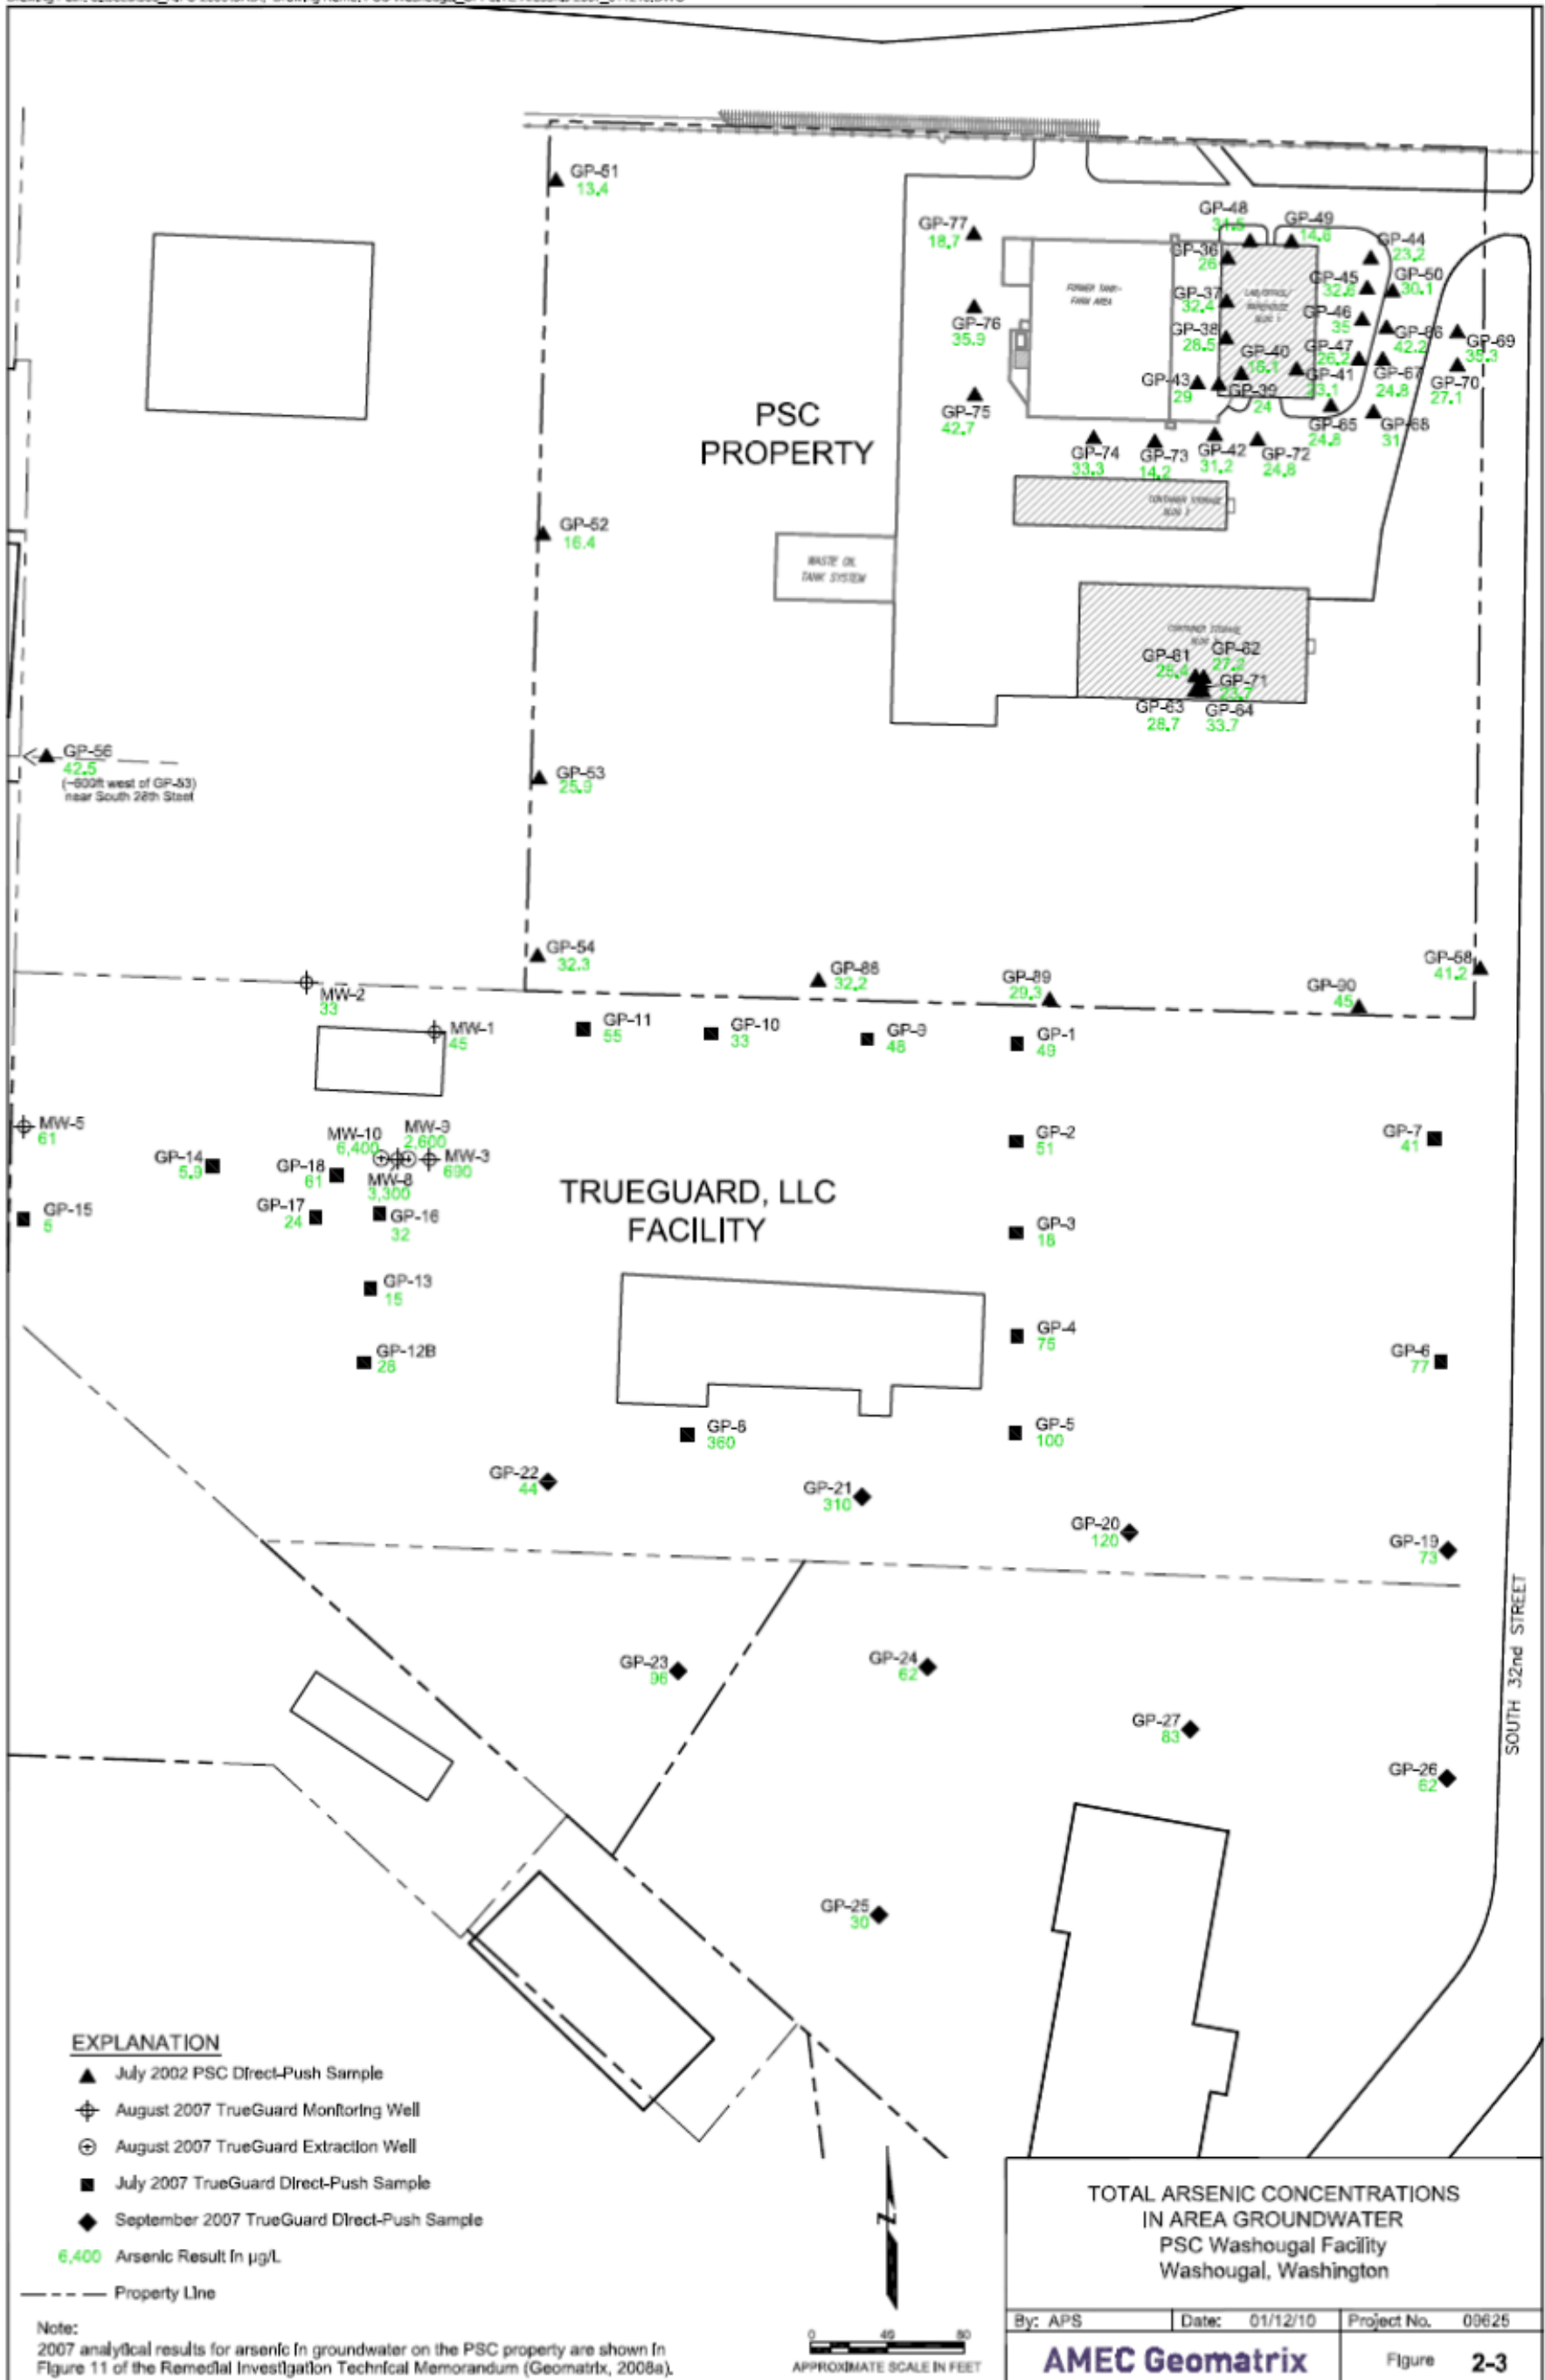
MFA's investigative work identified arsenic in shallow groundwater at concentrations ranging from about 600 to 6,400 ug/L in the central portion of the property (Attachment B). Concentrations decrease to values ranging from about 5 to 75 ug/L at the property boundaries (Attachment B). Iron, manganese, copper, and chromium are also detected at concentrations above preliminary cleanup up levels. Shallow groundwater at the site flows generally from northwest to the east-southeast towards Steigerwald Marsh, which is consistent with findings on the adjacent PSC property (see below).

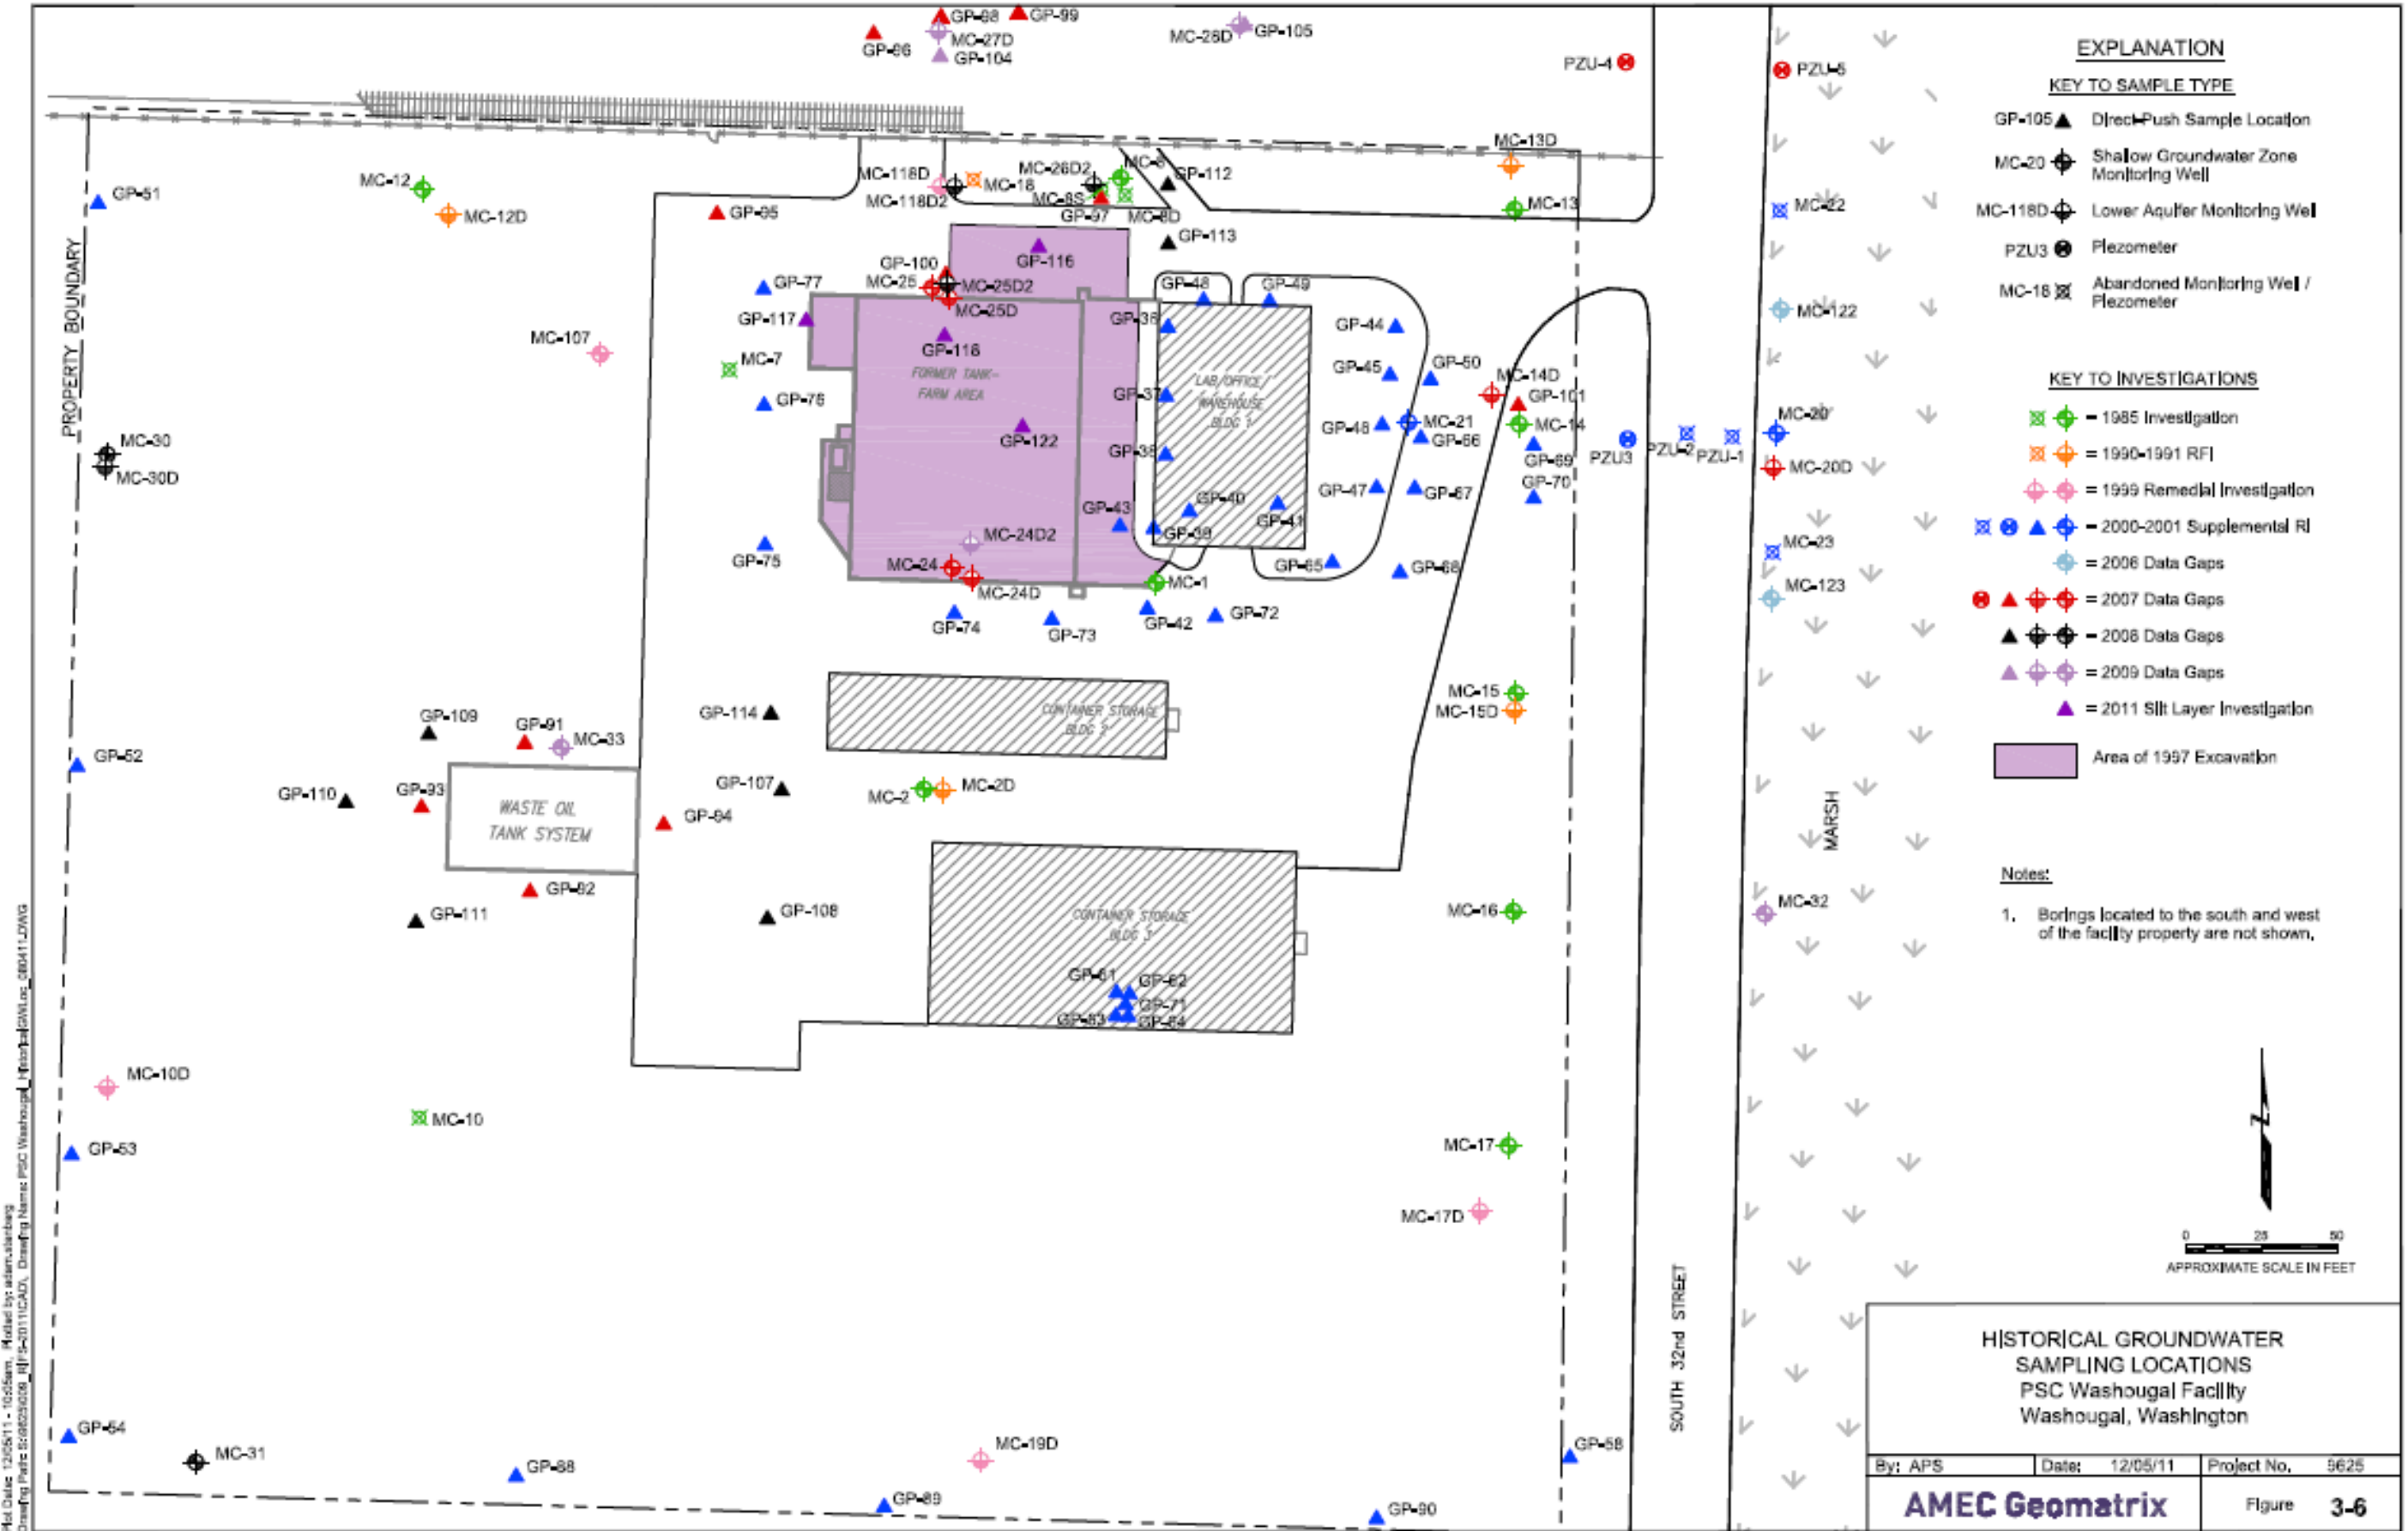
HISTORICAL GROUNDWATER SAMPLING LOCATIONS  
PSC Washougal Facility  
Washougal, Washington

The greatest impact to the *shallow aquifer* occurs east of Building 1 near South 32<sup>nd</sup> Street and extends eastward offsite towards Steigerwald Marsh (wells MC-14, MC-20 and MC-123 in Attachment C); however, a preferential northward flow path may also occur within permeable fill around a utility line that runs along South 32<sup>nd</sup> Street. Leaching of residual contaminants in shallow soils beneath Building 1 likely continues to contribute to high concentrations in the shallow aquifer at this location. COC concentrations in the shallow aquifer are either steady or slowly decreasing over time; although seasonal variability is apparent with fluctuating water levels, suggesting remobilization of soil contaminants may be ongoing.

The greatest impact to the *lower aquifer* occurs onsite below the former tank farm (MC-24D and MW-25D) and about 40 feet north of the former tank farm (MW-118D) - See Attachment C for well locations. Leaching of residual contaminants in the overlying silt layer continues to contribute to high concentrations of COCs in the lower aquifer at this

location. The concentrations of some chlorinated ethenes have increased over time (with seasonal variability) in the lower aquifer near the former tank farm. Vinyl chloride has slowly increased in monitoring wells MC-24D, MC-25D and MC-118D and cis-1,2-dichloroethene has slowly increased in MC-24D and MC-25D. The increasing trend may be partly related to on-going degradation of tetrachloroethene and trichloroethene. The concentration of 1,4-dioxane in MW-24D and MW-25D may also be slowly increasing; although the trend is much less discernible.
