# Geotechnical Engineering Report

Dawson's Ridge Density Transfer Subdivision  
NW McIntosh Road  
Camas, Washington

April 7, 2017  
Project No. 73197.000

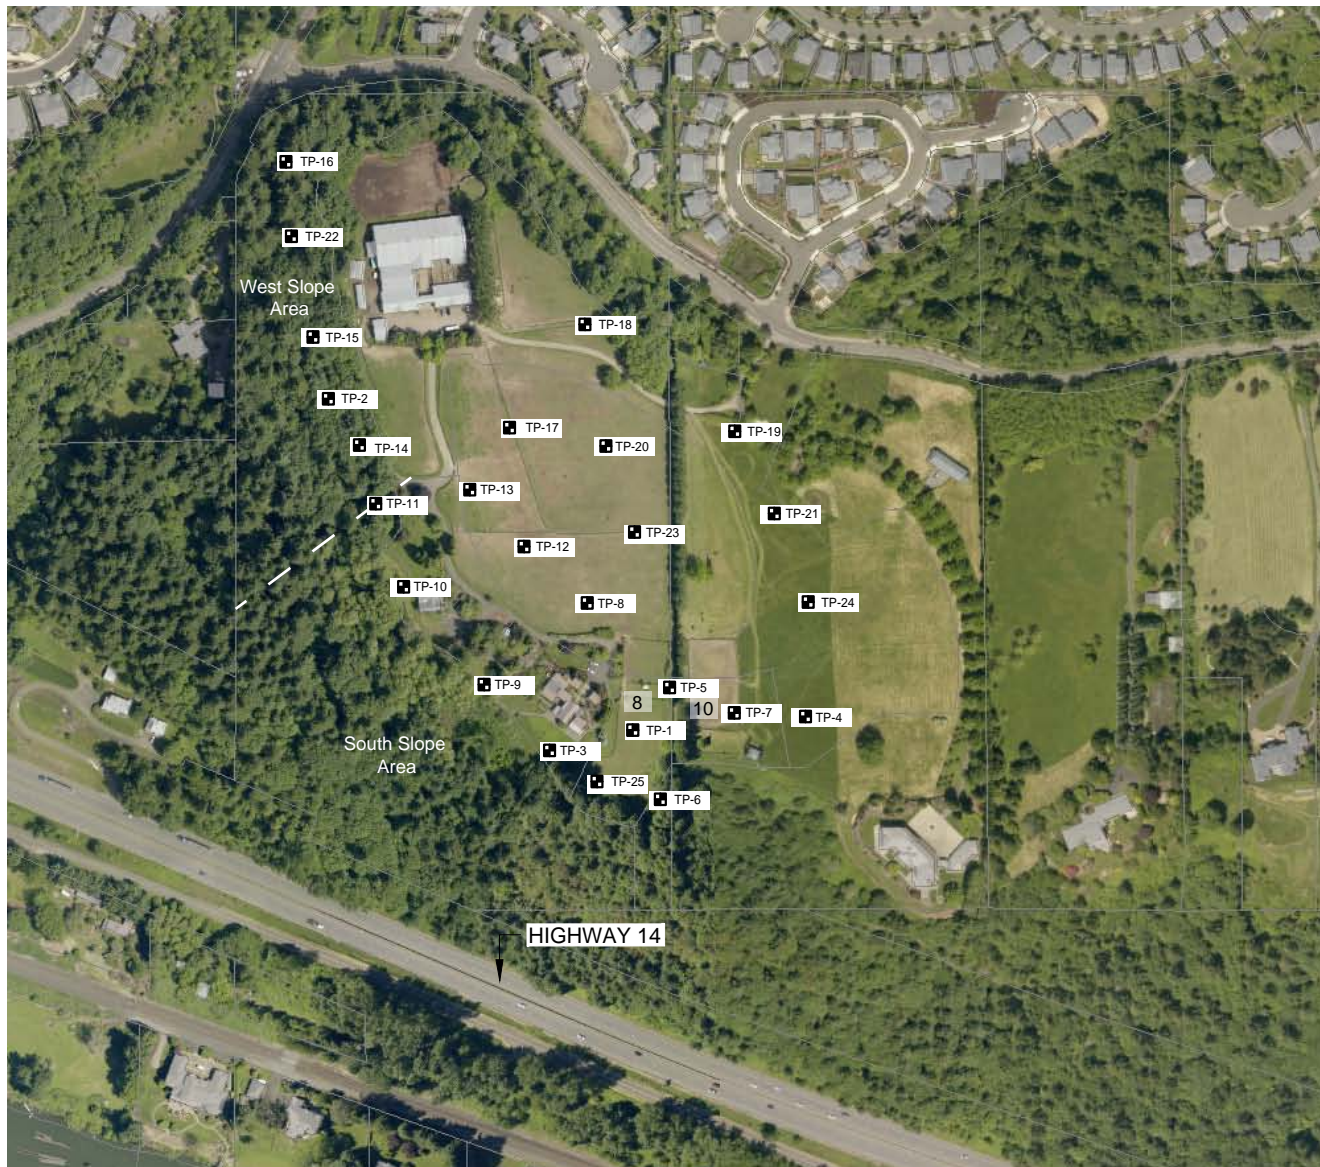
**2**

Figure 2 shows a dashed yellow line that indicates the approximate divide between the test pits where basalt was and was not observed. Deeper excavations should anticipate encountering the basalt throughout the site and the actual depths will vary.

Based on our observations and analyses, conventional, shallow foundations are feasible to support the detached, single-family houses. We recommend that houses on the west side of the yellow dashed bedrock boundary line have their foundations embedded into the underlying basalt bedrock unit and founded entirely on cuts into rock and not on structural fill (refer, Figures 2, 3, and 4).

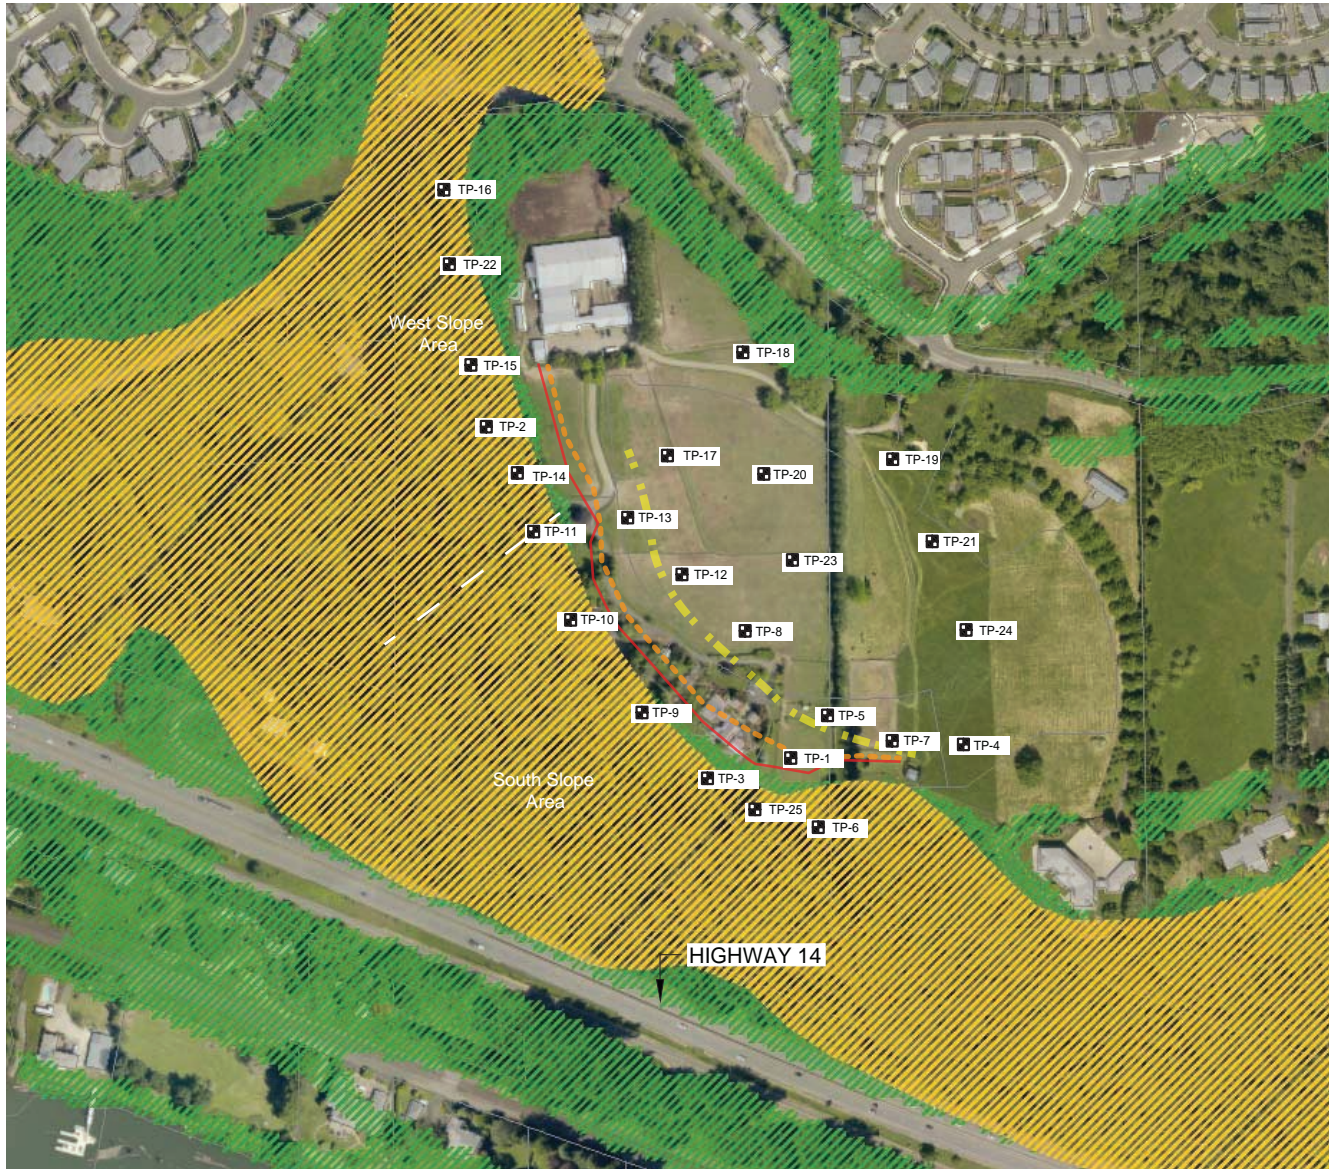
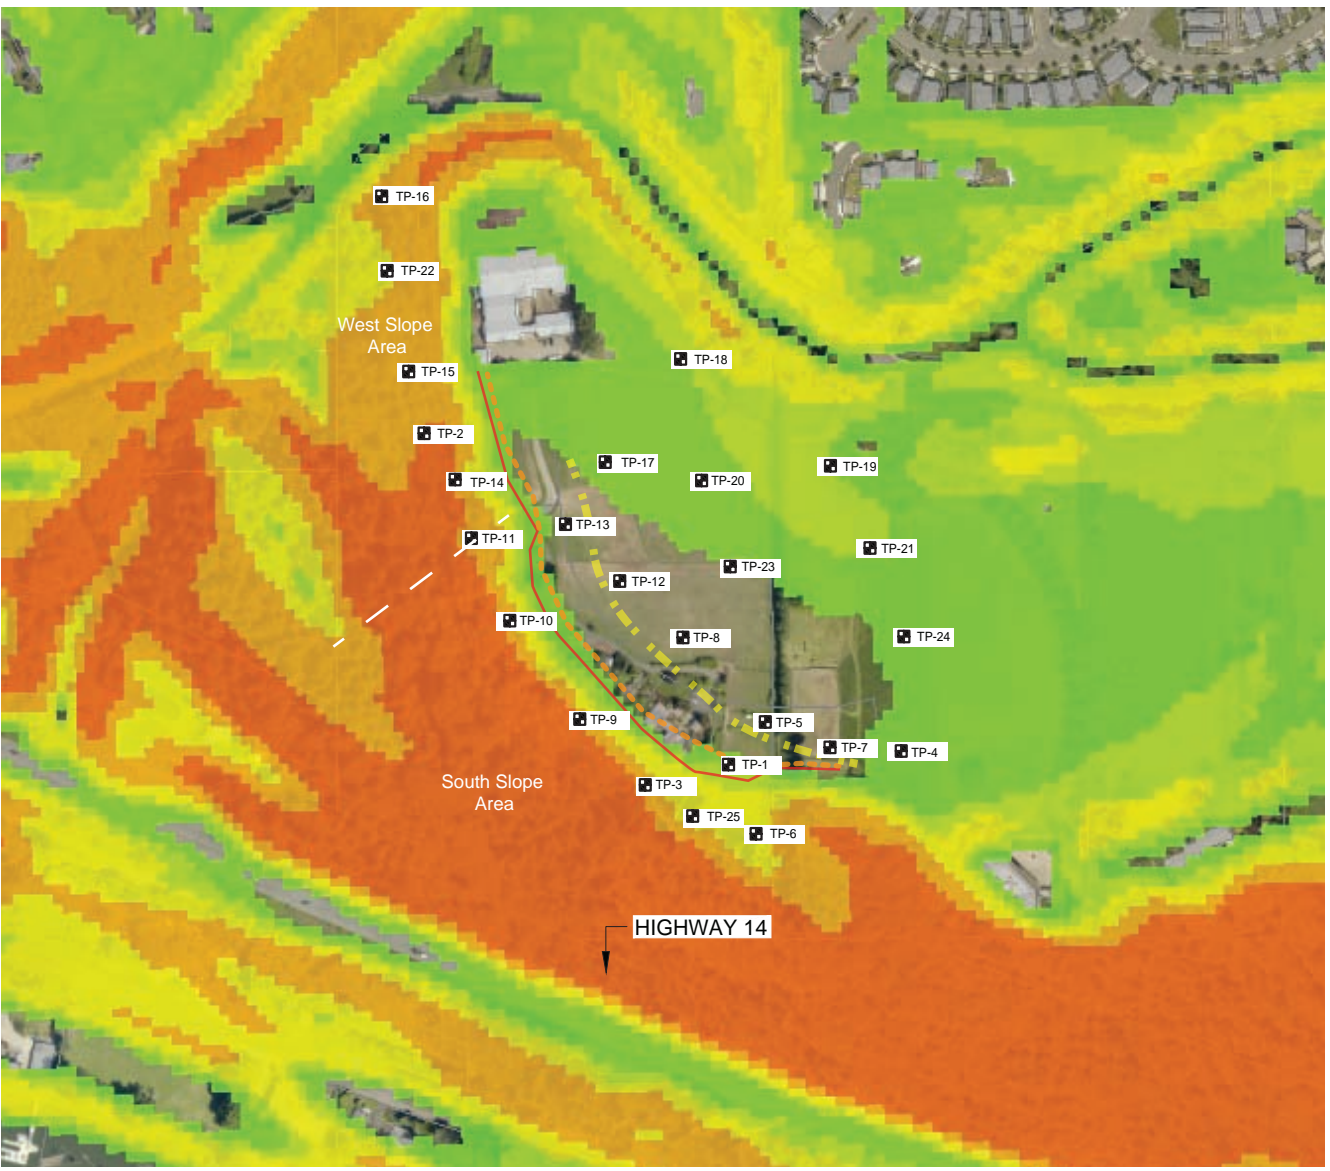
<b>LANDSLIDE</b>	
<b>HAZARD &amp; STEEP</b>	
<b>SLOPES MAPS</b>	
PROJECT:	73197.000
DATE:	APRIL 2017
FIGURE:	<b>3</b>

The southwestern portion of the site is within Clark County's designated Landslide Hazard Area and Severe Erosion Hazard Area, which is primarily based on the slope steepness along the southwest side of the property (Figure 3, Landslide Hazard and Steep Slope Maps). Because of these designations, design and development of the project must follow Clark County Code Section 43.430 Geologic Hazard Areas. The discussion and geotechnical recommendations associated with these designations are provided in Sections 3.1 Geotechnical Design Considerations and 3.2 Severe Erosion, Steep Slope, and Potential Slope Instability Hazards.

No buildings are proposed within the *Areas of Potential Instability*. Several indicators of slope instability were observed along the ridgeline that will affect the Townhome buffer/setbacks (refer, Figure 3). Four lots are partially located within the *Severe Erosion Hazard* zone (refer, Figure 4). Figures 3 and 4 present the approximate buffer/setback per Clark County Code (dashed orange line) of 50 feet. The types of failures in this area are surficial debris flows and rock falls that tend not to extend significantly beyond the ridgeline. Based on our site reconnaissance, explorations, and literature review, a proposed buffer/setback line (solid red line) has been considered that ranges between 25 and 45 feet from the *Areas of Potential Instability* zone.

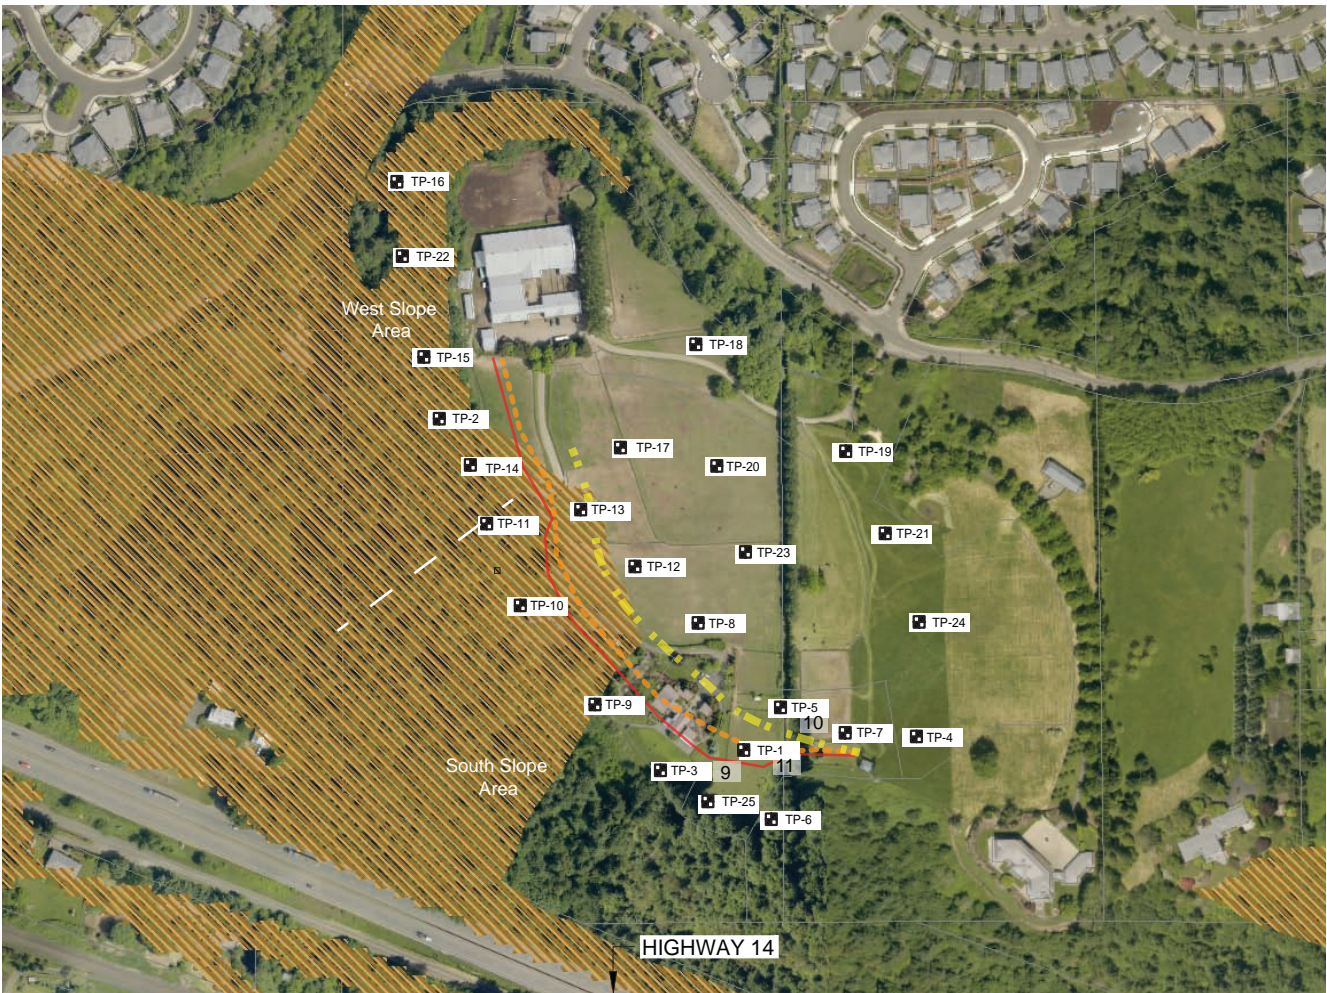
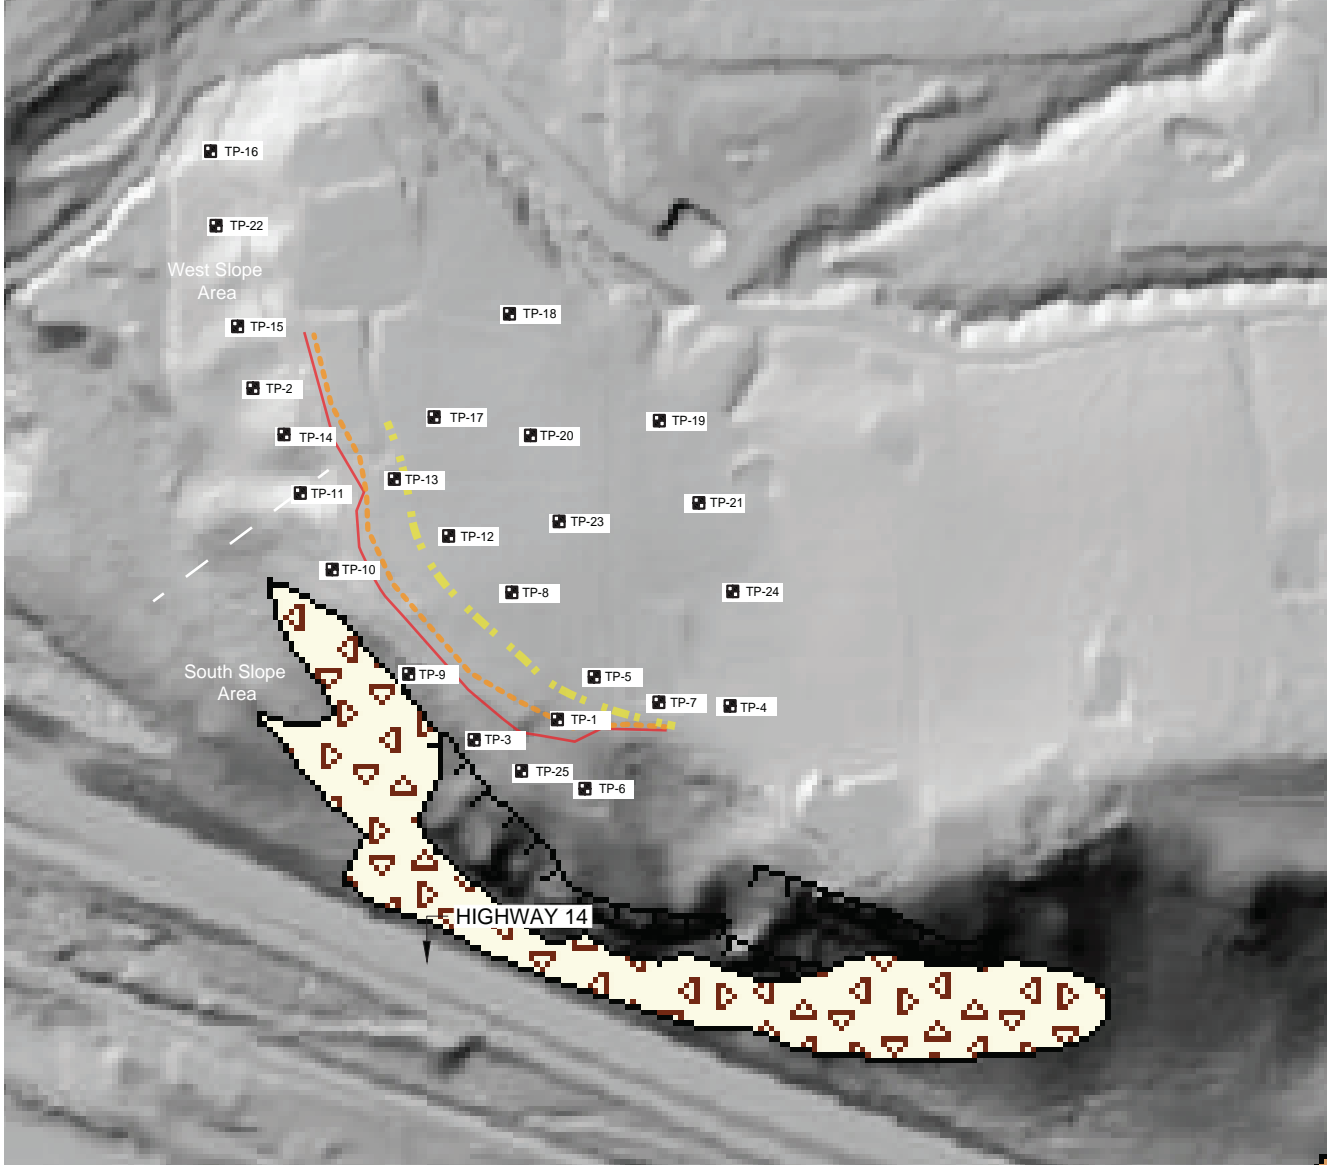
EROSION AND SLIDO MAPS	
PROJECT:	73197.000
DATE:	APRIL 2017
FIGURE:

A pre-historical (> 150 years) colluvium-talus deposit is identified in the SLIDO database along the slope descending between the proposed development and SR 14. The feature was interpreted by DOGAMI through LiDAR imagery and is mapped as a rock fall-type failure that occurred within the basalt bedrock along the steep slopes with the scarp shown as generally following the ridgeline.

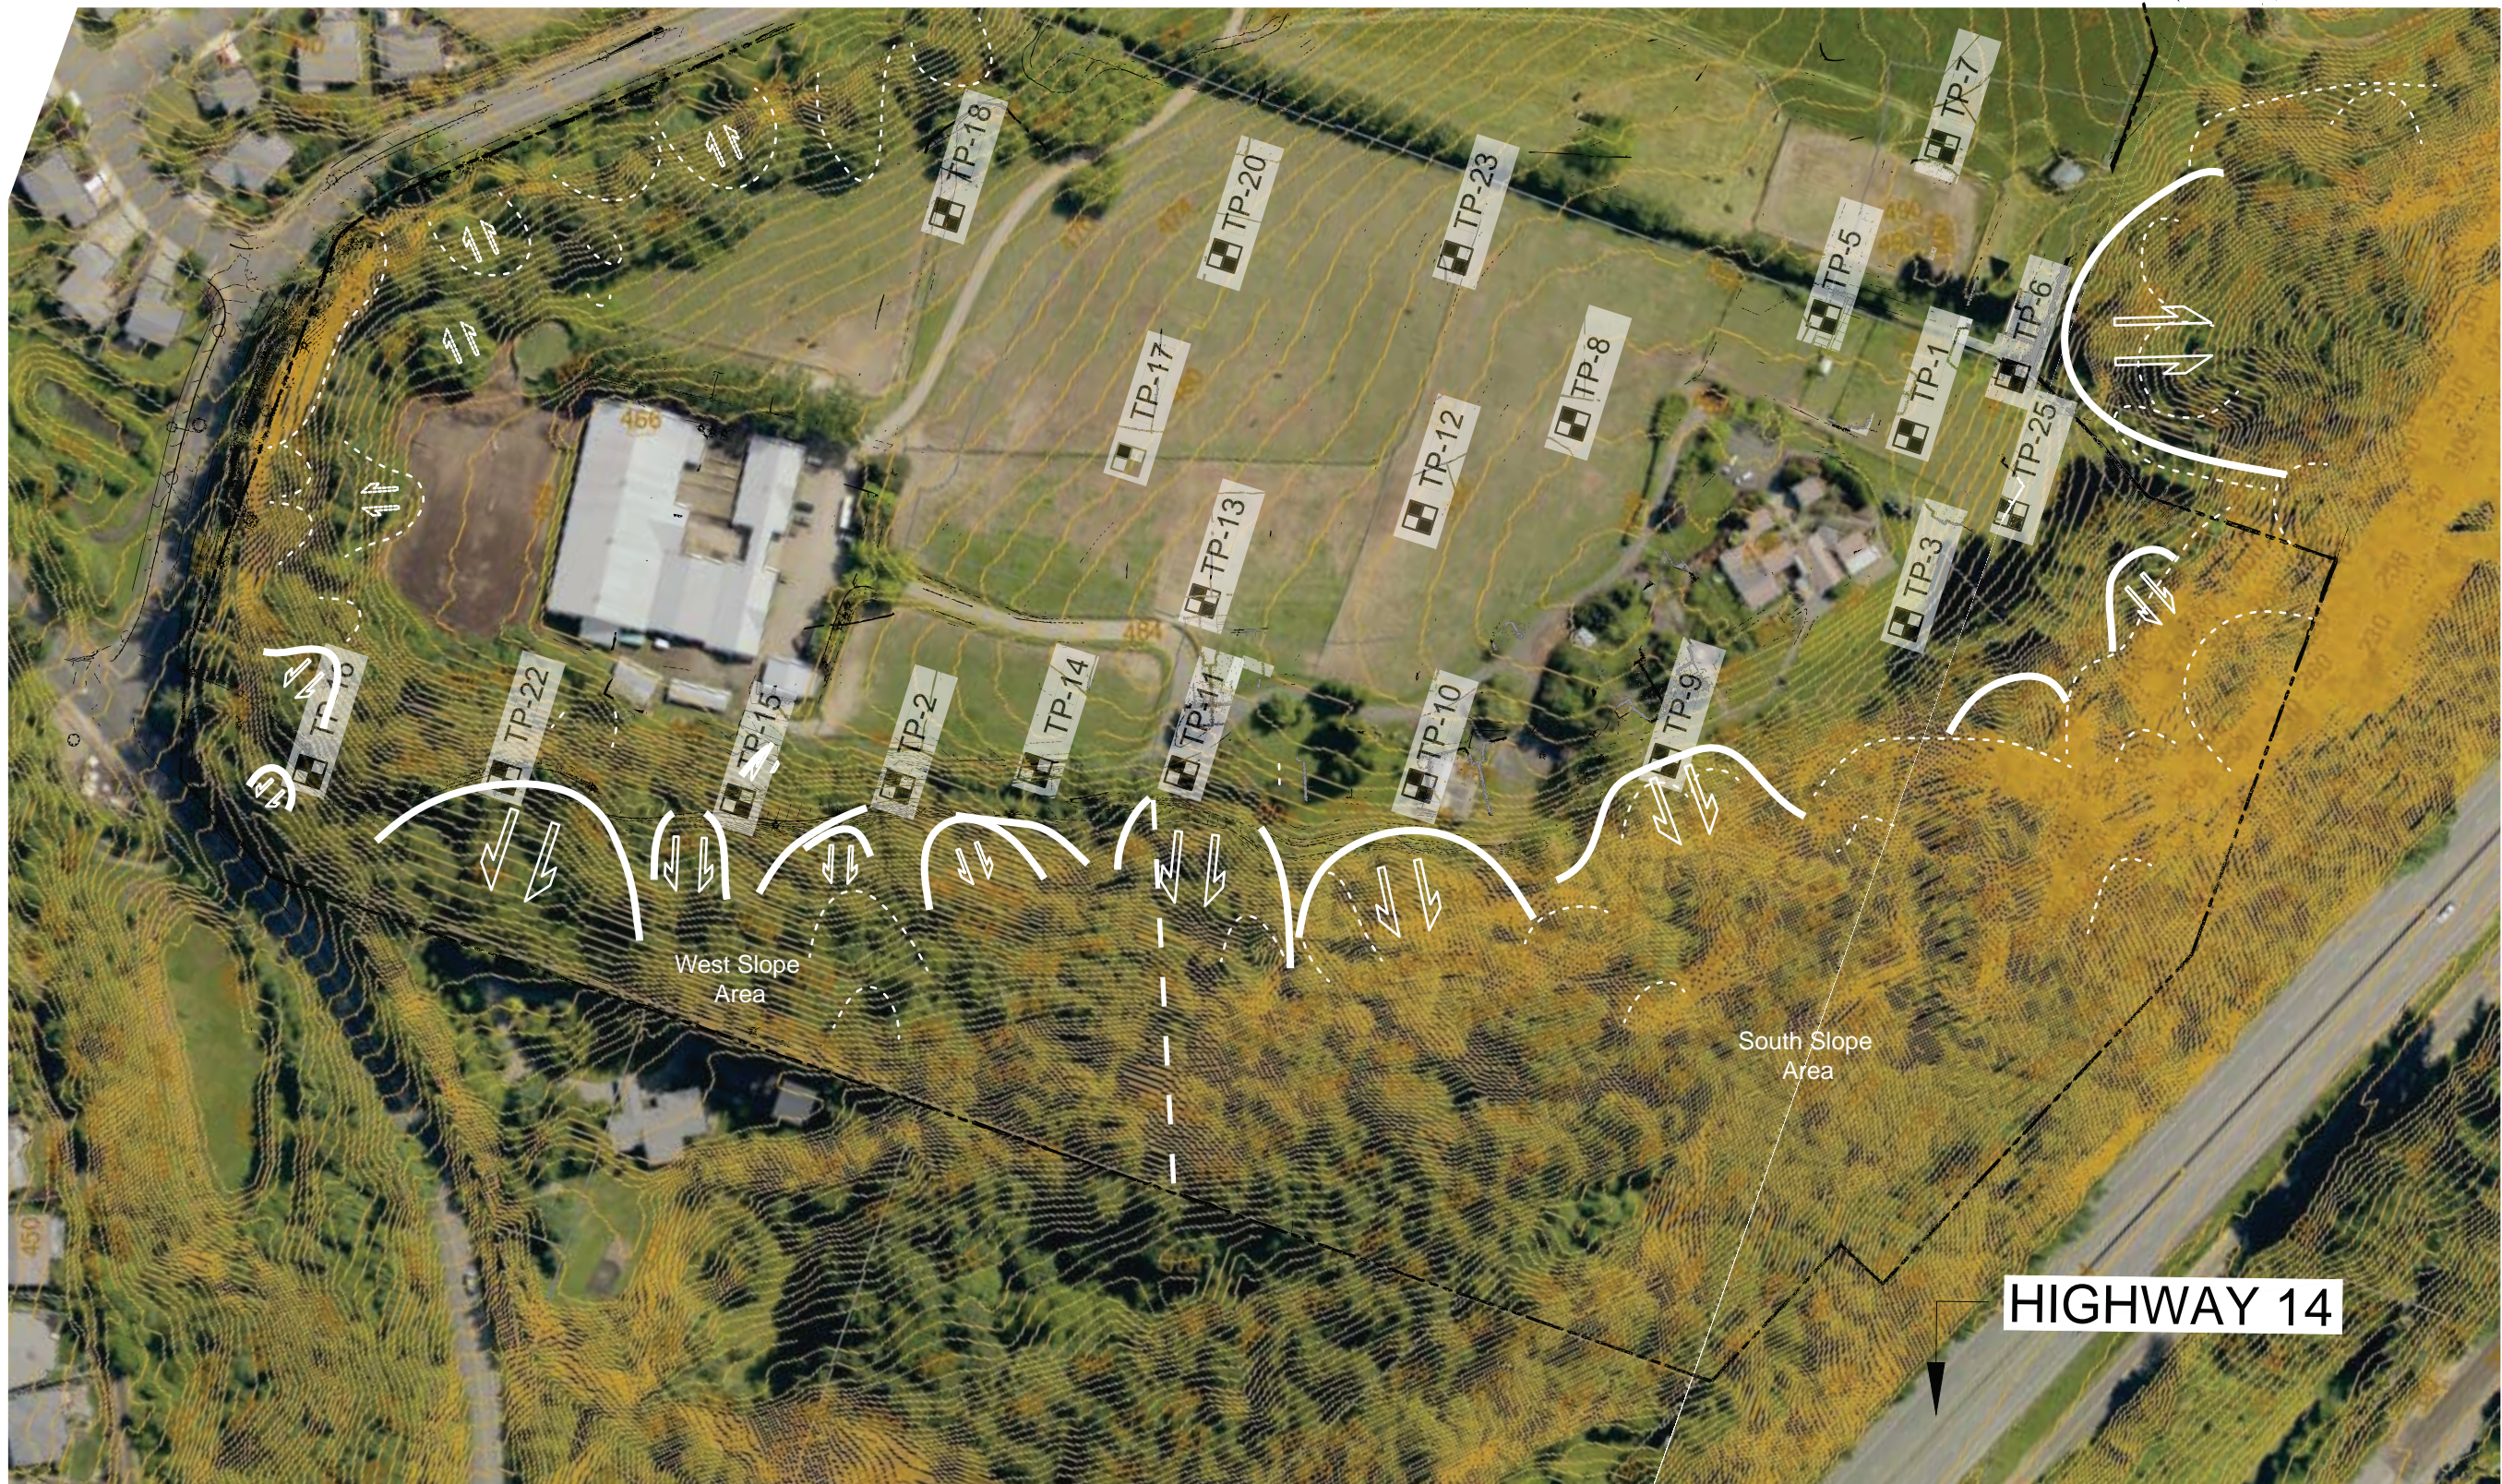
The site reconnaissance was focused along and adjacent to the access road, observing the conditions and identifying features that could directly affect its stability. The road appears to generally cut across several headscarps of older and/or potentially active landslides. Where fill was placed to cross drainages and level the road, the west sides of these prisms are over-steepened and the pavement has longitudinal cracks, potentially indicating down-slope movement.

South of where the horse trail splits and begins to descend downslope, and the paved road traverses east and upslope (near TP-13), an active landslide has sunken the trail, offset and damaged the fence line, and the trees are tilted downslope. A disconnected and broken drainage line was observed in the upper slope area and the pavement above the drainage head had a linear depression that appeared to be in line with the pipe. The pavement and landscaped area appeared to have recently been improved.

the slope. Several indicators of potential slope instabilities were observed along the ridgeline, including depressions, transverse cracks, scarps, and debris flow chutes that were generally within 10 feet of the ridgeline. The noted instabilities in the south slope area appear to be high-angle failures with steep headscarps that do not extend a significant distance (< 20 feet) east of the ridgeline.

The ridgeline near TP-10 appears to have a 3- to 5-foot-high scarp that has been excavated into the hill, apparently to create a flat horse trail along the toe of the cut slope. The fence, which is situated along the ridgeline, is tilted, offset, and is being undermined by erosion. A brief observation of the adjacent house did not show readily apparent indications of foundation damage.

An approximately 70-foot-long surface crack above a depressed wedge was observed near TP-9 and likely indicates the top of a debris flow-type landslide. The vegetation within 40 feet of the ridgeline was primarily cleared of trees and consisted of brambles and saplings. Downed and damaged trees were observed further downslope.

Similar features were observed along the remainder of the ridgeline as it traverses south, including the east side of TP-1 and at the head of the drainage near TP-7. The drainage was not accessible due to heavy foliage, fences, and steep terrain during the site reconnaissance. Based on review of site topography developed from LiDAR data, several headscarps and hummocky topography were interpreted.

Current plans do not show construction of any structures within the west slope area. The existing access road generally cuts across the headscarps. As a result, PBS recommends not developing the area downslope (west) of the existing access road. Placing fill to widen the road would load the head of the existing landslide deposits and could potentially destabilize the slope. Surface and groundwater flow should be contained, controlled, and diverted away from the road and slopes. If the road were to be considered as a primary access and/or expanded, soil borings, slope stability analyses, and monitoring would need to be performed to further characterize the subsurface conditions and provide additional geotechnical recommendations to conform to the Clark County Code.
