September 8, 2017

Regarding: Geotechnical Engineering Report – Addendum No. 1
Dawson Ridge Development, Northern Site Reconnaissance and Exploration
NW McIntosh Road
Camas, Washington
PBS Project No. 73197.000 Phase 0003

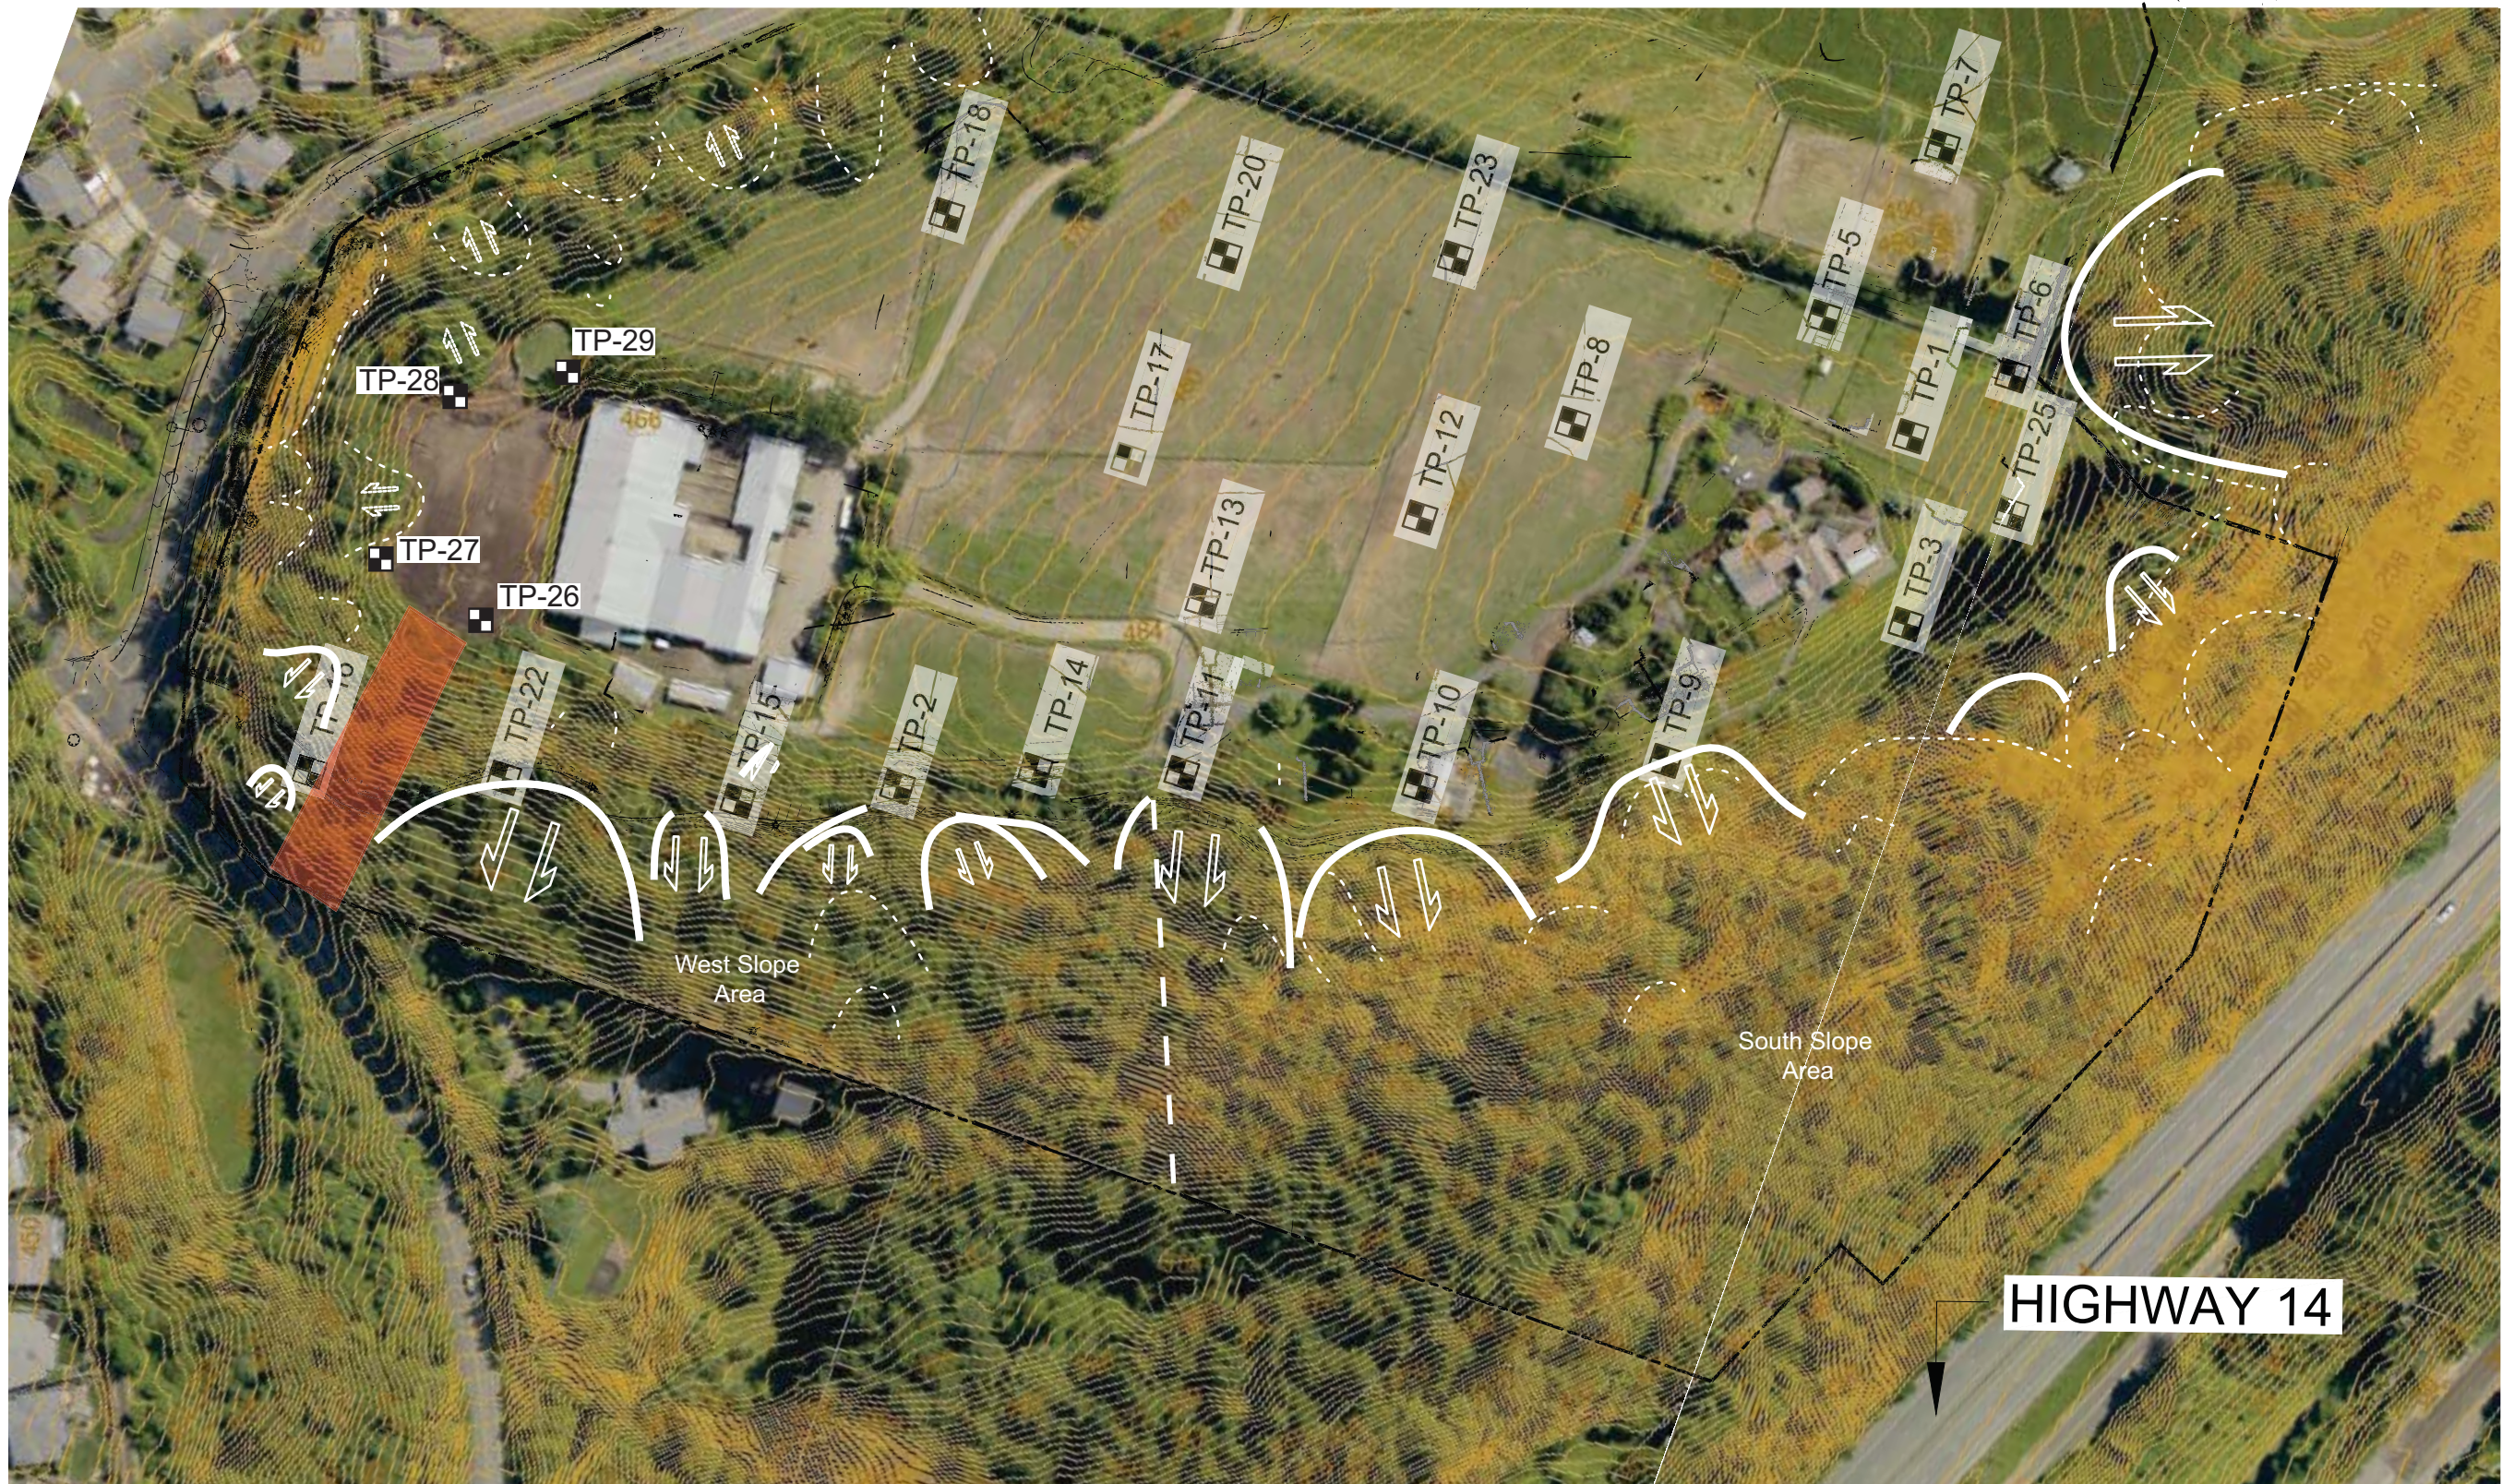
**SITE RECON
MAP**

The slopes on the north and northeast sides are generally consistent with the conditions mapped in our previous reports for the project (refer, Figure 3). We observed numerous trees leaning upslope throughout the reconnaissance area. The leaning trees consist almost entirely of deciduous trees, whereas the fir trees are almost all nearly vertical. The leaning trees show no sign of "corrective (new, vertical)" growth, indicating that the movement has been relatively recent. This is consistent with other signs of surficial downslope movement.

Based on conversations with staff at the Equestrian Facility, drain tiles are reportedly present beneath the outdoor arena. These have reportedly been disconnected. PBS observed a drain outlet approximately 8 feet below the upper slope break on the northwest end of the area observed for this study. The pipe was daylighting onto the slope and has eroded a 1- to 1.5-foot-deep channel down the face of the slope

The area in the vicinity of the outdoor arena and adjacent ring have been graded to create relatively flat areas by pushing fill north over the slope. This is consistent with the subsurface conditions encountered in our recent test pit explorations. PBS observed some relatively small, localized failures along the slope break in the relatively soft/loose fill.

Utility Trench Location and Excavation – Due to the presence of mapped areas of previous instability, we recommend the outfall pipe from the stormwater facility extend downslope generally north and west between the mapped areas of instability (see Figure 3). The actual location of the pipe should be confirmed in the field by the geotechnical engineer prior to beginning construction. In addition, removal of vegetation should be limited to that required to install the pipe, with vegetation established over the disturbed area once the installation of the pipe has been completed. The geotechnical engineer should be contacted immediately if subsurface or groundwater conditions vary from those described in this addendum.
