# Tree Survey and Assessment

Lake Rd & Everett St  
Camas, WA

January 14, 2020  
PBS Project 71070.000

Prepared by:  
Robert Phipps, PLA, PWS  
ISA Certified Arborist PN-8751A

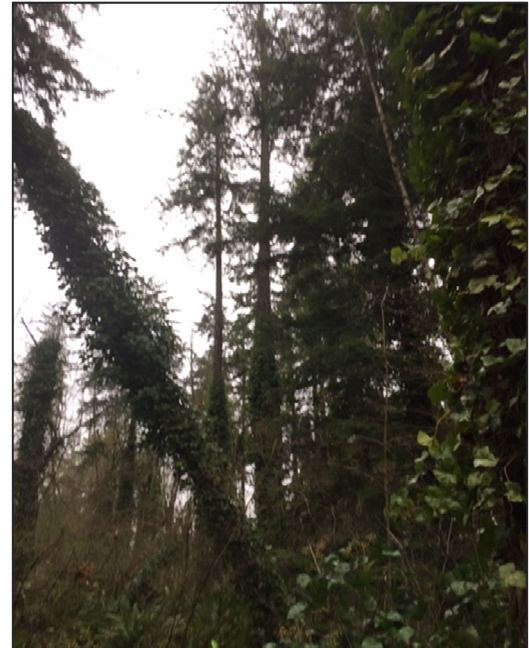
Much of the existing trees are subject to thick established English ivy (*Hedera helix*) in the understory. English ivy is a weedy, invasive, clinging evergreen vine that has taken over close to 90% of the understory native species. The English Ivy in thick bands have attached to the trees' outer layer of bark producing continued biotic stress. Most of the trees have English ivy vines reaching 10' or more up the trunks, adding additional weight to already stressed trees, and deterring production of proper vertical arrangement of scaffold branching, competing for nutrient, water and oxygen availability and suppressing native wildlife habitat. As of 2018, English Ivy is a WA State Class C noxious weed. Class C species are regulated for control but not required under this classification.

**English Ivy adding additional stress and promoting early failure**

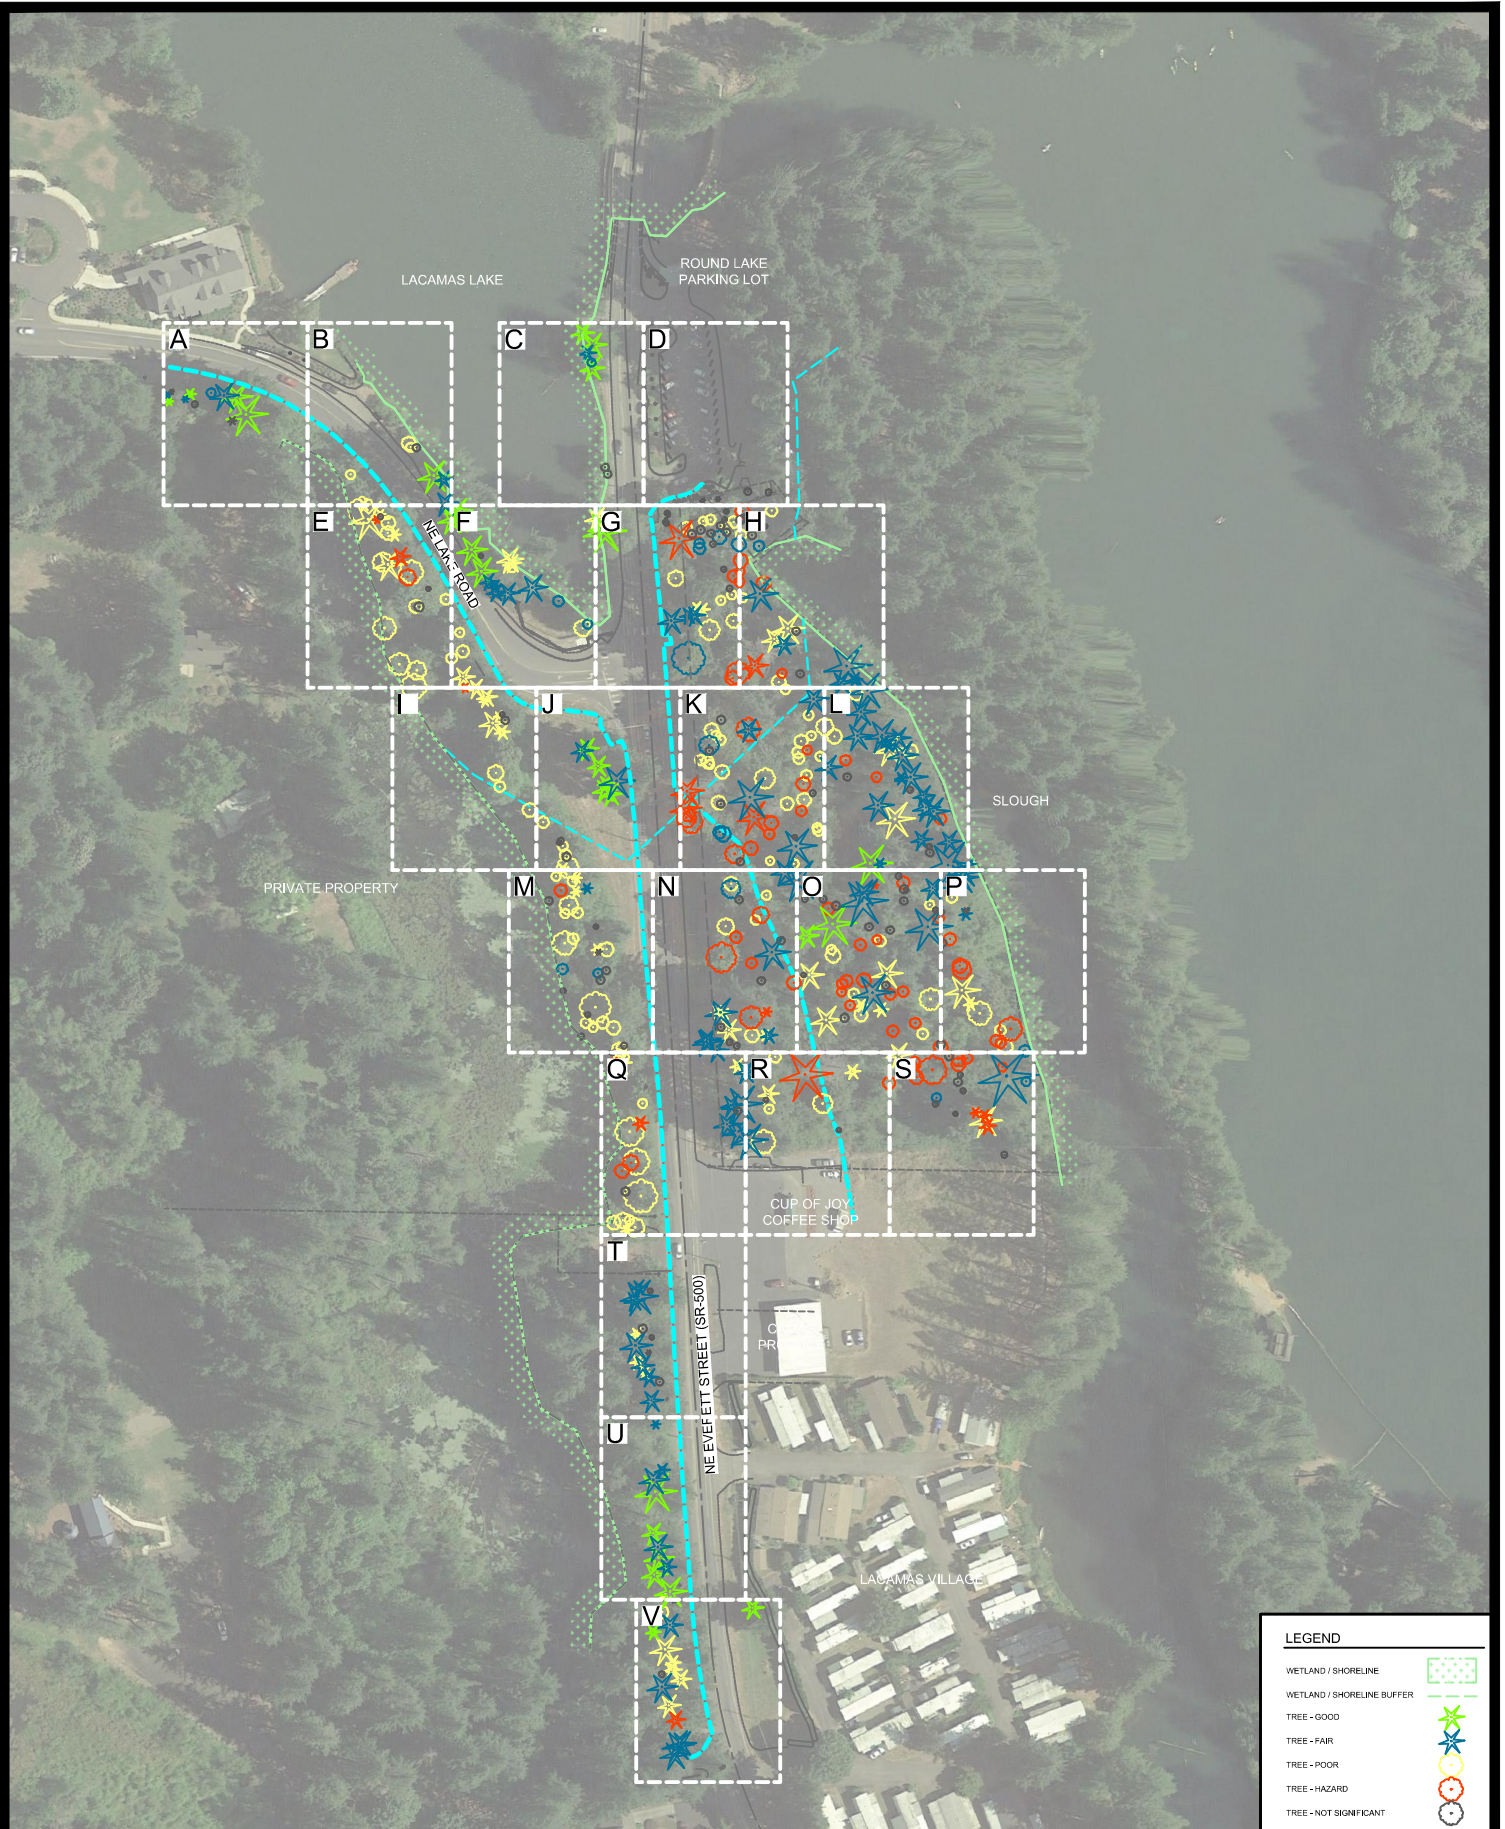
## LAKE RD & EVERETT ST. INTERSECTION IMPROVEMENTS TREE PLAN - OVERALL

See **Figure 1** for tree plan exhibits showing existing tree locations, ID number, and color-coded condition within and outside critical area buffers.

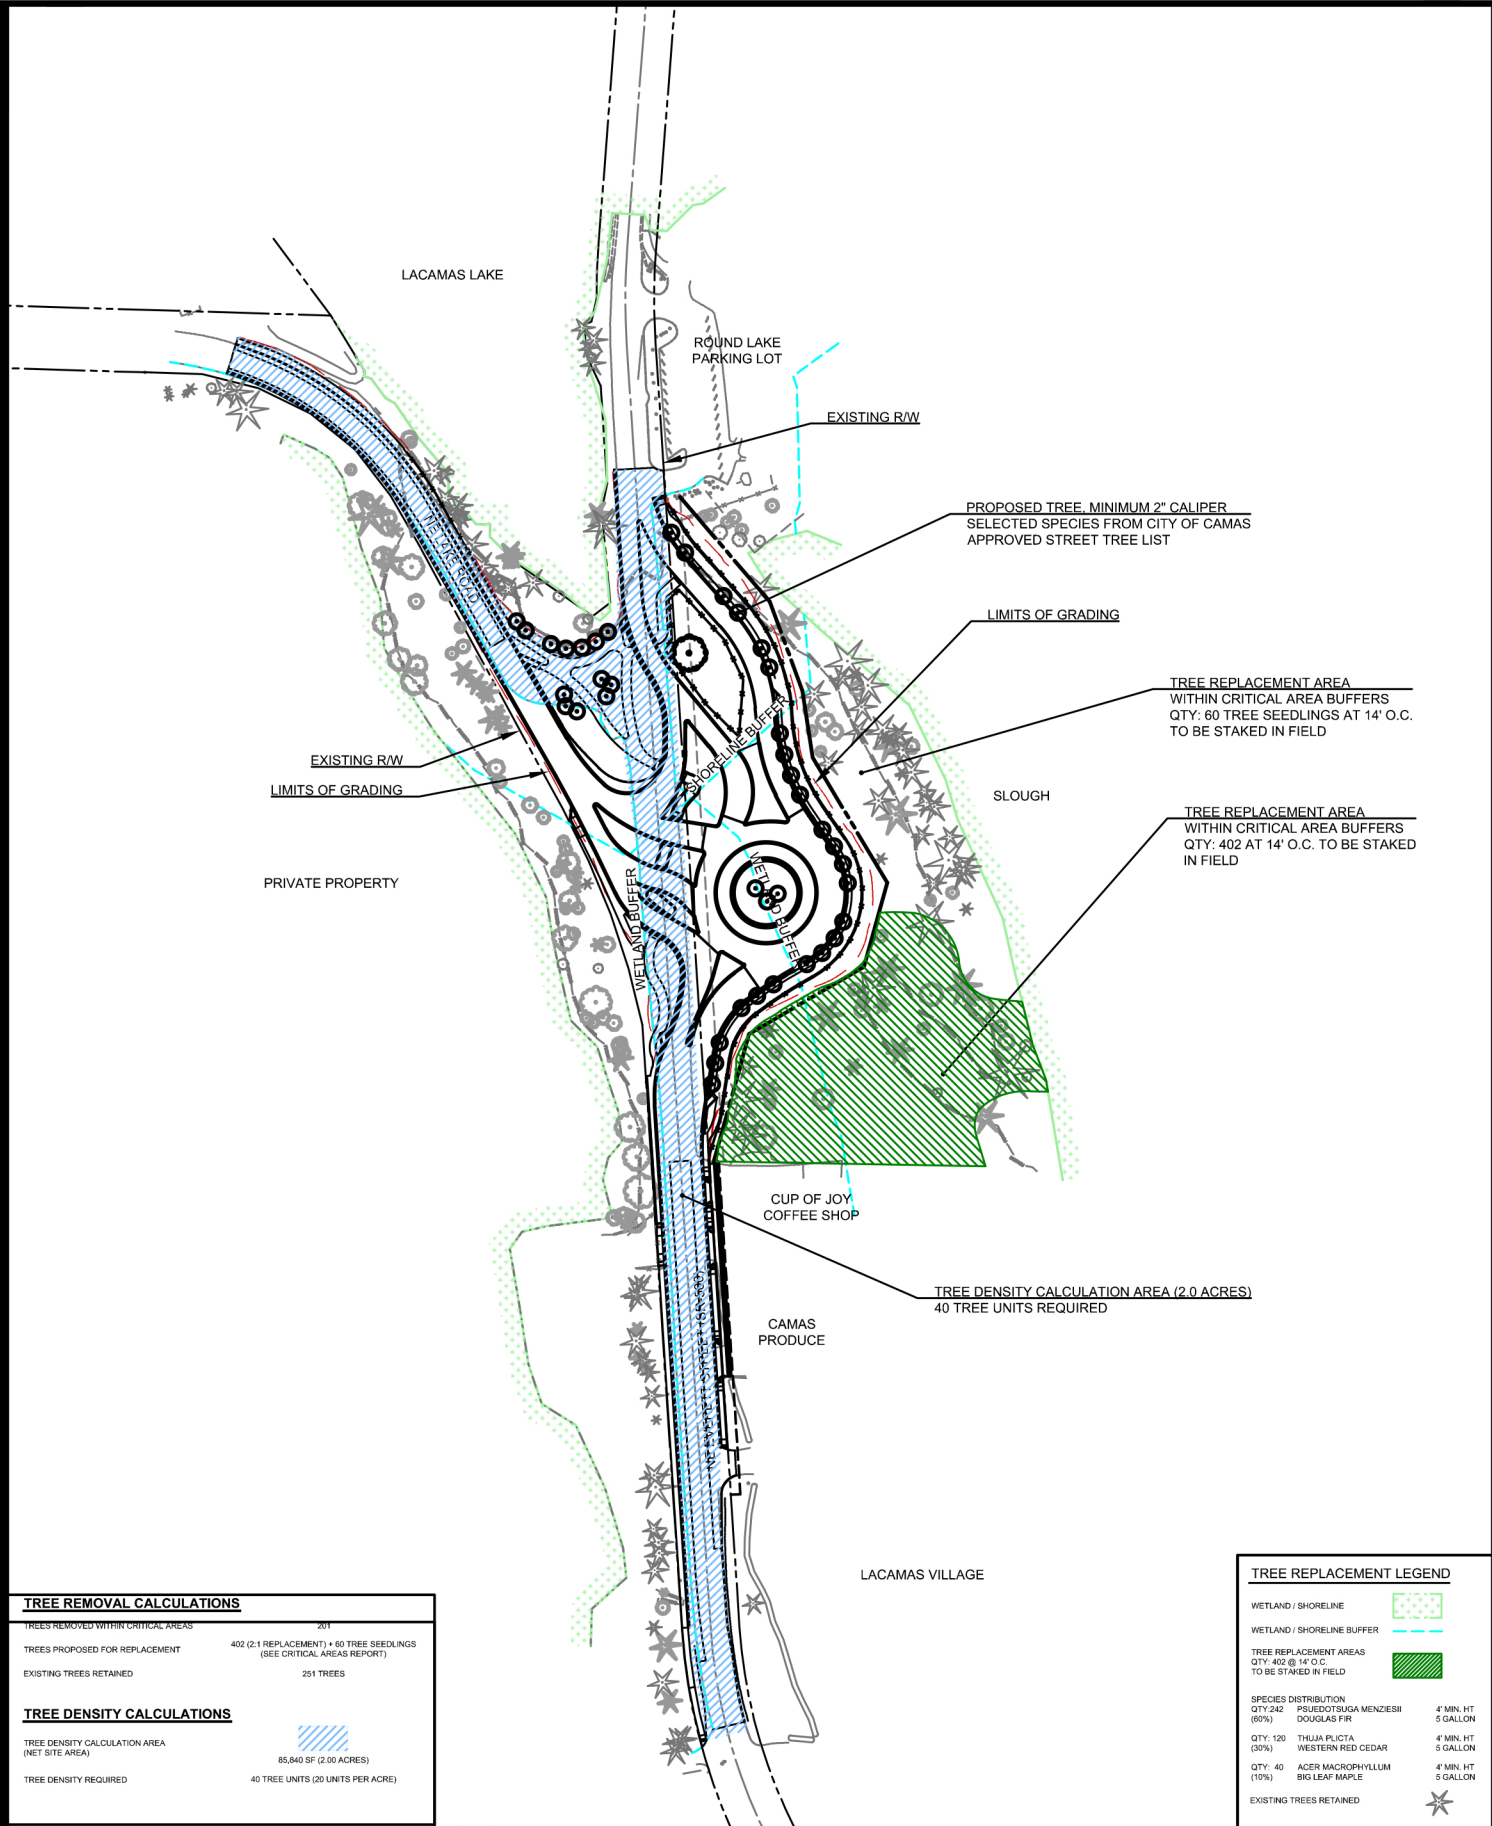
### **Landscape, Tree and Vegetation Plan**

201 trees (within proposed construction limits and hazard tree removal) are proposed to be removed within the critical area buffers. Following CMC requirements, a minimum of 402 trees will be required to be installed. Tree species will include native species of Douglas Fir (60%), Western Red Cedar (30%) and Big Leaf Maple (10%).

TREES REMOVED WITHIN CRITICAL AREAS	201
TREES PROPOSED FOR REPLACEMENT	402 (2:1 REPLACEMENT) + 60 TREE SEEDLINGS (SEE CRITICAL AREAS REPORT)
EXISTING TREES RETAINED	251 TREES

See **Figure 2** for the Tree Mitigation Plan showing replacement quantities and percentage proposed.
