MEMORANDUM

RE: City of Camas Camp Lacamas STEP Sewer Project – Vegetation Near the NE Restroom

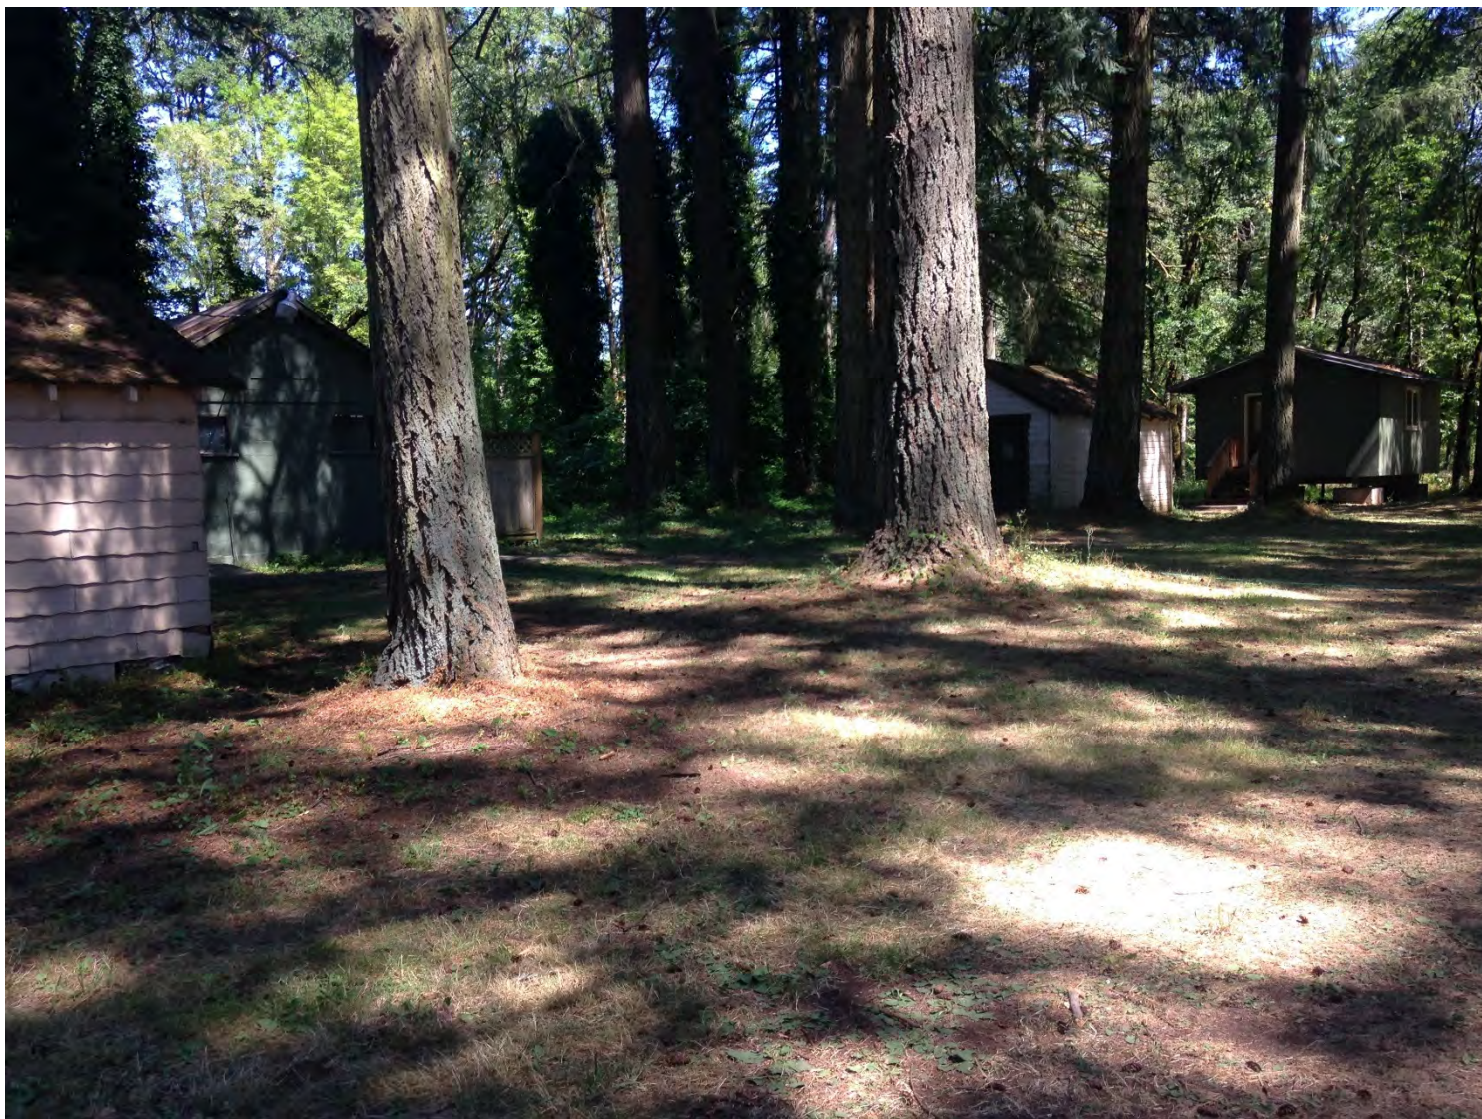
Photograph 1: View east towards the restroom (back left), showing generally barren and sparsely vegetated understory in the vicinity of the proposed alignment. The storage building can be seen, front left, and two cabins are on right, in background. Photograph taken July 28, 2017.

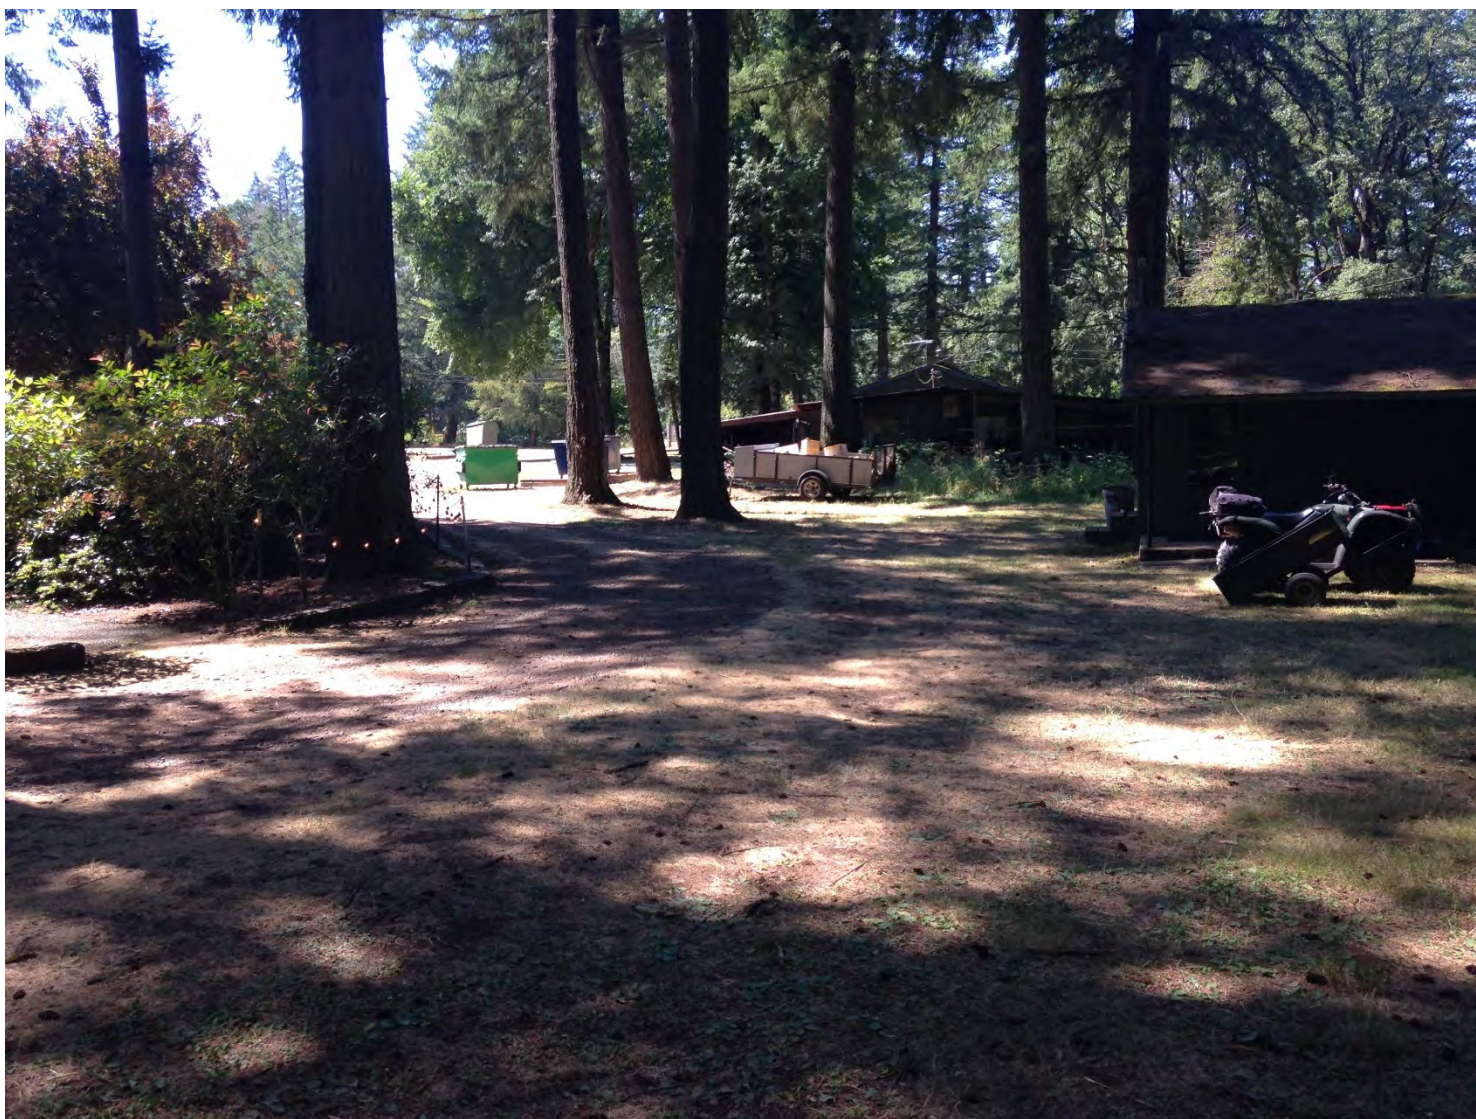
Photograph 2: View west towards gravel driveway, showing generally barren and sparsely vegetated area along the proposed pipe alignment, which would run left to right in the foreground of the photograph. Camp “snack shack” is on the right behind the ATV. Photograph taken July 28, 2017.

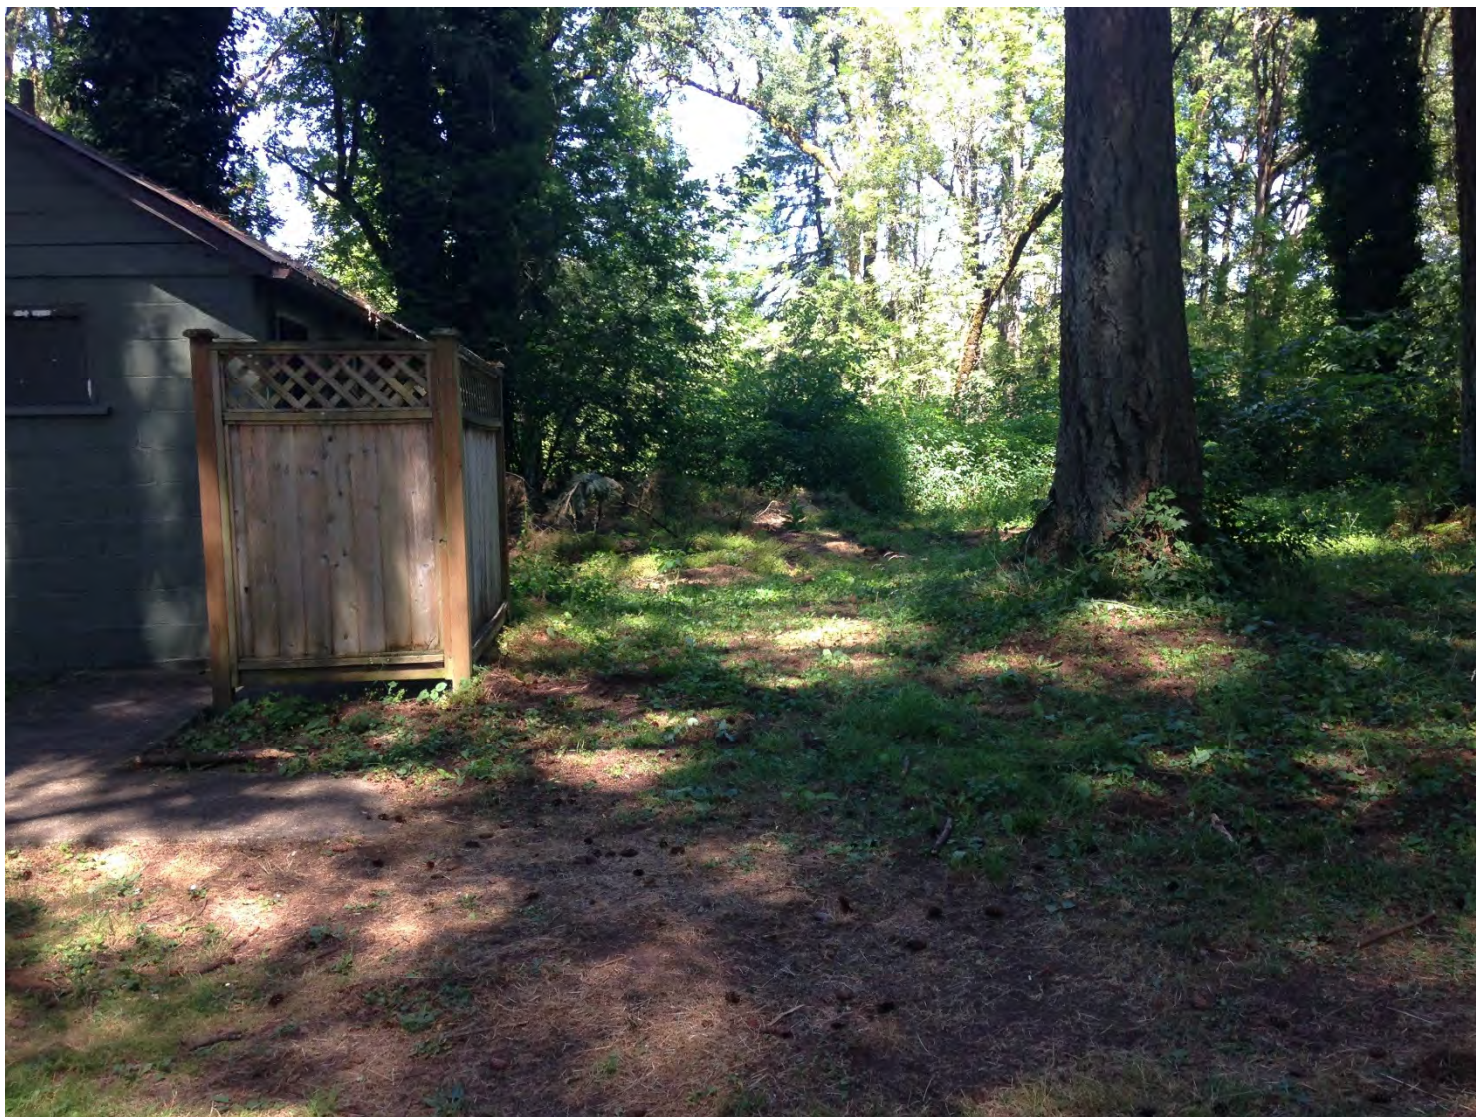
Photograph 3: View along east side of restroom, showing barren soil and sparse vegetation in foreground and area of less trampled (taller) vegetation and piles of grass clippings at back of restroom. The tall shrubs at the edge of the herbaceous cover are beyond the area of impact. The proposed alignment runs between the building and the Douglas fir on right center. Photograph taken July 28, 2017.

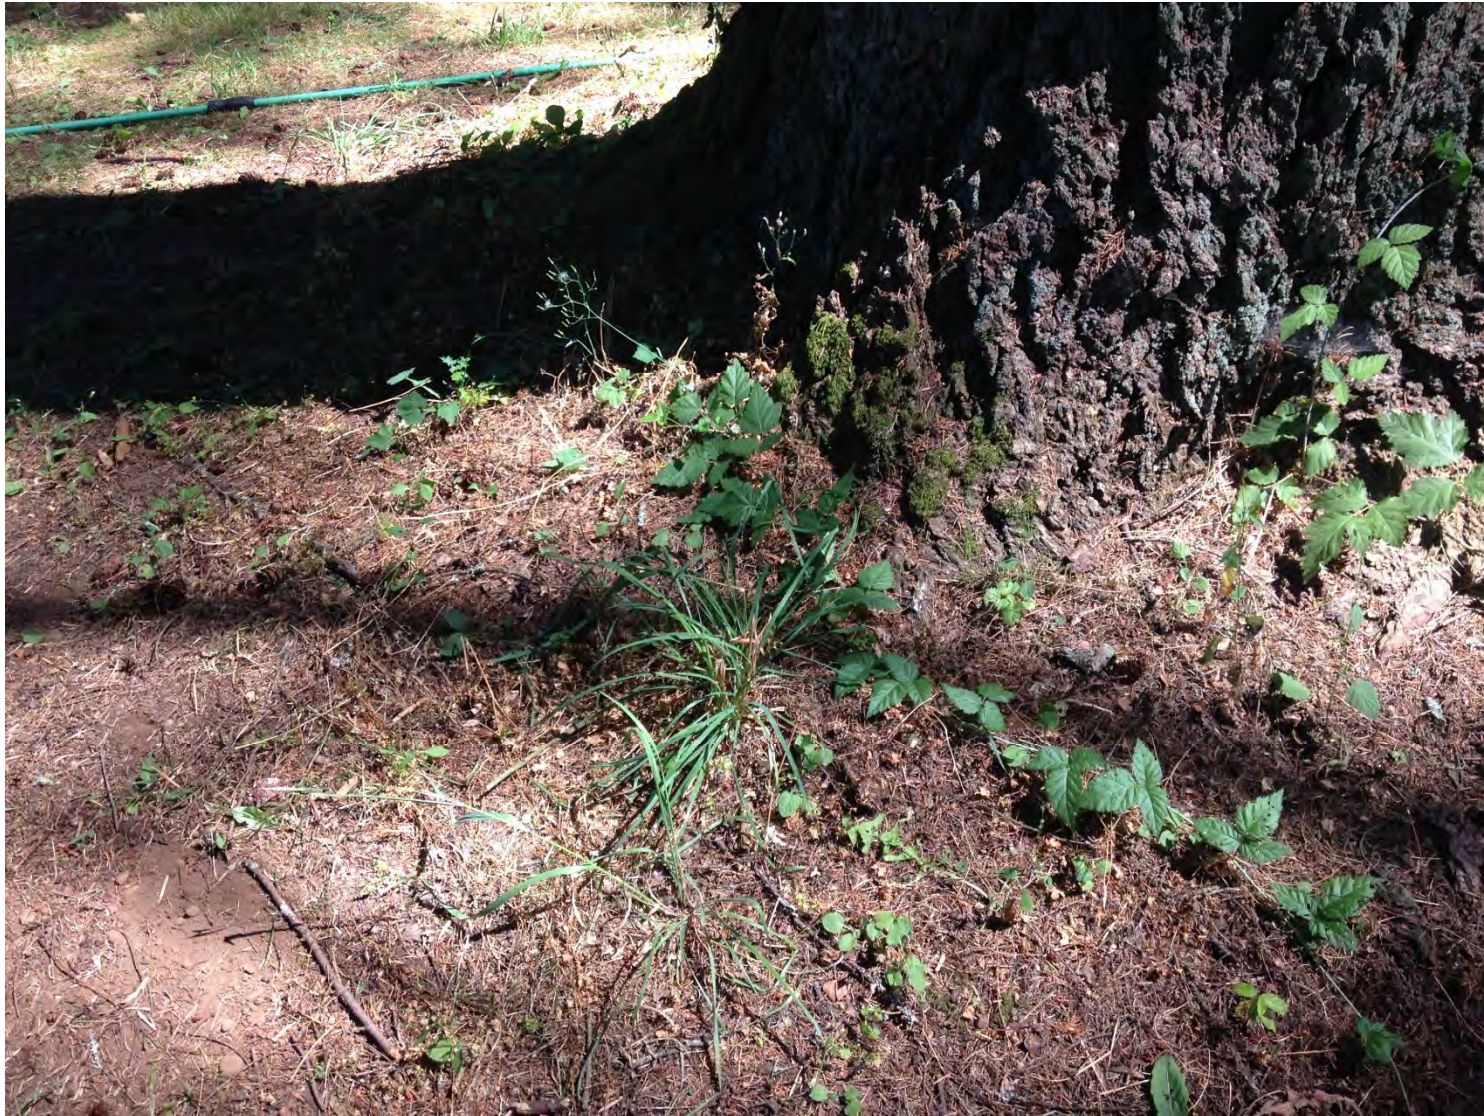
Photograph 4: View around base of a Douglas fir in the vicinity of the proposed alignment, showing barren ground and sparse vegetation. Photograph taken July 28, 2017.
