MEMORANDUM

FROM: Todd Prager, RCA #597, ISA Board Certified Master Arborist

RE: Tree Removal and Protection Recommendations for Grass Valley Development

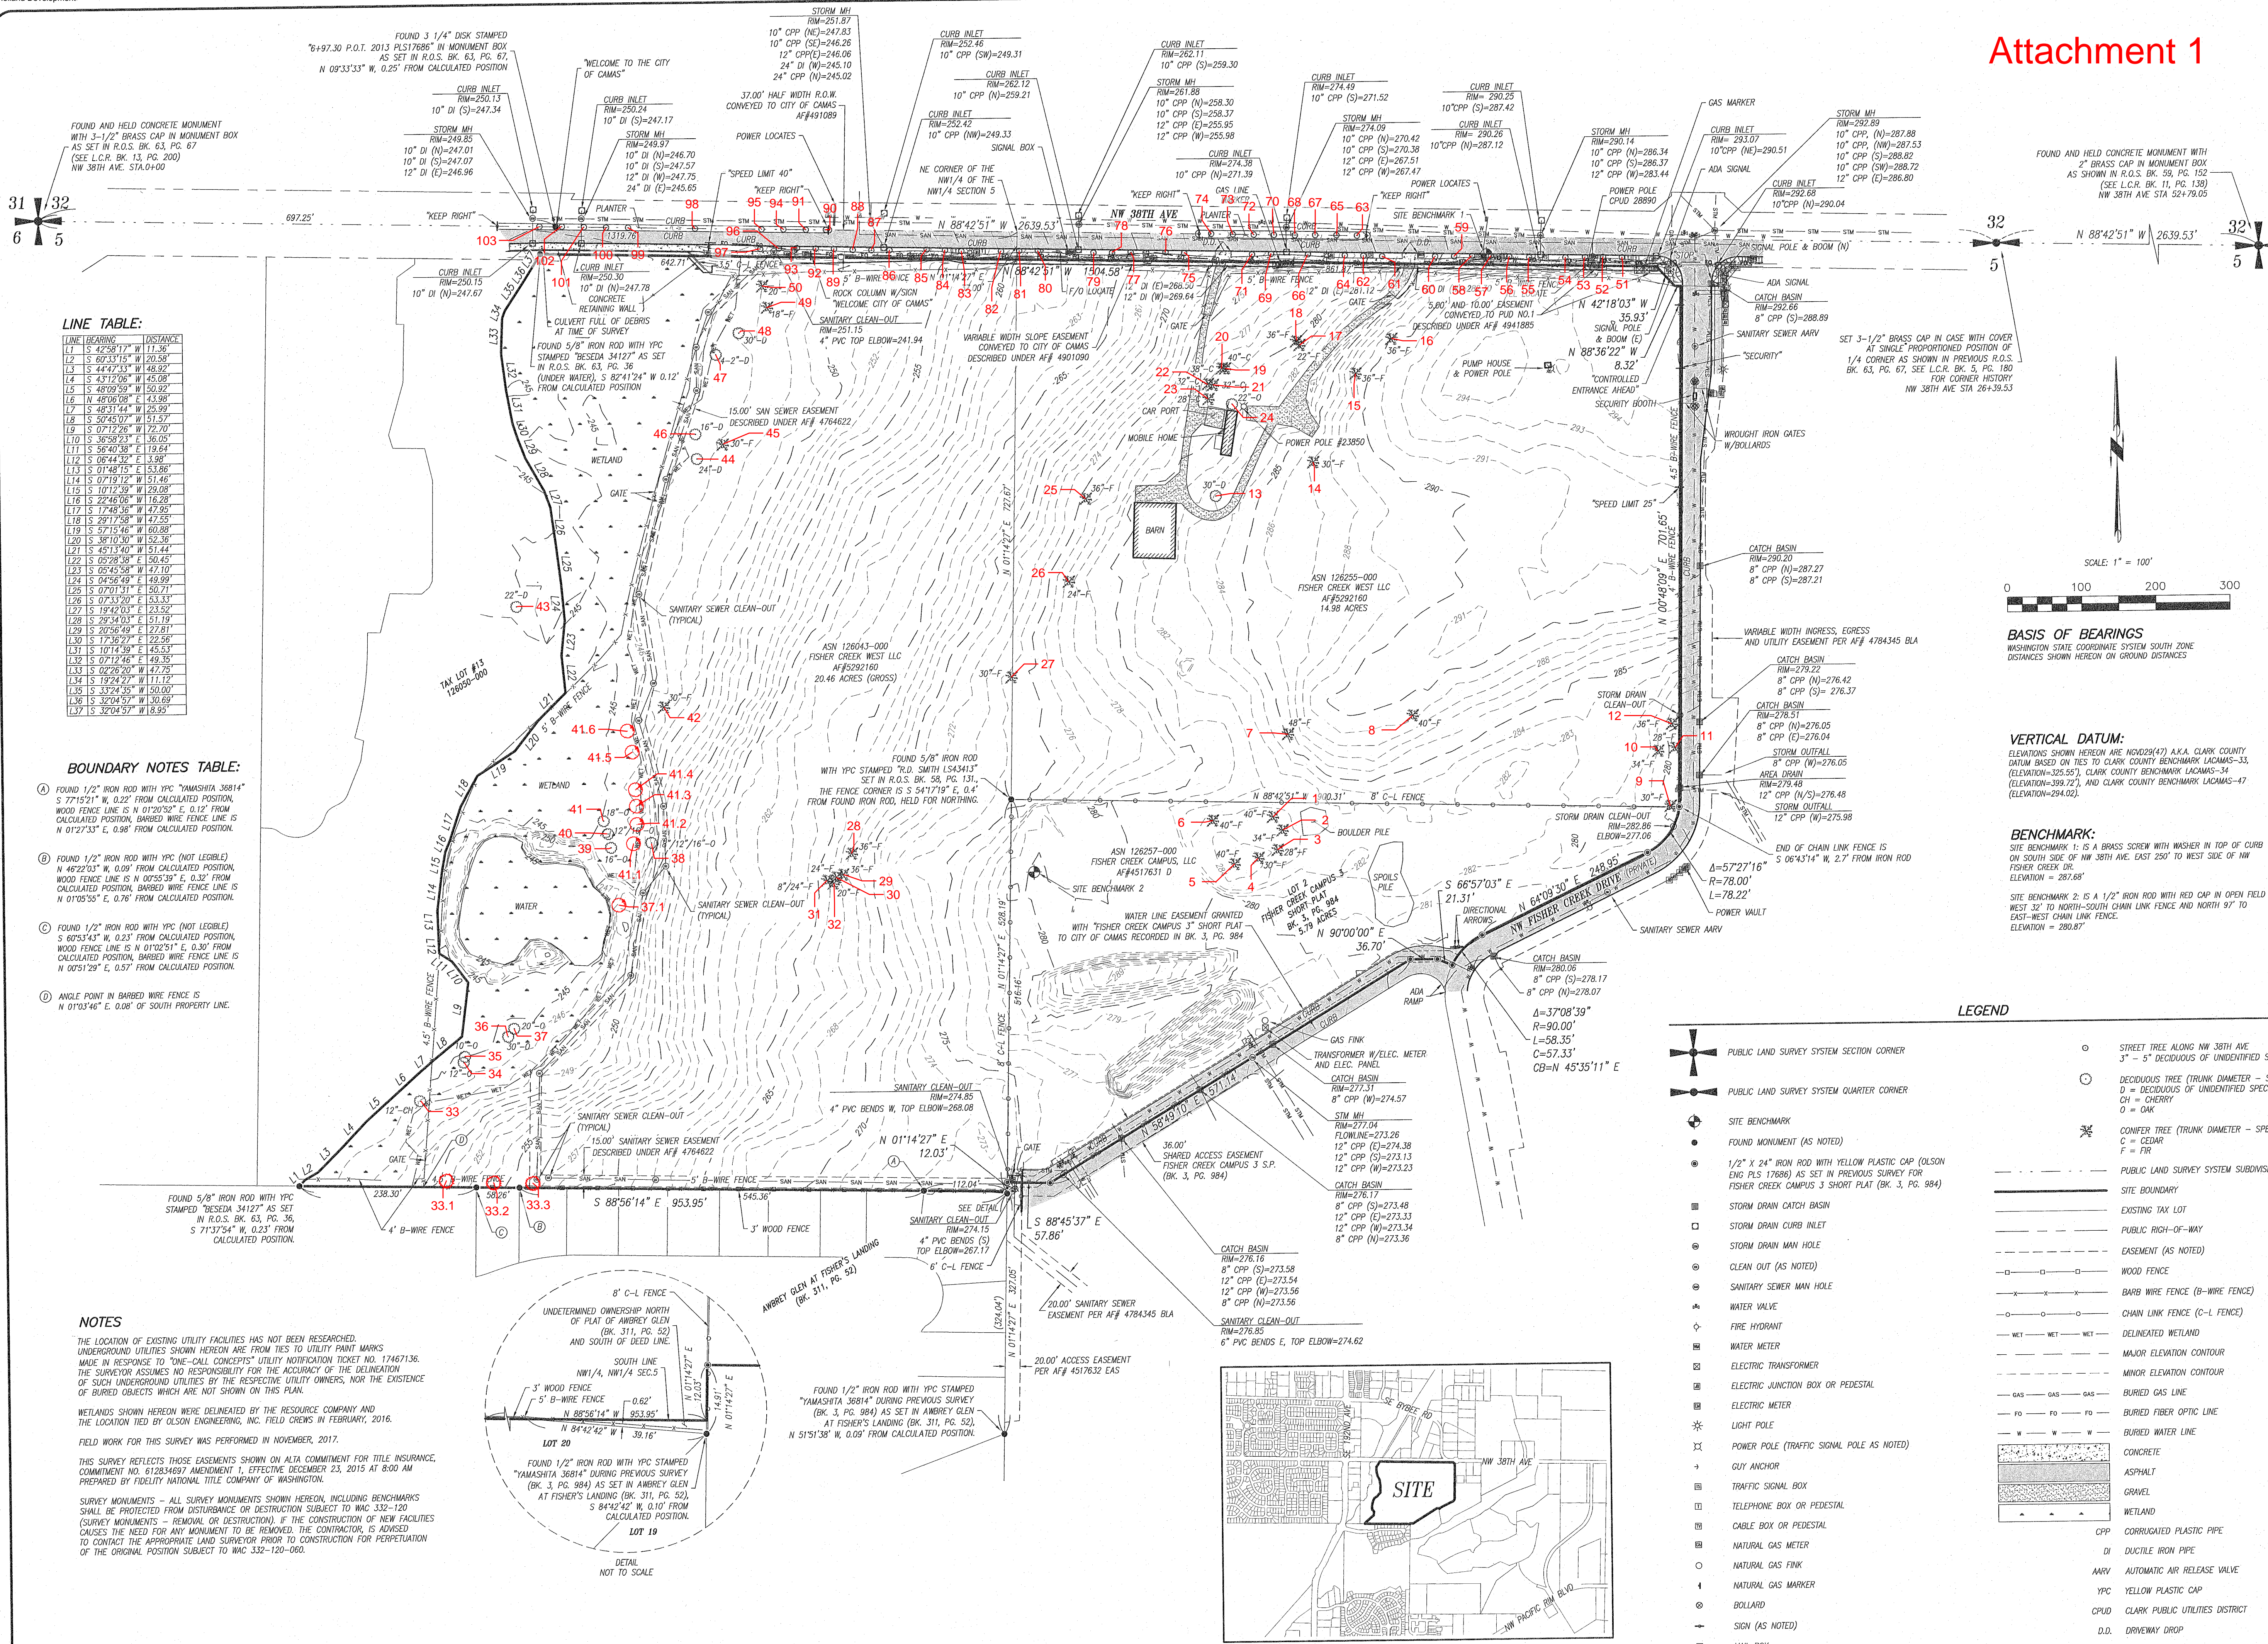
Attachment 1

On February 6, 2018, I completed my assessment of the surveyed trees. The complete inventory data is provided in the tree inventory spreadsheet in Attachment 3. The data collected for each tree includes the tree number, species (common and scientific names), trunk diameter (DBH), tree health condition, tree structural condition, pertinent comments, and treatment (remove or retain). The tree numbers in the tree inventory in Attachment 3 correspond to the tree numbers on the plans in Attachments 1 and 2.

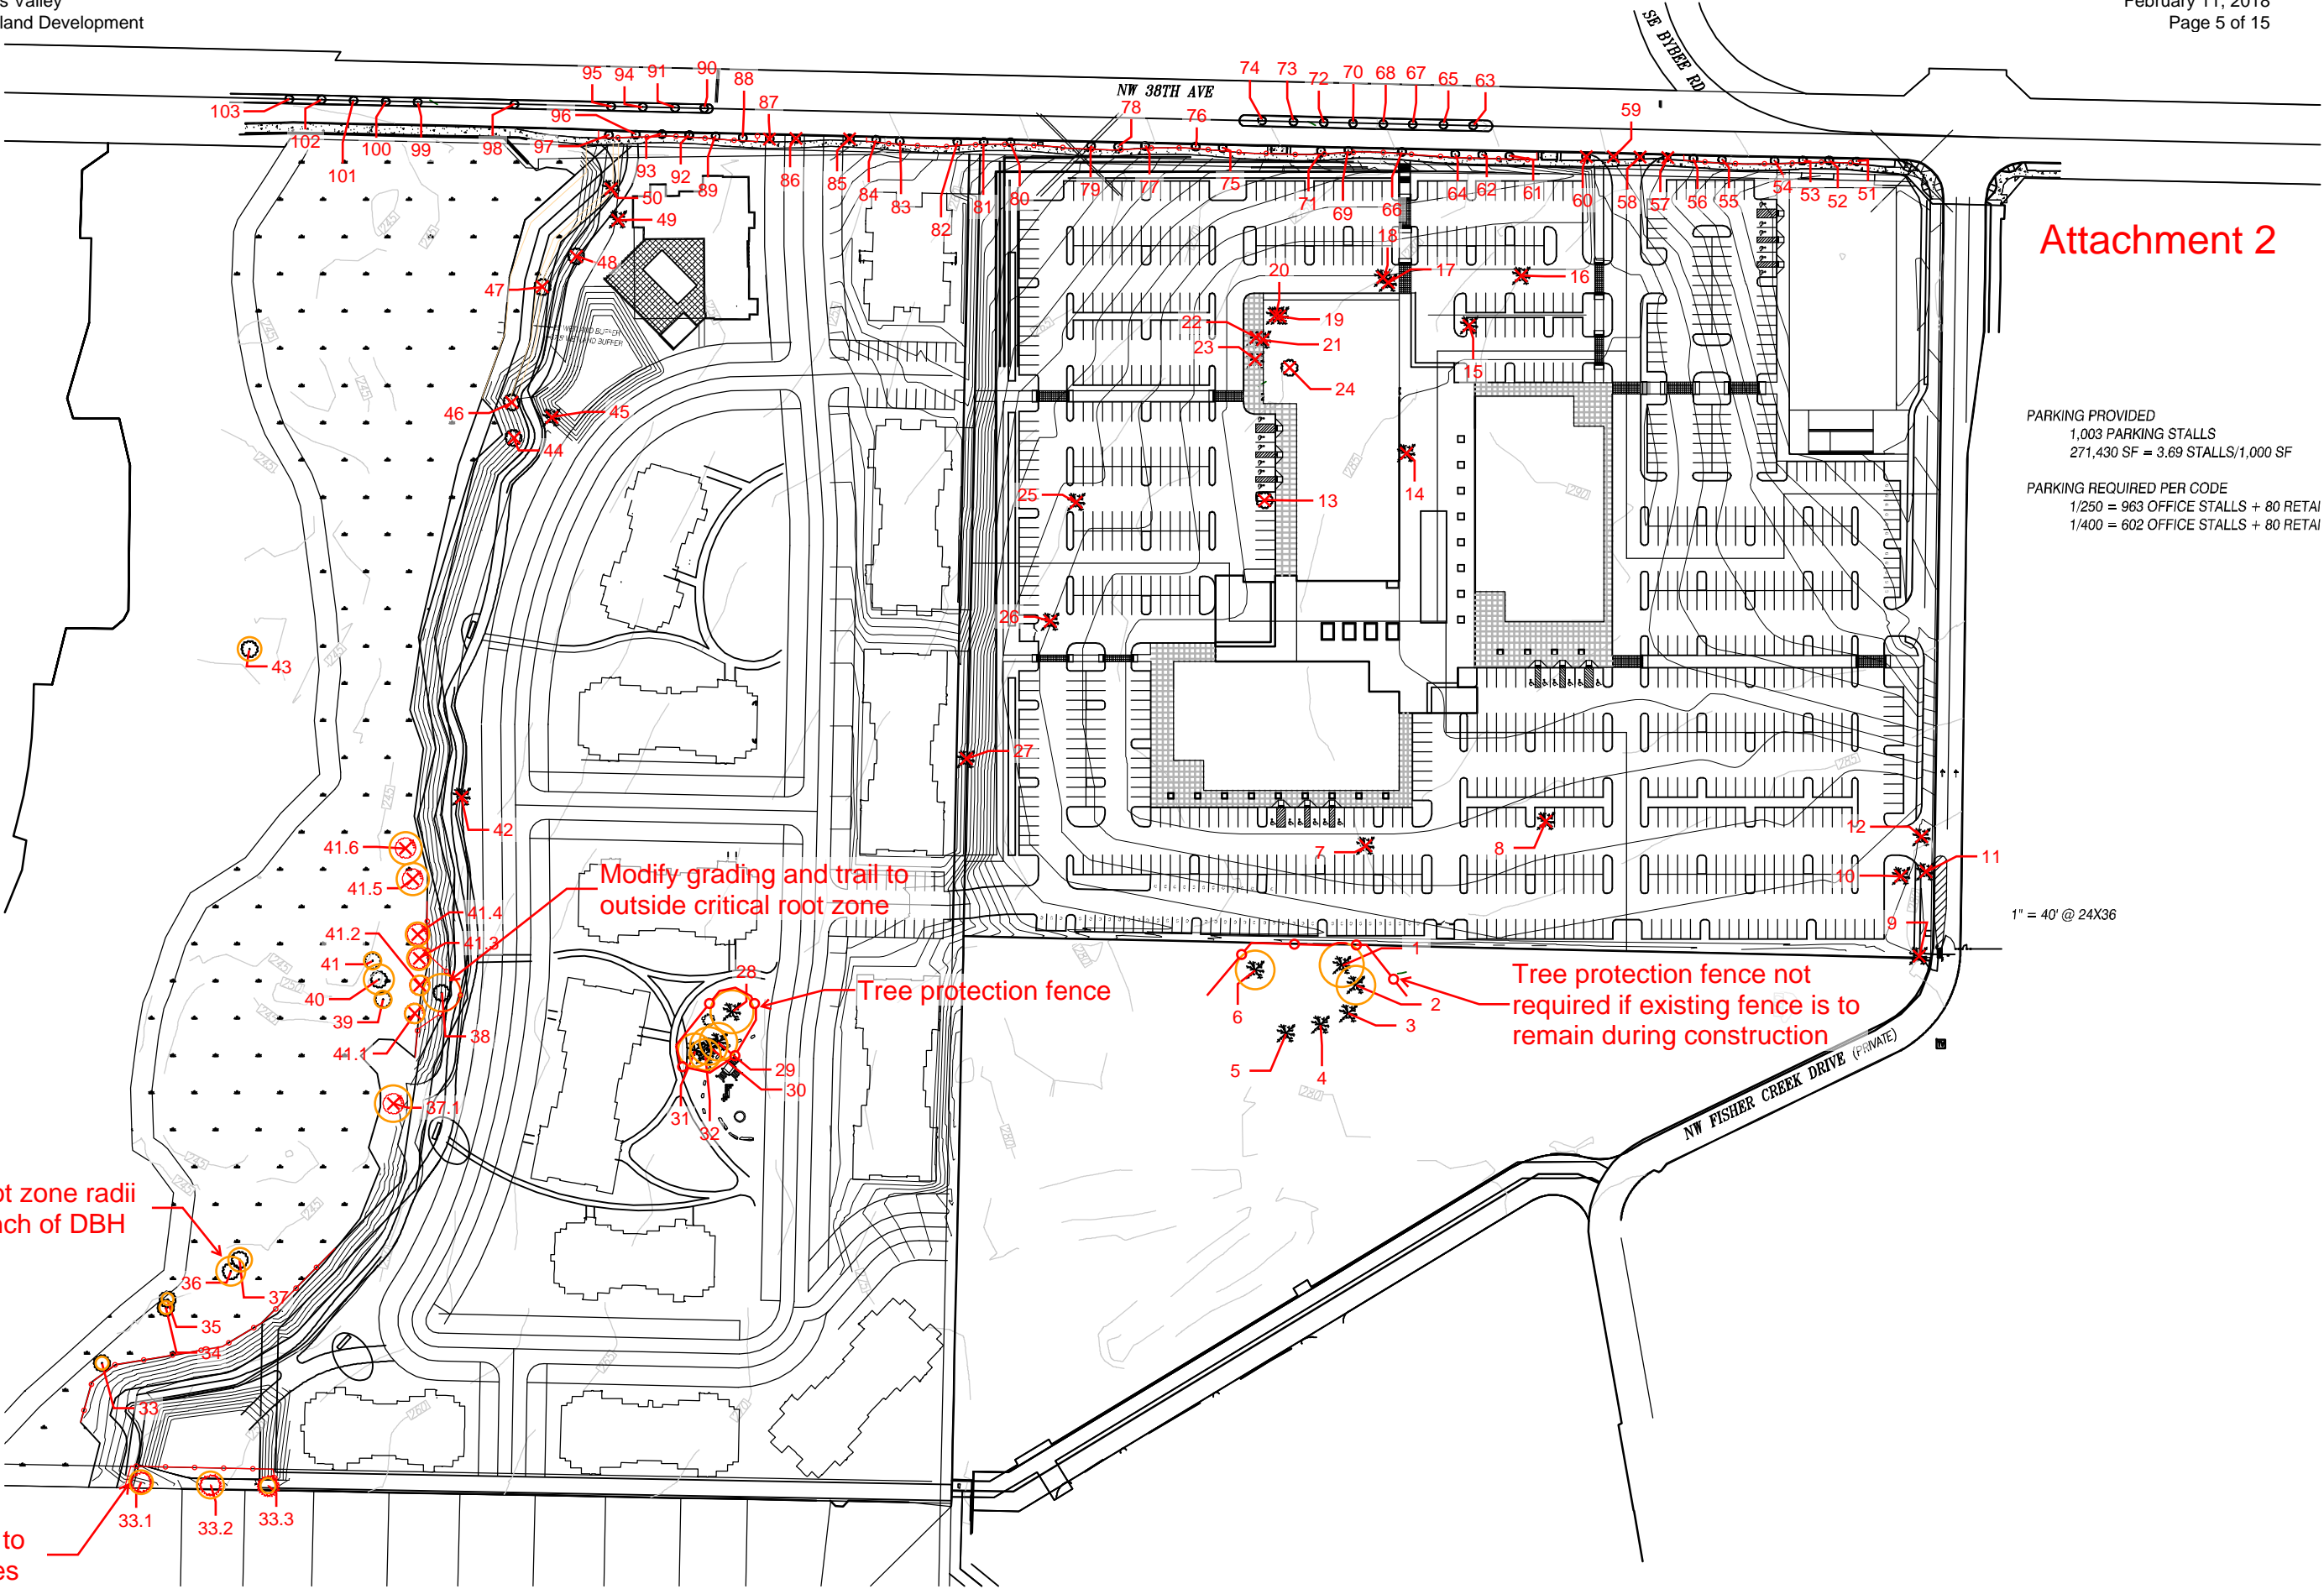
Attachment 2 shows the proposed impacts for site improvements in relation to the trees. Forty-three (43) of the 108 trees at the site are proposed for removal for the following reasons:

- **Trees 7 through 27 and 44 through 50:** Construction impacts from site grading and improvements.
- **Trees 37.1, 41.5, and 41.6:** Potential grading impacts.
- **Trees 41.1 through 41.4:** Very poor health and structural condition, risk to improvements, potential grading impacts.
- **Trees 57 through 60 and 85 through 87:** Site access from NW 38th Avenue.

Modify grading and trail to
outside critical root zones

- **Protection Fencing:** Establish tree protection fencing in the locations shown in Attachment 2. The intent of the tree protection fencing is to protect a minimum root protection zone radius around each tree to be retained of .5 feet per inch of DBH (e.g. 12-foot radius around a 24-inch tree). Note that tree protection fencing is not required for trees 1 through 6 if the existing fence is to remain during construction.

- **Modify Grading and Pathway:** Grading and pathway construction is proposed within the critical root zones of trees 31, 33.1, 33.2, 33.3, and 38. The grading and pathway construction should be relocated so it is outside the critical root zones. Note that the use of retaining walls may be required to move proposed grading outside the root zones.
