E PLAN AND ASSESSMENT BY
WHYNN J. DEAN, ISA CERTIFIED
IST #PN-6396A AND TRAQ #1571

LACAMAS CREEK PARK TREE PLAN

LACAMAS CREEK
SANITARY SEWER
PUMP STATION
IMPROVEMENTS

CITY PROJECT NO. S1000

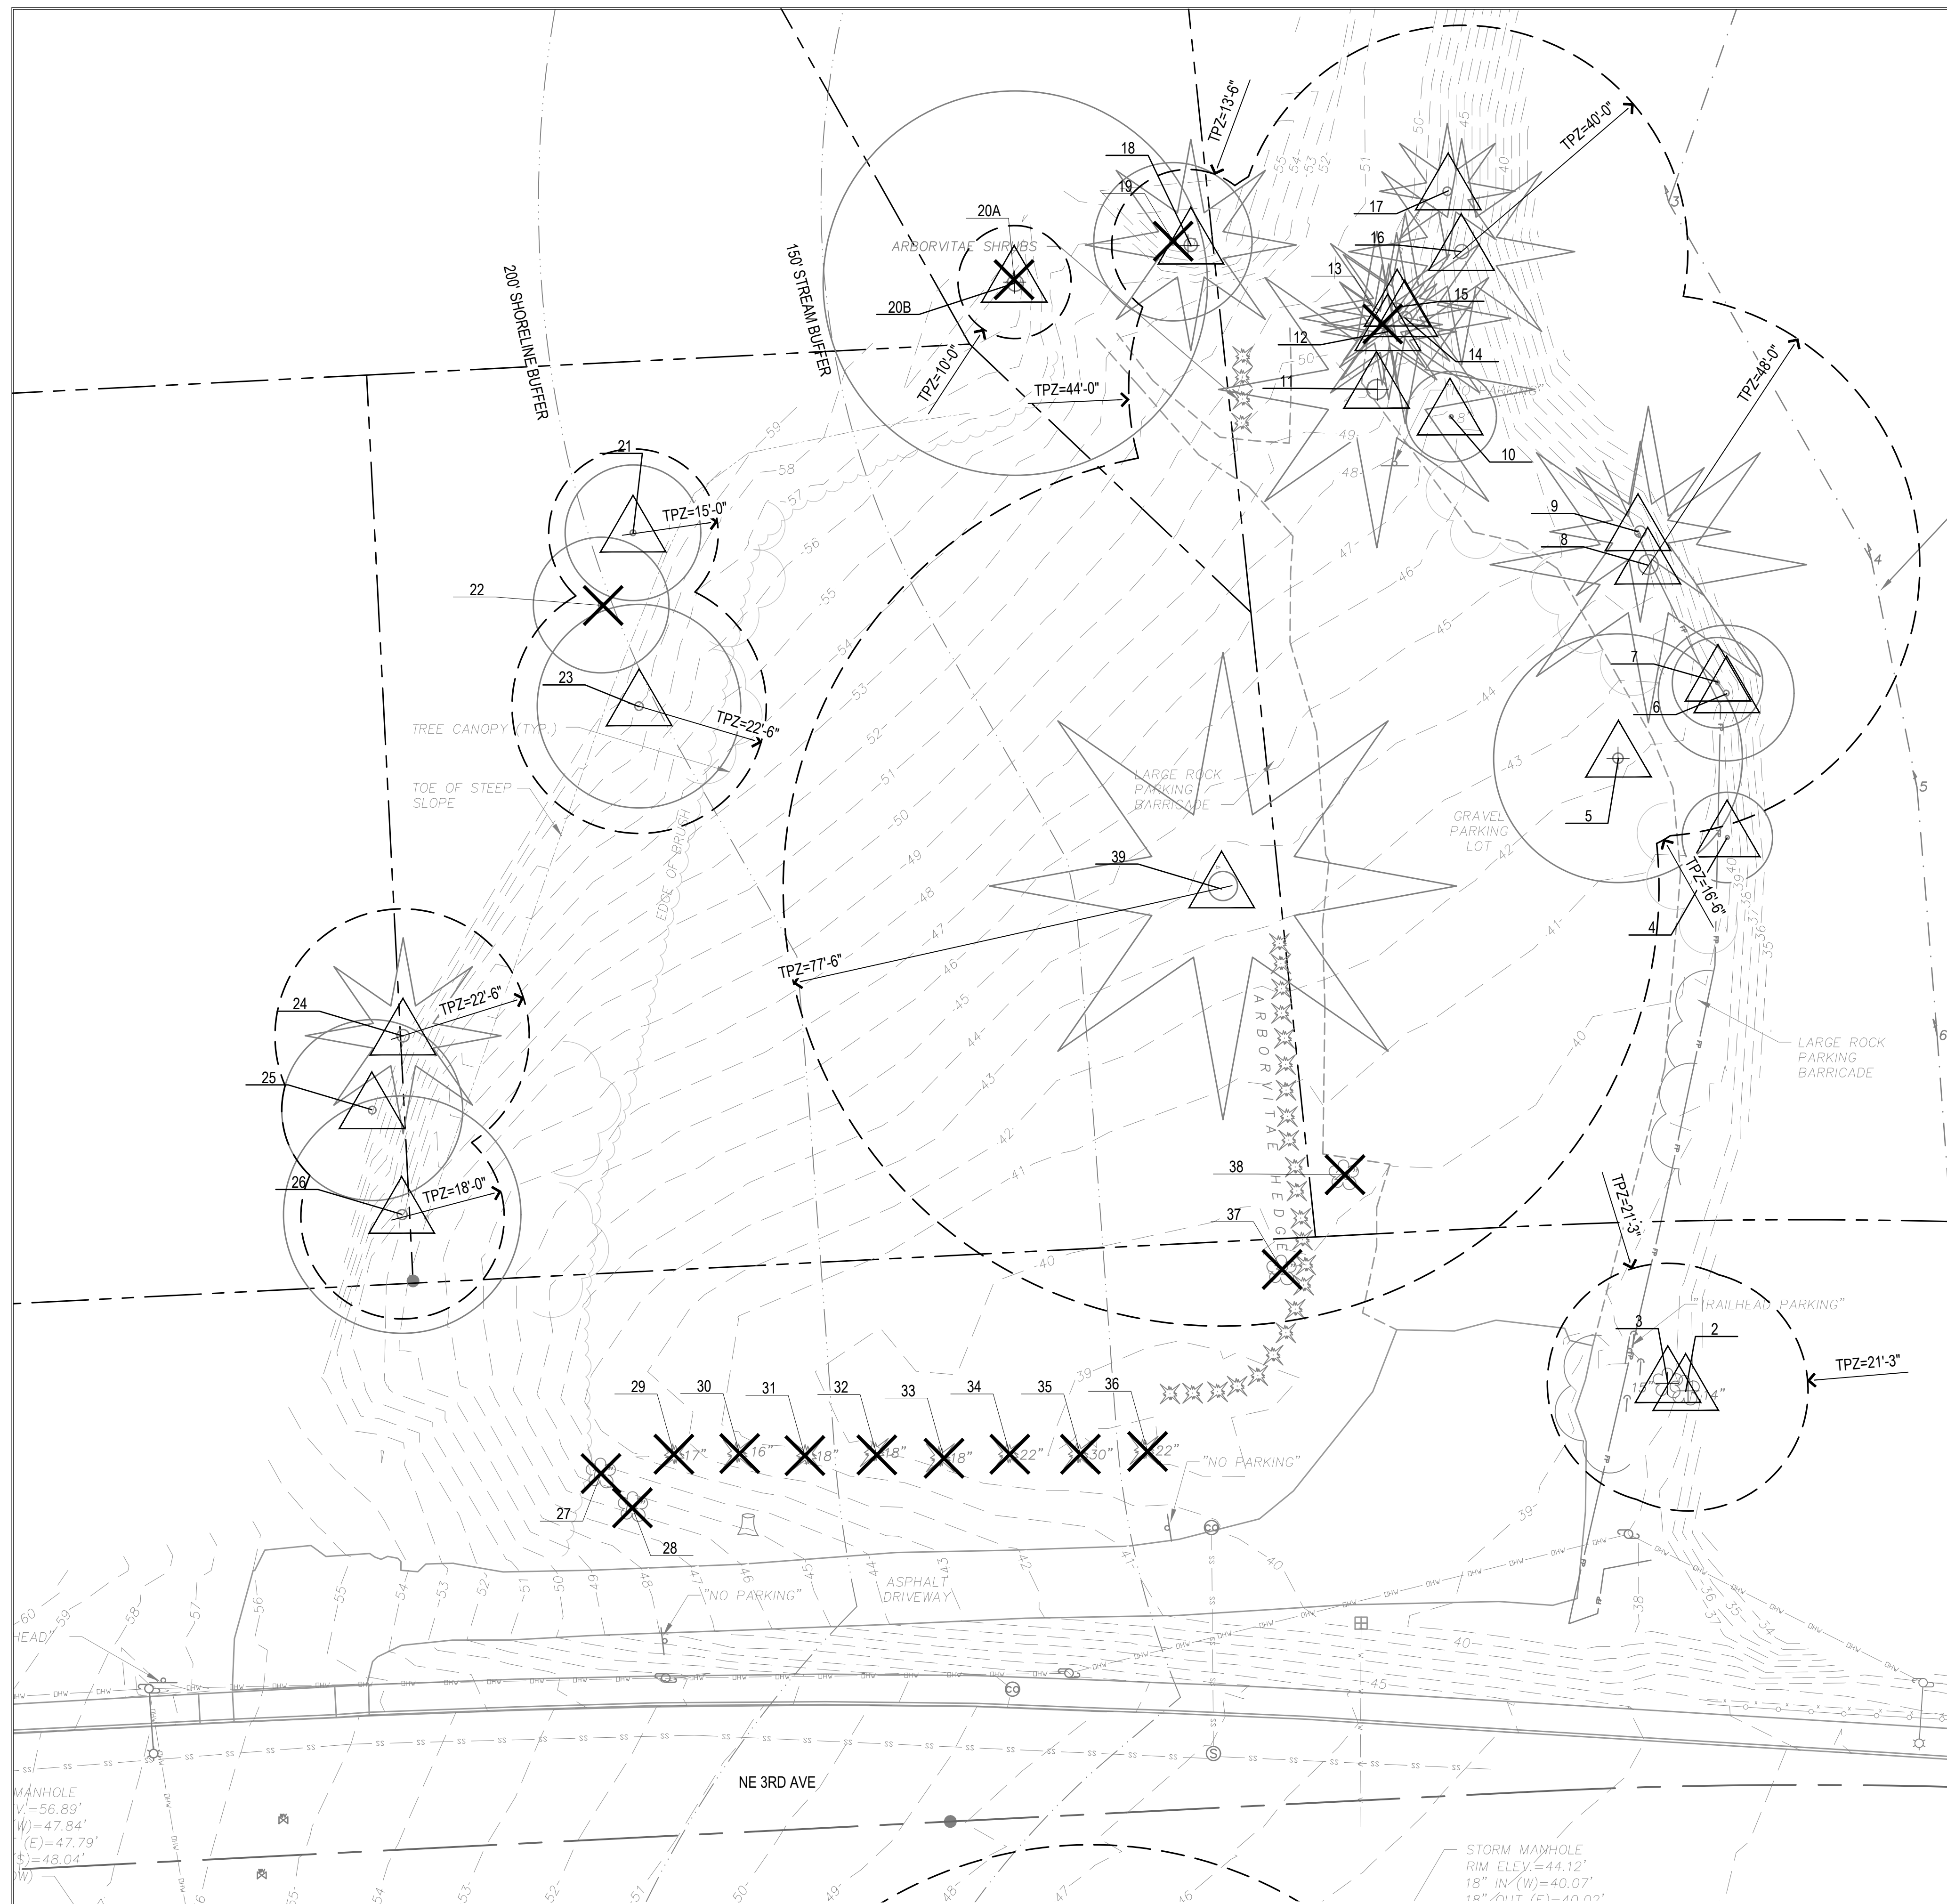
TABLE OF TREES									<div>GREENWORKS</div> <div>GreenWorks, P.C. Landscape Architecture Environmental Design</div> <div>24 NW 2nd Avenue, Suite 100 Portland, Oregon 97209 Ph:503.222.5612 / F:503.222.2283 Email: info@greenworkspc.com</div> <div>GREENWORKS PROJECT NO: 118060.2</div>
TREE NUMBER	CONIFER OR DECID.	COMMON NAME	BOTANICAL NAME	SIZE (DBH)	CONDITION (STRUCTURAL STABILITY)	COMMENTS	HAZARD (RATING)	RECOMMENDATION	
1	-	ID NUMBER NOT USED							
2	D	BIGLEAF MAPLE	ACER MACROPHYLLUM	17	FAIR	#2 AND #3 ARE CODOMINANT STEMS OF SAME TREE. ABNORMAL BARK PATTERNS MAY INDICATE DECAY IN STEMS. NO CONKS EVIDENT BUT HEAVY IVY COVER MAY BE CONCEALING ANY ON GROUND. SOUNDING REVEALED NO OBVIOUS DECAY COLUMN. THIS TREE SHOULD BE RE-EVALUATED ONCE CANOPY LEAFS OUT. MORE IN-DEPTH TESTING (DRILLING, SONIC TOMOGRAPHY) MAY BE HELPFUL IF DESIRE IS TO RETAIN TREE.		RETAIN AND MONITOR	
3	D	BIGLEAF MAPLE	ACER MACROPHYLLUM	17	FAIR

4	D	NOT SIGNIFICANT TREE		8					
5	D	OREGON WHITE OAK	QUERCUS GARRYANA	22	GOOD.	WELL-HEALED WOUNDS AT 3' HT AND BELOW.		RETAIN. PROVIDE TREE PROTECTION ZONE AS SHOWN ON PLANS PRIOR TO START OF CONSTRUCTION.	
6	D	OREGON WHITE OAK	QUERCUS GARRYANA	12	FAIR	TREE LOCATED AT TOP OF SLOPE OVERLOOKING CREEK. NUMEROUS SMALL CONKS ON TRUNK MAY INDICATE COLUMN OF INTERNAL DECAY NOT REVEALED BY SOUNDING. HEAVY IVY COVER OBSCURES INSPECTION OF ROOT FLARE OR SURROUNDING GROUND. SEASONAL LACK OF FOLIAGE MEANS CANOPY HEALTH CANNOT BE REVIEWED FOR OTHER SIGNS OF INTERNAL DECAY. THIS TREE SHOULD BE RE-EVALUATED ONCE FOLIAGE IS PRESENT. DUE TO TREE'S LOCATION AND LEAN, IF IT WERE TO FAIL IT WOULD MOST LIKELY FALL EAST INTO THE CREEK (LOW TARGET RATING).		RETAIN AND MONITOR	
7	D	NOT SIGNIFICANT TREE		8					
8	C	DOUGLAS FIR	PSEUDOTSUGA MENZIESII	48	GOOD	SUPPRESSED BY #9		RETAIN	
9	C	DOUGLAS FIR	PSEUDOTSUGA MENZIESII	35	GOOD	SUPPRESSED BY #8.		RETAIN

10	D	NOT SIGNIFICANT TREE		8					
11	C	DOUGLAS FIR	PSEUDOTSUGA MENZIESII	44	GOOD			RETAIN	
12	C	DOUGLAS FIR	PSEUDOTSUGA MENZIESII	17	FAIR	SUPPRESSED BY #13. SELF-CORRECTED LEAN.		RETAIN	
13	C	WESTERN RED CEDAR	THUJA PLICATA	19	FAIR	DECAYED STUB ON SE SIDE WITH CENTRAL COLUMN OF DECAY. TOP GONE. SUPPRESSED BY #11 AND #15.	YES (9)	REMOVE FOR CONDITION. ALTHOUGH THUJA PLICATA CAN REMAIN STANDING WITH CENTRAL COLUMN OF DECAY, THIS TREE'S ADJACENCY TO THE TRAIL MEANS THE TARGET RATING IS VERY HIGH. A CODOMINANT STEM IS ALREADY GONE LEAVING A DECAY CAVITY. IF DESIRE IS TO RETAIN THIS TREE, MORE INVASIVE TESTING (DRILLING/SONIC TOMOGRAPHY) SHOULD BE USED TO GIVE MORE INFO ON EXTENT OF INTERNAL DECAY AND THICKNESS OF STEM WALL.	
14	C	DOUGLAS FIR	PSEUDOTSUGA MENZIESII	28	GOOD	SELF-CORRECTED LEAN. ROOTED UNDER #15		RETAIN	
15	C	WESTERN RED CEDAR	THUJA PLICATA	25	GOOD			RETAIN	
16	C	DOUGLAS FIR	PSEUDOTSUGA MENZIESII	40	GOOD	TREE AT CREST OF SLOPE. SWELLING ON UPHILL SIDE AT BASE OF TRUNK APPEARS TO CONTAIN OLD PHAEOLUS SCHWEINTZII CONK. NO OTHER CONKS OR RESINOSUS OBSERVED.		RETAIN AND MONITOR

17	C	DOUGLAS FIR	PSEUDOTSUGA MENZIESII	20	GOOD	LOW CROWN RATIO. AT CREST OF SLOPE. SLIGHT SELF-CORRECTED LEAN.		RETAIN.	
18	C	DOUGLAS FIR	PSEUDOTSUGA MENZIESII	28	GOOD	SUPPRESSED ON NORTH SIDE BY TREES UPHILL (OFF-SITE)		RETAIN	
19	D	OREGON OAK	QUERCUS GARRYANA	18	POOR	TOP GONE. DECAYED STUB AT 15' HT. LOTS OF PRUNING CUTS NOT WELL-HEALED. LARGE NUMBERS OF SMALL YOUNG FUNGUS ON STEM. TREE LOCATED ON SLOPE ABOVE LAWN AREA.	YES (7)	REMOVE FOR CONDITION.	
20A	D	BIGLEAF MAPLE	ACER MACROPHYLLUM	18 + 20	FAIR	SURVEY GROUPED 3 STEMS AS ONE TREE; ACTUALLY TWO TREES: ONE MAPLE WITH TWO STEMS AND ONE SMALLER OAK GROWING IN CLOSE PROXIMITY. THE MAPLE HAS TWO CODOMINANT STEMS WITH INCLUDED BARK, SPLIT ALONG INCLUSION LINE AND CAVITY WITH CALLUSED EDGES. NO OBVIOUS DECAY COLUMN REVEALED BY SOUNDING WITH MALLET; GROUND INSPECTION LIMITED BY HEAVY IVY GROWTH.	YES (8)	EITHER REMOVE OR DO CROWN REDUCTION TO REDUCE PROBABILITY OF FAILURE IF DESIRE IS TO RETAIN TREE. TREE IS ON SLOPE ABOVE LAWN (HIGH TARGET RATING/ FREQUENTLY OCCUPIED) AND ANOTHER TREE HAS RECENTLY FAILED TO THE SOUTH OF THIS ONE.

20B	D	GARRY OAK	QUERCUS GARRYANA	10	FAIR	THE OAK OF THIS GROUP HAS NO OBVIOUS HEALTH PROBLEMS, BUT IS LEANING SIGNIFICANTLY ON THE SLOPE ABOVE THE LAWN AREA. HEAVY IVY INFESTATION OF GROUND MAKES DETECTION OF ANY FUNGAL FRUITING BODIES ON ROOTS IMPOSSIBLE. RE-EVALUATE WHEN CANOPY LEAFS OUT FOR ANY SIGNS OF ROOT ROT.		RETAIN AND RE-EVALUATE. CROWN REDUCTION TO REDUCE WEIGHT.	
21	D	BIGLEAF MAPLE	ACER MACROPHYLLUM	12	GOOD	SELF-CORRECTED LEAN DUE TO SLOPE. HEAVY IVY INFESTATION.		RETAIN	
22	D	BIGLEAF MAPLE	ACER MACROPHYLLUM	12	FAIR	TOP IS GONE, HEAVY IVY INFESTATION. CAVITY AT ROOT FLARE ON DOWNHILL SIDE. TREE ON SLOPE ABOVE LAWN AREA.		REMOVE	
23	D	BIGLEAF MAPLE	ACER MACROPHYLLUM	12 + 16	GOOD	CODOMINANT AT 2' HT. NO CRACK OR SPLIT AT INCLUSION LINE. HEAVY IVY INFESTATION.		RETAIN	
24	C	DOUGLAS FIR	PSEUDOTSUGA MENZIESII	30	GOOD	HEAVY IVY INFESTATION.		RETAIN	
25	D	BIGLEAF MAPLE	ACER MACROPHYLLUM	16	FAIR	HEAVY IVY INFESTATION OBSCURING BASE. LEANS 15° TOWARDS LAWN ON STEEP SLOPE. RECOMMEND RE-EVALUATION ONCE CANOPY LEAFS OUT.		RETAIN AND MONITOR

26	D	BIGLEAF MAPLE	ACER MACROPHYLLUM	14 + 15	FAIR	CODOMINANT STEMS AT 2' HT; NO CRACKS, CAVITIES OR CONKS OBSERVED. HEAVY IVY INFESTATION OBSCURING BASE. RECOMMEND RE-EVALUATION ONCE CANOPY LEAFS OUT TO DETERMINE AMOUNT OF DEADWOOD IN CROWN AND REVIEW FOLIAGE HEALTH. PRIOR FAILURE OF LARGE TREE TO SOUTH.		RETAIN AND MONITOR. MAY NEED CROWN CLEANING TO REDUCE WEIGHT ON BRANCHES LEANING OUT TO LAWN (TARGET AREA).	
27	D	RED ALDER	ALNUS RUBRA	16	POOR	DEAD/DYING. MULTIPLE SAPROPHYTIC CONKS ON STEM.	YES (10)	REMOVE FOR CONDITION	
28	D	RED ALDER	ALNUS RUBRA	17	POOR	DEAD/DYING. LARGE AREA OF DECAY AT BASE OF STEM ON EAST WHERE CODOMINANT STEM TORE OUT. CONKS. LEANING IN TO LAWN AREA.	YES (10)	REMOVEFOR CONDITION	
29	C	LEYLAND CYPRESS	X CUPRESSOCYPARIS LEYLANDII	17	GOOD			REMOVE FOR CONSTRUCTION	
30	C	LEYLAND CYPRESS	X CUPRESSOCYPARIS LEYLANDII	16	GOOD			REMOVE FOR CONSTRUCTION	
31	C	LEYLAND CYPRESS	X CUPRESSOCYPARIS LEYLANDII	19	GOOD			REMOVE FOR CONSTRUCTION

32	C	LEYLAND CYPRESS	X CUPRESSOCYPARIS LEYLANDII	20	GOOD			REMOVE FOR CONSTRUCTION	
33	C	LEYLAND CYPRESS	X CUPRESSOCYPARIS LEYLANDII	19	GOOD			REMOVE FOR CONSTRUCTION	
34	C	LEYLAND CYPRESS	X CUPRESSOCYPARIS LEYLANDII	22	FAIR	CODOMINANT STEMS WITH INCLUDED BARK UP TO 5'		REMOVE FOR CONSTRUCTION	
35	C	LEYLAND CYPRESS	X CUPRESSOCYPARIS LEYLANDII	25 @ 2'	FAIR	FOUR STEMS; INCLUDED BARK AT ATTACHMENTS		REMOVE FOR CONSTRUCTION	
36	C	LEYLAND CYPRESS	X CUPRESSOCYPARIS LEYLANDII	28 @ 3'	GOOD			REMOVE FOR CONSTRUCTION	
37	D	EMPRESS TREE	PAULOWNIA TOMENTOSA	34	GOOD	ONESIDED CROWN TO SOUTH.		REMOVE FOR CONSTRUCTION	
38	D	RED ALDER	ALNUS RUBRA	31 @ 3'	POOR	CONKS, VISIBLE WHITE ROT WHERE STEM TO NORTH BROKE OUT IN PAST AND NO WOUND CLOSURE HAS OCCURRED.	YES (9)	REMOVE FOR CONDITION	
39	C	DOUGLAS FIR	PSEUDOTSUGA MENZIESII	62	GOOD	CODOMINANT STEMS WITH INCLUDED BARK UP TO 8'. WEST STEM TOP GONE		RETAIN AND MONITOR - PROVIDE TREE PROTECTION FENCING AS SHOWN ON PLANS. THE PLANNED FULL BUILD-OUT WILL IMPACT APPROXIMATELY 66% OF THIS TREE'S TPZ. RECOMMENDATION IS TO MINIMIZE IMPACTS WHERE POSSIBLE BY MOVING PLANNED IMPROVEMENTS FURTHER FROM TREE, CONSTRUCTING HARD SURFACES ON GRADE WHERE POSSIBLE AND REDUCING AREA OF FILL BY USE OF RETAINING WALLS. WALLS SHALL BE MIN. 16' FROM TRUNK TO MAINTAIN ORIGINAL GRADE WITHIN CRITICAL ZONE CLOSE TO TRUNK. MINIMIZE ROOT DAMAGE BY LIMITING WORK TO ONLY HAND TOOLS WHERE TRENCHING MUST RUN THROUGH TPZ; NO ROOTS OVER 3" TO BE SEVERED; ANY ROOTS THAT ARE PRUNED SHOULD LEAVE FLAT SURFACE WITH CLEAN EDGES; ROOTS SHALL NOT BE LEFT UNCOVERED AND ALLOWED TO DRY OUT. ARBORIST SHOULD MONITOR EXCAVATION IN CASE ROOTS OVER 3" Ø ARE ENCOUNTERED. DOUG FIRS ARE RELATIVELY TOLERANT OF FILL AS LONG AS IT DOES NOT EXCEED 25% OF THE TPZ. THIS TREE WILL NEED TO BE MONITORED ANNUALLY AFTER CONSTRUCTION TO CHECK FOR SIGNS OF DECLINE.

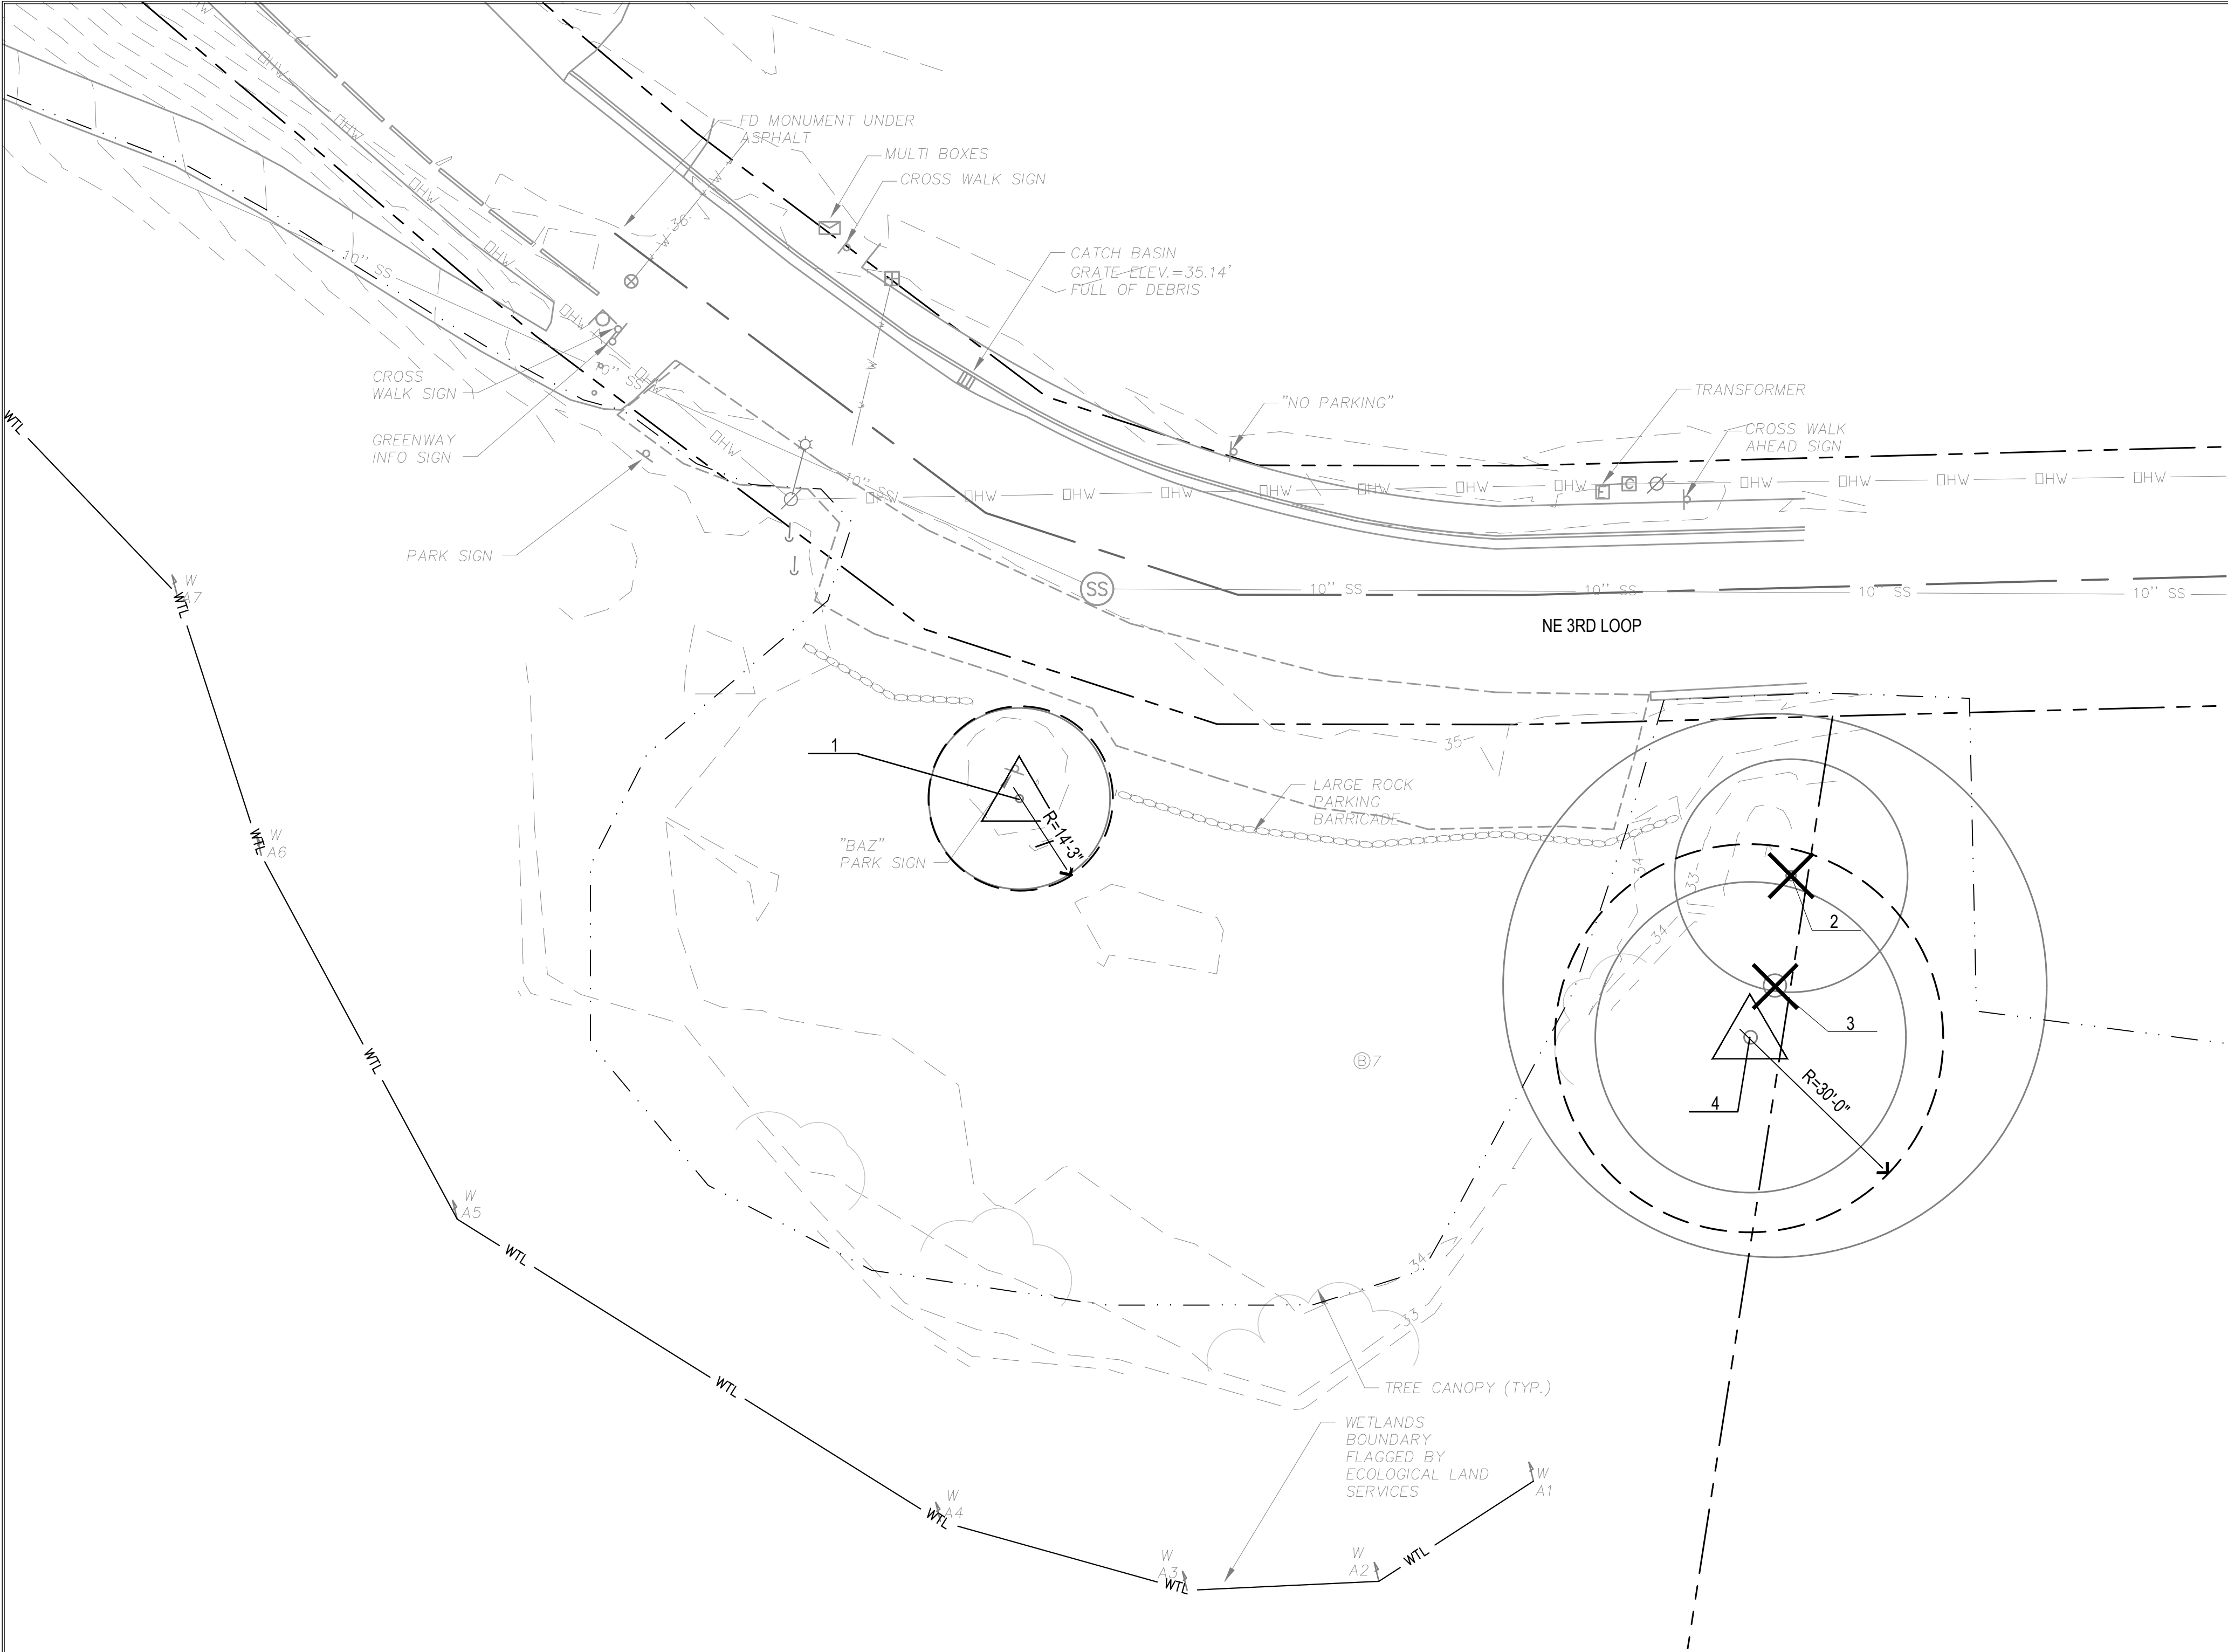
BAZ PARK TREE PLAN

TABLE OF TREES									
TREE NUMBER	CONIFER OR DECID.	COMMON NAME	BOTANICAL NAME	SIZE (DBH)	CONDITION (STRUCTURAL STABILITY)	COMMENTS	HAZARD (RATING)	RECOMMENDATION	
1	C	ARBORVITAE	THUJA OCCIDENTALIS	3 STEM: 4.5", 6" AT 2.5' AND 9" AT GRND	GOOD			RETAIN	
2	D	BLACK COTTONWOOD	POPULUS TRICHOCARPA	23"	POOR	HEAVY IVY INFESTATION UP ENTIRE STEM. TOP MISSING AT 30'. BARK SEPARATING FROM SAPWOOD ON WEST SIDE OF STEM FROM GROUND LEVEL UP TO 6', EXPOSING PARTIALLY HEALED AREA OF DECAY THAT ENCOMPASSES ALMOST ONE-HALF OF STEM'S CIRCUMFERENCE.SOME CALLUS WOOD FORMED AT EDGES OF DECAY. DEAD BRANCHES WITH MISSING BARK IN CROWN. TREE IS LEANING 9-10° TO NORTHEAST BUT IS SHORT ENOUGH THAT IT WOULD NOT IMPACT THE NEARBY RESIDENCE IN THE EVENT OF TOTAL FAILURE. LEAN OF THIS TREE (AND #3 AND #4) APPEAR TO BE PHOTOTROPIC; THESE WERE PROBABLY ALL EDGE TREES BEFORE THE ADJACENT BAZ PARK WAS CREATED.	YES (11)	REMOVE

3	D	BLACK COTTONWOOD	POPULUS TRICHOCARPA	40"	POOR/FAIR	DYING 12" STEM ON NORTH WITH MISSING BARK FROM GROUND LEVEL UP TO 2/3 OF TOTAL HEIGHT, CONKS, MISSING LEADER, AND BIRD NESTING CAVITIES. LEANING TO NE; COMPLETE FAILURE COULD IMPACT DECK OF ADJACENT RESIDENCE DEPENDING ON DIRECTION OF FAILURE. SOUTH STEM (36") HAS HAD MULTIPLE BRANCHES FAIL PREVIOUSLY, HAS BARK LIFTING FROM SAPWOOD AT BASE UP TO ABOUT 7' HT., AND CONSTRUCTION DEBRIS (CONCRETE CHUNKS) PILED AROUND BASE. HEAVY IVY AND BLACKBERRY COVER MAKES INSPECTION OF ROOTS IMPOSSIBLE; IT APPEARS FILL HAS BEEN PLACED OVER ORIGINAL GRADE. THERE IS ONE VISIBLE LARGE ROOT ON EAST SIDE OF TREE THAT HAS BEEN REPEATEDLY DAMAGED.	YES (11 - NORTH STEM, 10 - SOUTH STEM)	REMOVE	
4	D	BLACK COTTONWOOD	POPULUS TRICHOCARPA	24"	FAIR	MISSING ORIGINAL LEADER, ONE-SIDED CROWN DUE TO #3, SELF-CORRECTED LEAN TO SOUTHEAST. VERY HEAVY IVY AND BLACKBERRY COVER SO ROOTS CANNOT BE VISUALLY EXAMINED. LARGE DEAD BRANCH ON NORTH SIDE AT ABOUT 30'.		RETAIN; CROWN CLEAN, REMOVE LARGE DEAD LIMB.

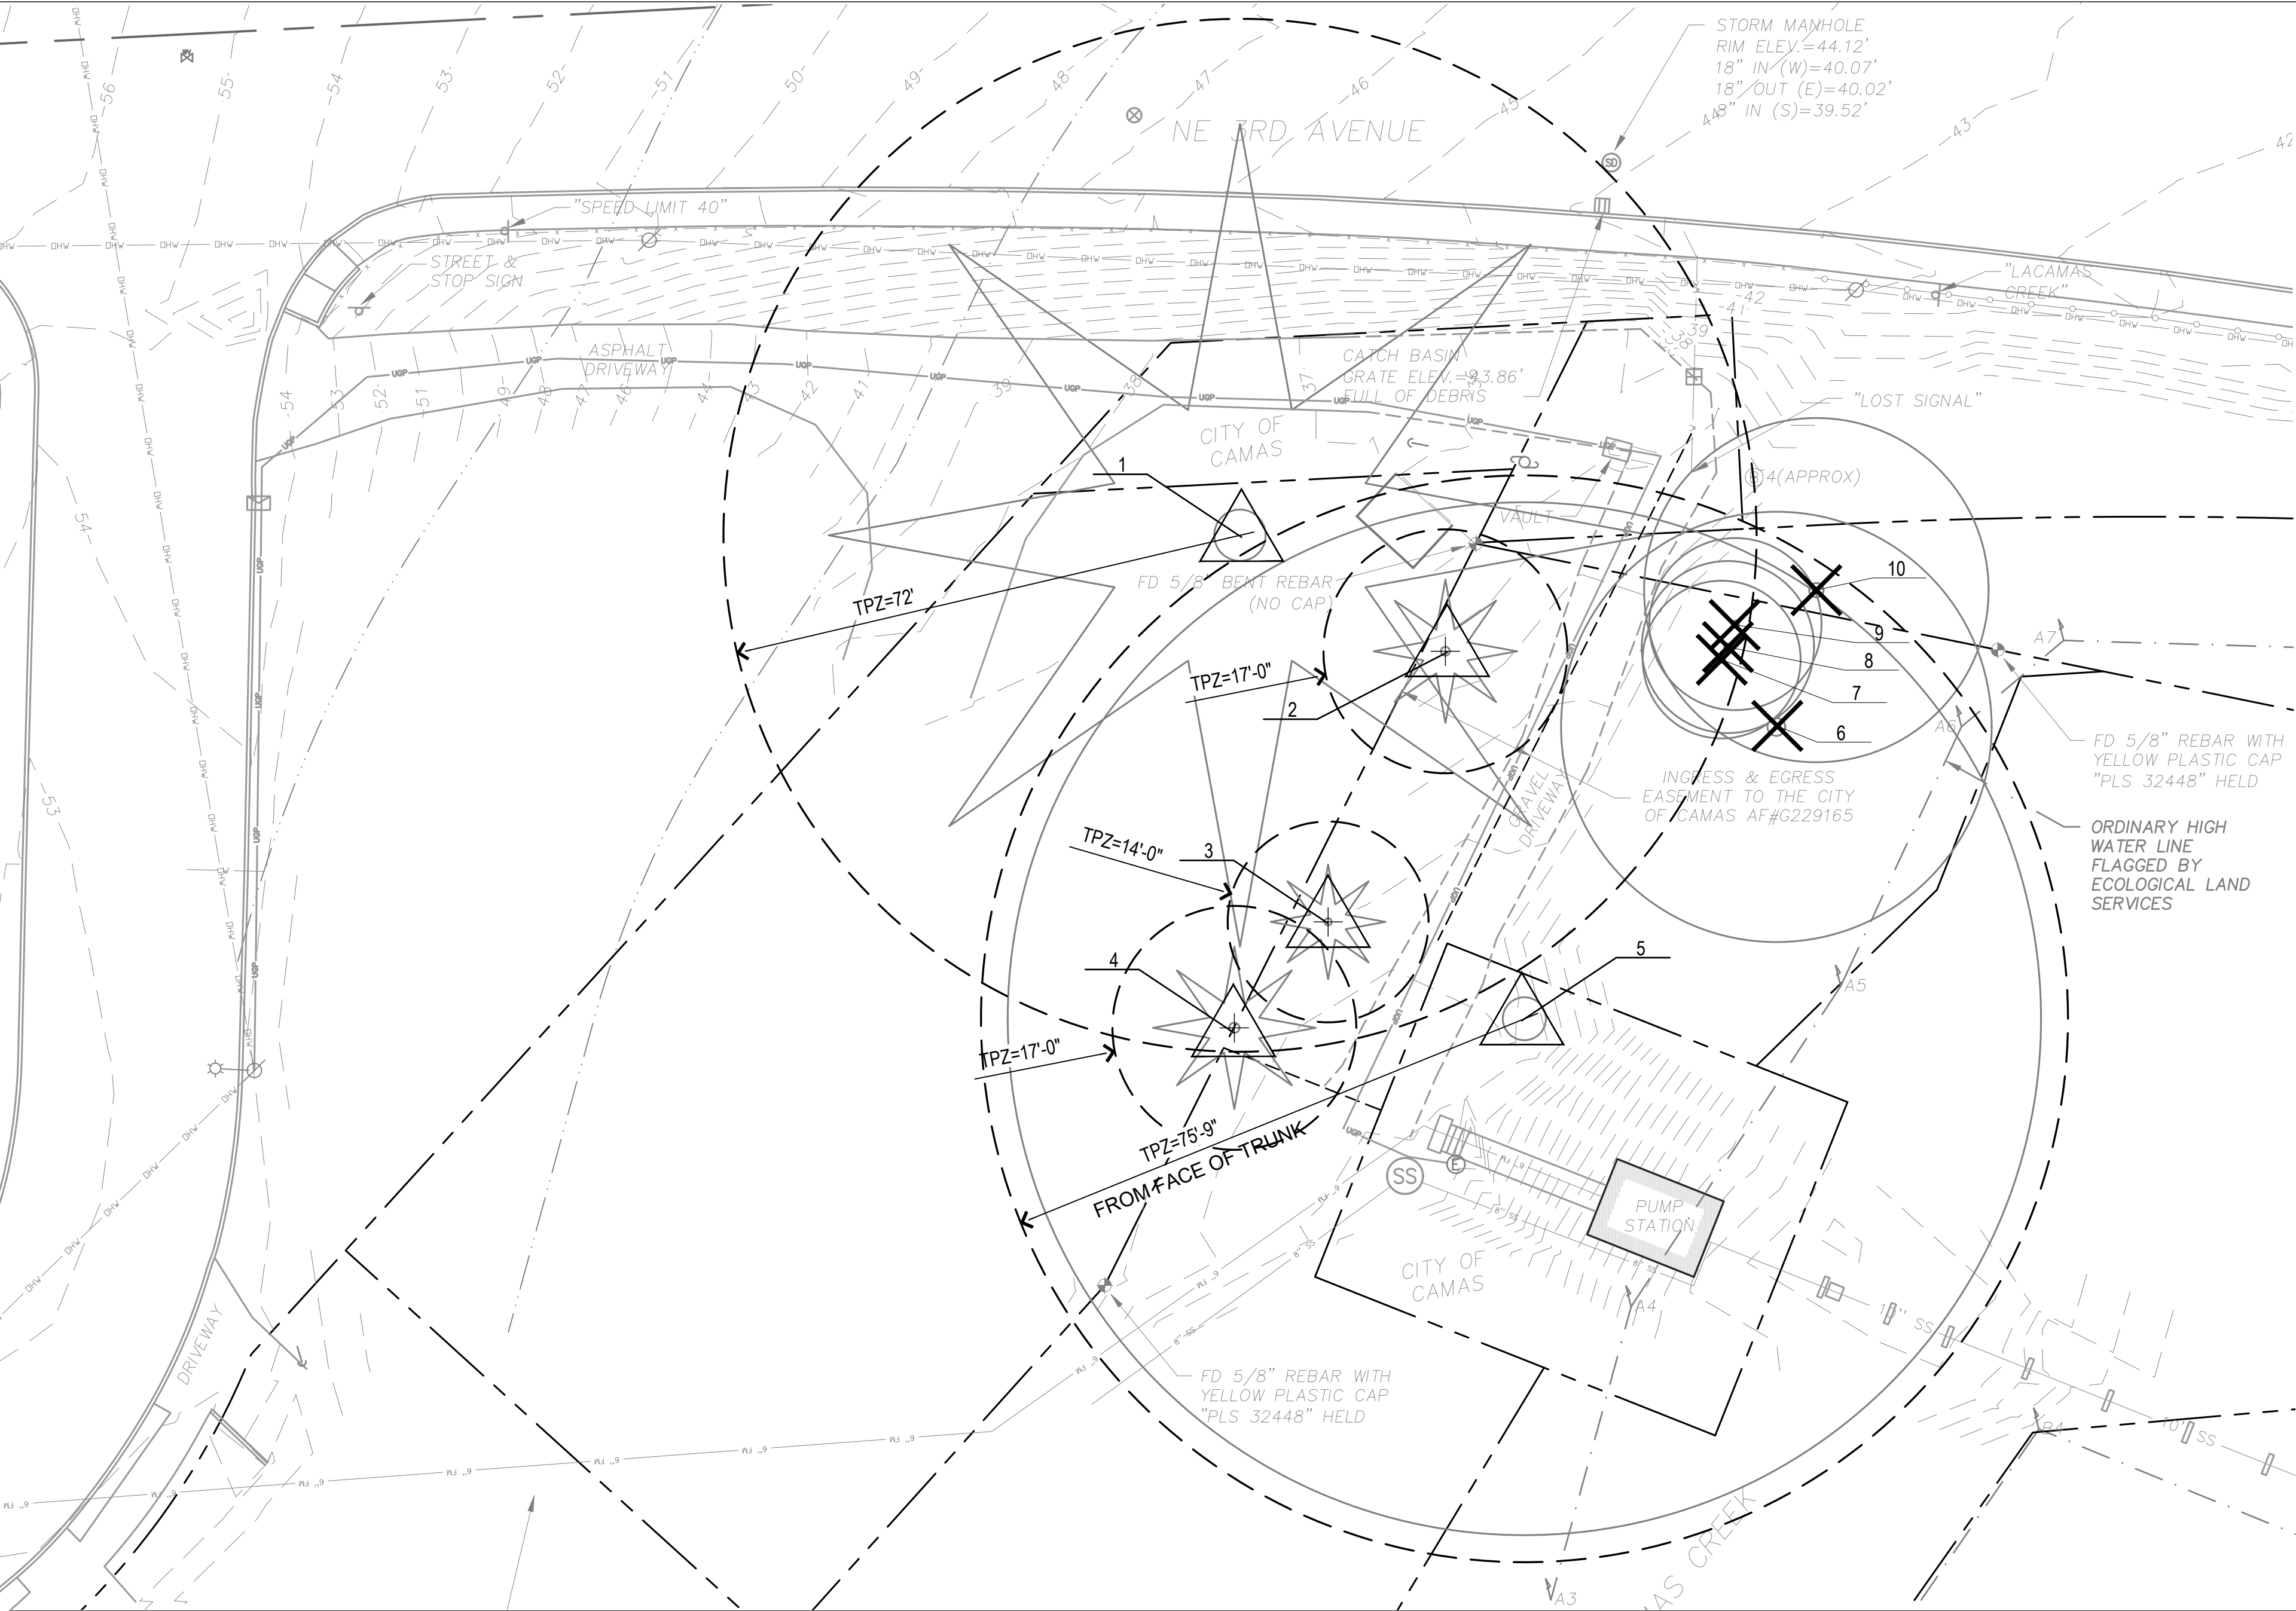
LACAMAS CREEK
SEWER LINE
TREE PLAN

TABLE OF TREES								
TREE NUMBER	CONIFER OR DECID.	COMMON NAME	BOTANICAL NAME	SIZE (DBH CAL-INCHES)	CONDITION (STRUCTURAL STABILITY)	COMMENTS	HAZARD (RATING)	RECOMMENDATION
1	C	GIANT SEQUOIA	SEQUOIAENDRON GIGANTEUM	95	GOOD			RETAIN. DO NOT SEVER ROOTS OVER 3'Ø; ANY ROOTS THAT ARE PRUNED SHOULD LEAVE FLAT SURFACE WITH CLEAN EDGES; DO NOT TEAR ROOTS. EXPOSED ROOTS SHALL NOT BE LEFT UNCOVERED AND ALLOWED TO DRY OUT.
2	C	SHORE PINE	PINUS CONTORTA	17	FAIR	LOW LIVE CROWN RATIO. SOME RESINOSUS AT BASE		RETAIN
3	C	DOUG FIR	PSEUDOTSUGA MENZIESII	14	FAIR	SHADED OUT BY #6; THINNING FOLIAGE WITH APPARENT NEEDLE RUST INFECTION.		RETAIN
4	C	LOW'S FIR	ABIES CONCOLOR V. LOWIANA	17	FAIR	FINE DEAD TWIGS IN CROWN. UNHEALED WOUND AT BASE.		RETAIN
5	D	OREGON OAK	QUERCUS GARRYANA	91 AT 1' HT.	GOOD	MASSIVE TREE WITH 7 STEMS DIVIDING AT 1' ABOVE GRADE. AT TOP OF SLOPE. CAVITY WITH CALLUS EDGES AT BASE OF NORTH STEM. UNHEALED BARK WOUND AT BASE ON SOUTHWEST SIDE. NEW SEWER LINE PROPOSED WITHIN LESS THAN 10' OF FACE OF TRUNK. TRENCHING WILL CUT UPHILL ROOTS.		RETAIN. RECOMMEND RELOCATING NEW SEWER LINE OUTSIDE THE TREE PROTECTION ZONE. WHERE SEWER LINE PASSES WITHIN A 40' RADIUS OF THE TRUNK FACE, RECOMMEND INSTALLATION OF NEW LINE BY BORING OR TUNNELING AT A MIN. DEPTH OF 3'. WITHIN THE TPZ, TRENCHING SHALL OCCUR UNDER THE SUPERVISION OF AN ARBORIST TO ENSURE TREE STABILITY IS NOT COMPROMISED. WHERE CONSTRUCTION ACTIVITY SHALL OCCUR WITHIN THE TPZ, PROVIDE 6"-16" DEPTH WOOD CHIPS OVER GEOTEXTILE TO MINIMIZE SOIL COMPACTION; LEAVE IN PLACE UNTIL COMPLETION OF CONSTRUCTION. DO NOT SEVER ROOTS OVER 3'Ø; ROOTS SHALL NOT BE TORN OR CRUSHED; PRUNED ROOTS SHALL BE LEFT WITH FLAT SURFACE WITH ADJACENT BARK FIRMLY ATTACHED. EXPOSED ROOTS SHALL NOT BE LEFT UNCOVERED AND ALLOWED TO DRY OUT. TRENCH BACKFILL SHALL BE NATIVE SOIL WHEN POSSIBLE. IF ROCK BACKFILL IS USED, EXPOSED ROOTS SHALL BE WRAPPED IN GEOTEXTILE PRIOR TO BACKFILLING. RECOMMEND PROTECTING TRUNK OF TREE FROM MECHANICAL INJURY DURING CONSTRUCTION TO A MIN. HT. OF 8'. TREE TO BE MONITORED ANNUALLY FOR SIGNS OF DECLINE.

6	D	BIGLEAF MAPLE	ACER MACROPHYLLUM	38	DEAD/DYING	COMPLETELY GIRDLED BY BEAVER. TOP GONE.	YES (8)	REMOVE
7	D	CHERRY	PRUNUS SPP.	13	FAIR	TREE AT TOP OF SLOPE IN GROUP OF 3 WITH #8 AND #9. SELF-CORRECTED LEAN TO SW. PROPOSED TRENCH WILL CUT UPHILL ROOTS.		REMOVE. SINCE THIS TREE IS IN CLOSE PROXIMITY TO #8 AND #9 AND IS NOT A VALUABLE OR UNUSUAL TREE, RECOMMEND REMOVAL. EXPECT THAT ROOTS OF ALL THREE TREES ARE INTERTWINED, SO REMOVING #8 AND #9 MAY COMPROMISE ROOT STABILITY OF THIS TREE AND INCREASE CHANCE OF WINDTHROW FAILURE.
8	D	COTTONWOOD	POPULUS TRICHOCARPA	14	POOR	GIRDLED BY BEAVER, ONLY 1/3 OF STEM REMAINING. PROPOSED TRENCH WILL CUT UPHILL ROOTS.	YES (9)	REMOVE. DO NOT EXCAVATE ROOT WAD IF #7 TO BE RETAINED.
9	D	CHERRY	PRUNUS SPP.	16	POOR	15° LEAN OVER GRAVEL DRIVE. LARGE STEM BULGE. PROPOSED TRENCH WILL CUT UPHILL ROOTS.	YES (7)	REMOVE. DO NOT EXCAVATE ROOT WAD IF #7 TO BE RETAINED.
10	D	COTTONWOOD	POPULUS TRICHOCARPA	27	POOR	BEAVER-GIRDLED FOR THREE-QUARTERS OF CIRCUMFERENCE. CONKS ON EXPOSED SAPWOOD. PROPOSED TRENCH WILL MOST LIKELY CUT ANCHORING UPHILL ROOTS.	YES (9)	REMOVE
