May 29, 2015

**Re: Preliminary Geotechnical Soils Investigation Results  
The Village at Camas Meadows  
Clark County Parcel No. 175951000  
Camas, Washington  
CWE W.O. No. 15064**

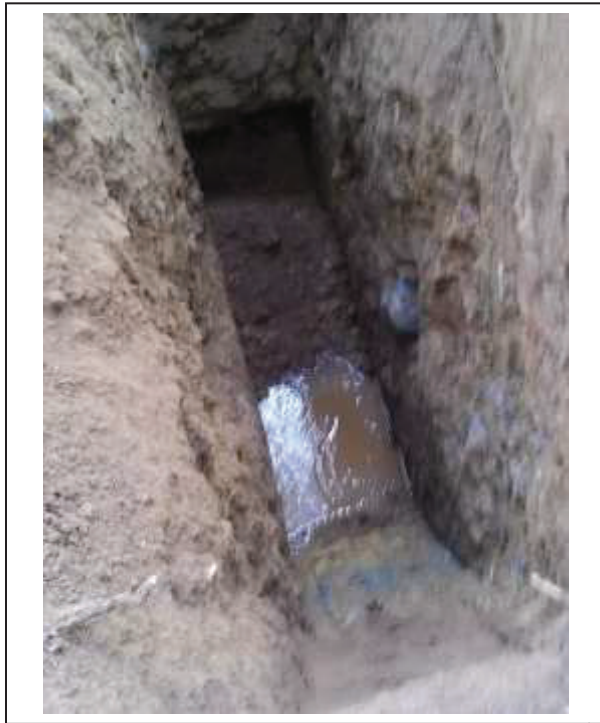
Groundwater Seeps at 10 feet in TP-1

Reddish brown to yellow brown CONGLOMERATE BEDROCK, damp, very dense, competent bedrock (excavator refusal) at 15 feet.					
15						Bottom of test pit at 15.0 feet. Heavy groundwater seeps at 10 feet.

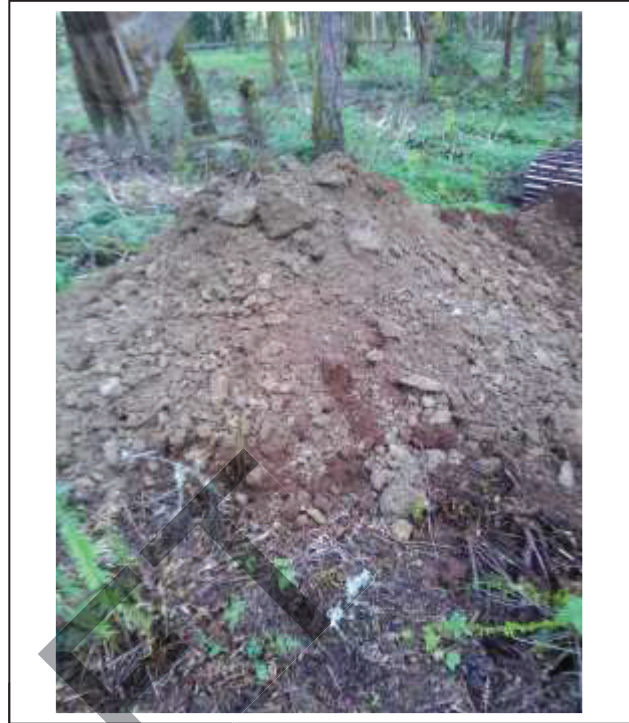
Weathered Conglomerate in TP-5

Weathered Conglomerate: Reddish brown to yellow brown clayey GRAVEL, moist, stiff, moderate plasticity. Rounded to sub-angular gravels and cobbles increase with depth. Represents weathering conglomerate bedrock.

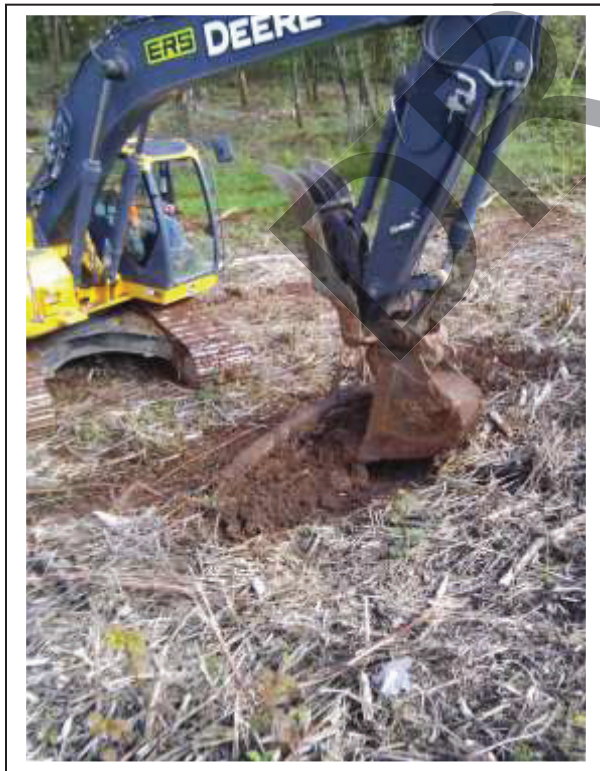
Soils in test pits TP-7 through TP-11, TP-16, and TP-17, located in the general vicinity of the gravel parking area north of the existing building, consisted of unconsolidated sand, clay and weathered conglomerate soils mixed with concrete slab remnants, asphalt remnants, wood debris, and organic-rich soils. Soils within this fill area are not suitable for bearing support of structures or paved areas in the present condition and may not be suitable for re-use as structural fill due to the presence of large pieces of debris and organic soils.

Exploring unconsolidated fill material in  
TP-8

Unconsolidated fill material was encountered in a large area located north of the existing structure on the property. The area was previously used as a parking lot. As mentioned above, this fill material contained a significant amount of organic-rich soils and various construction debris (concrete, asphalt, etc.), unsuitable for structural support and likely unsuitable for re-use as structural fill. It may be possible to re-use portions of the material if time and care is taken to remove deleterious materials from the unconsolidated fill. The unconsolidated material should be removed completely in locations proposed for future structures.

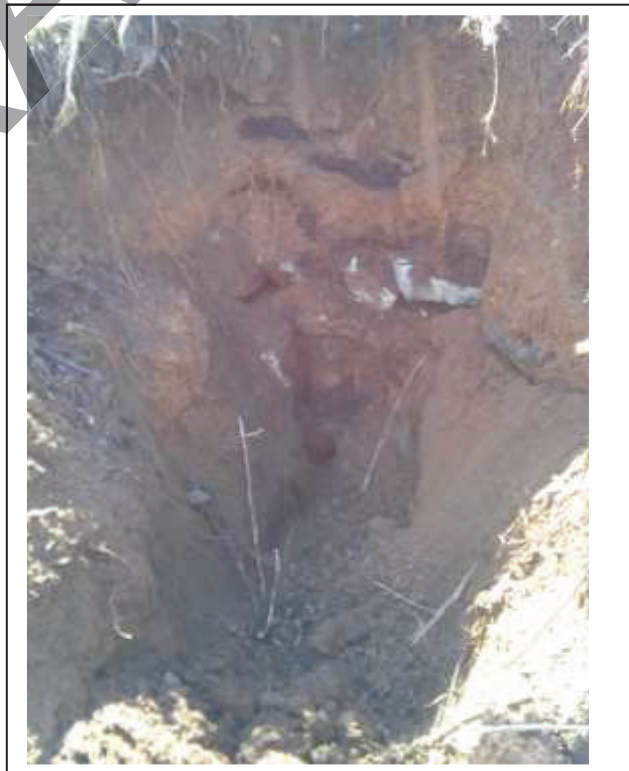
Unconsolidated fill material in TP-8

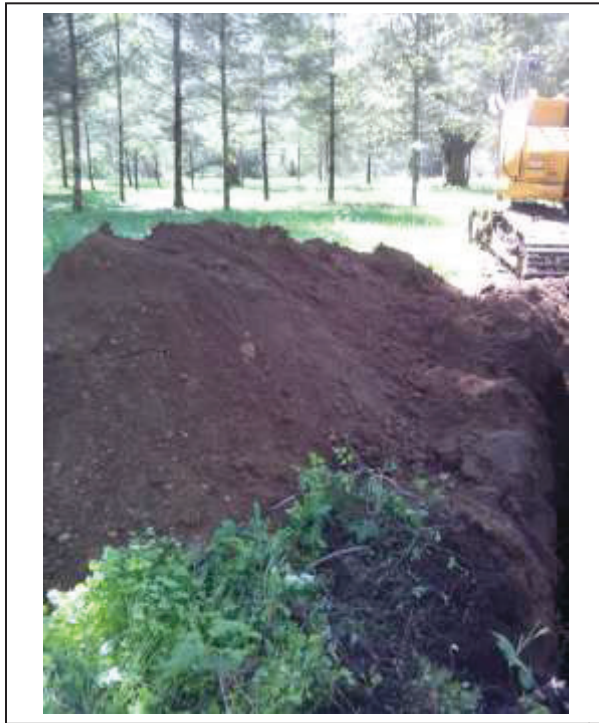
Sandy soils in TP-12

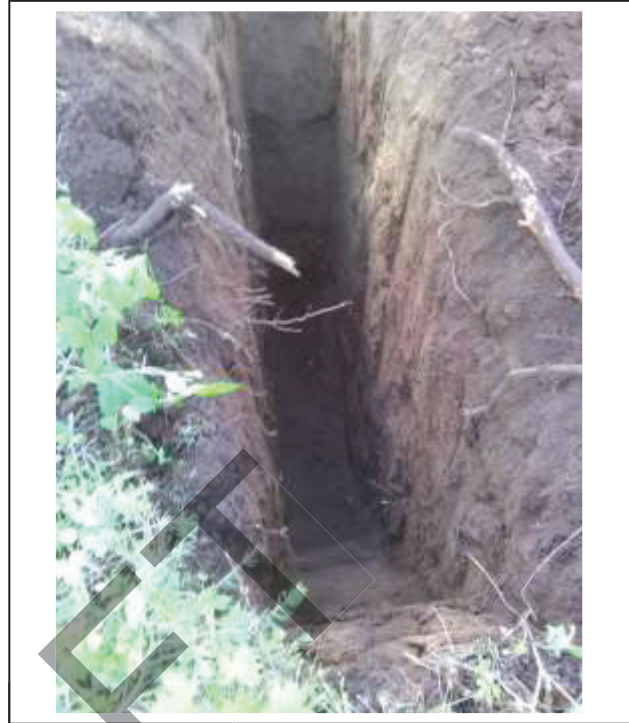
Dry, sandy soils to 16 feet in TP-12

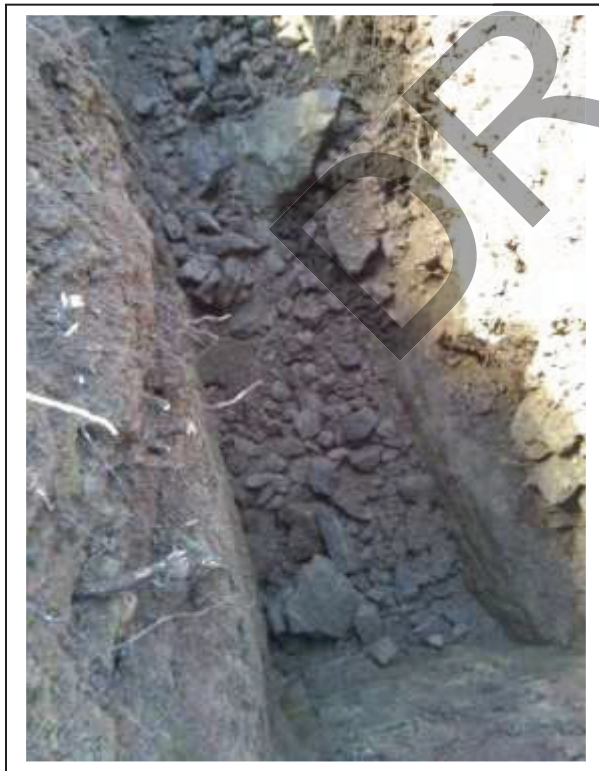
The conglomerate was generally weathered in the top few feet, but became dense and massive with depth. If significant utilities or other excavations are designed at elevations that encounter bedrock, specialized rock-excavation techniques or blasting may be necessary. As mentioned previously,

Excavator refusal in Conglomerate  
Bedrock, TP-15

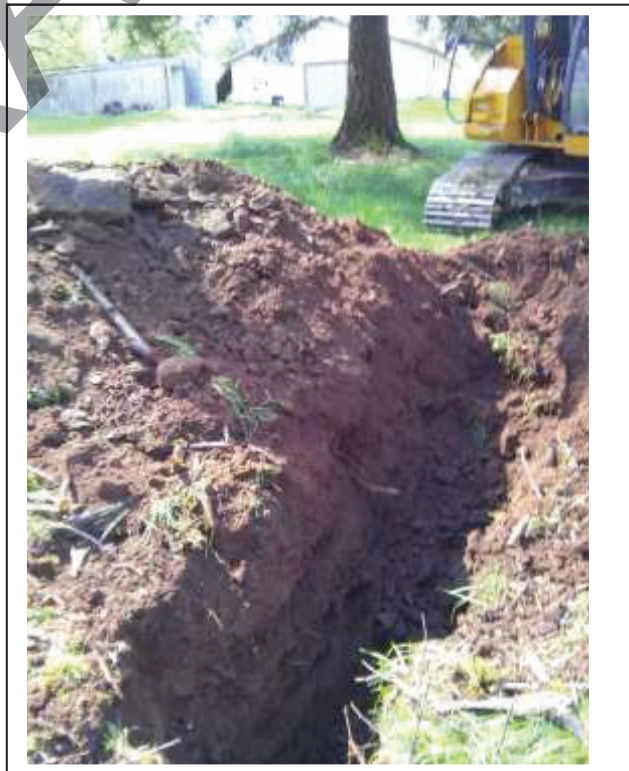
Shallow Bedrock (5 feet) in TP-15
