# APPENDIX A

**A-1 GIS Development Packet**

- 1) Fig. 1A Historic Basin Map**
- 2) Fig 1B Historic Basin Map – add projects**
- 3) Fig 2A Project Areas**
- 4) Fig 2B Soils Map**
- 5) Fig 3 Post Subbasin Map**

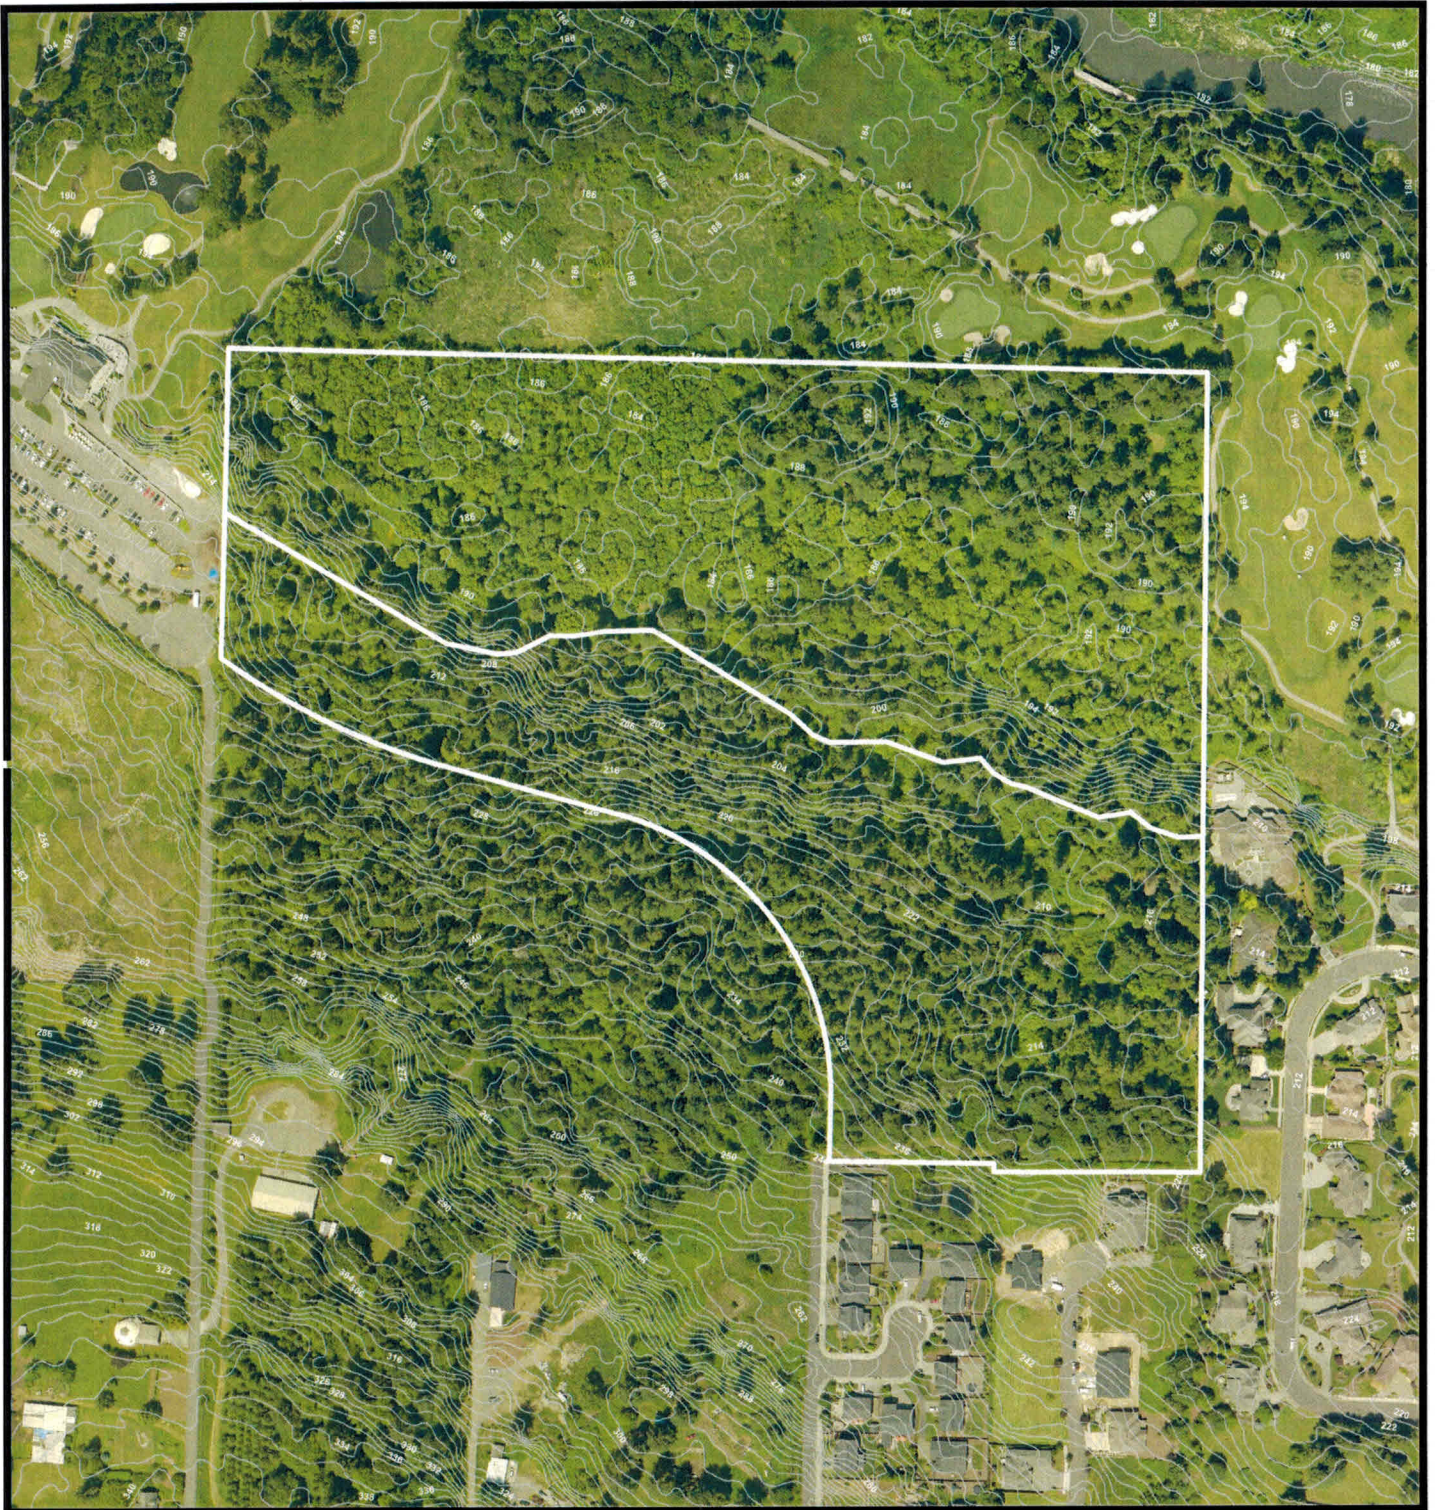
### 2014 Aerial Photography with Contours

- Proposed Development Area
- 2' Elevation Contours

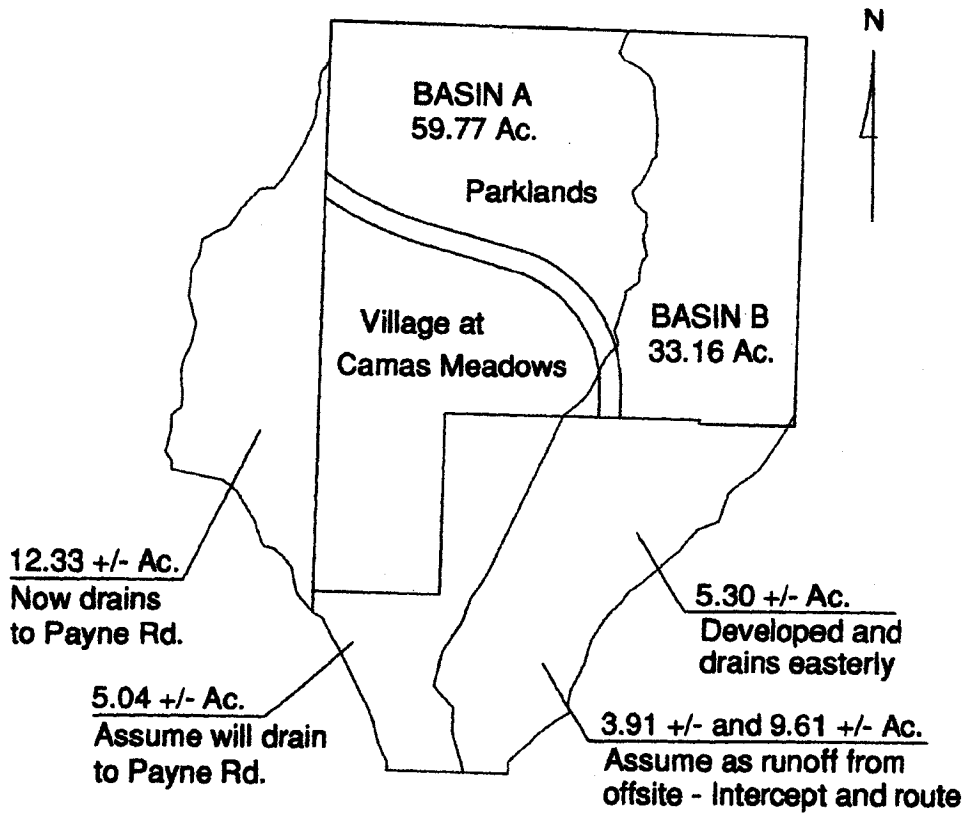
**FIG. 1B HISTORIC BASIN MAP**

**- add PROJECTS**
