Geotechnical Site Investigation

Parklands at Camas Meadows

Camas, Washington

June 23, 2015

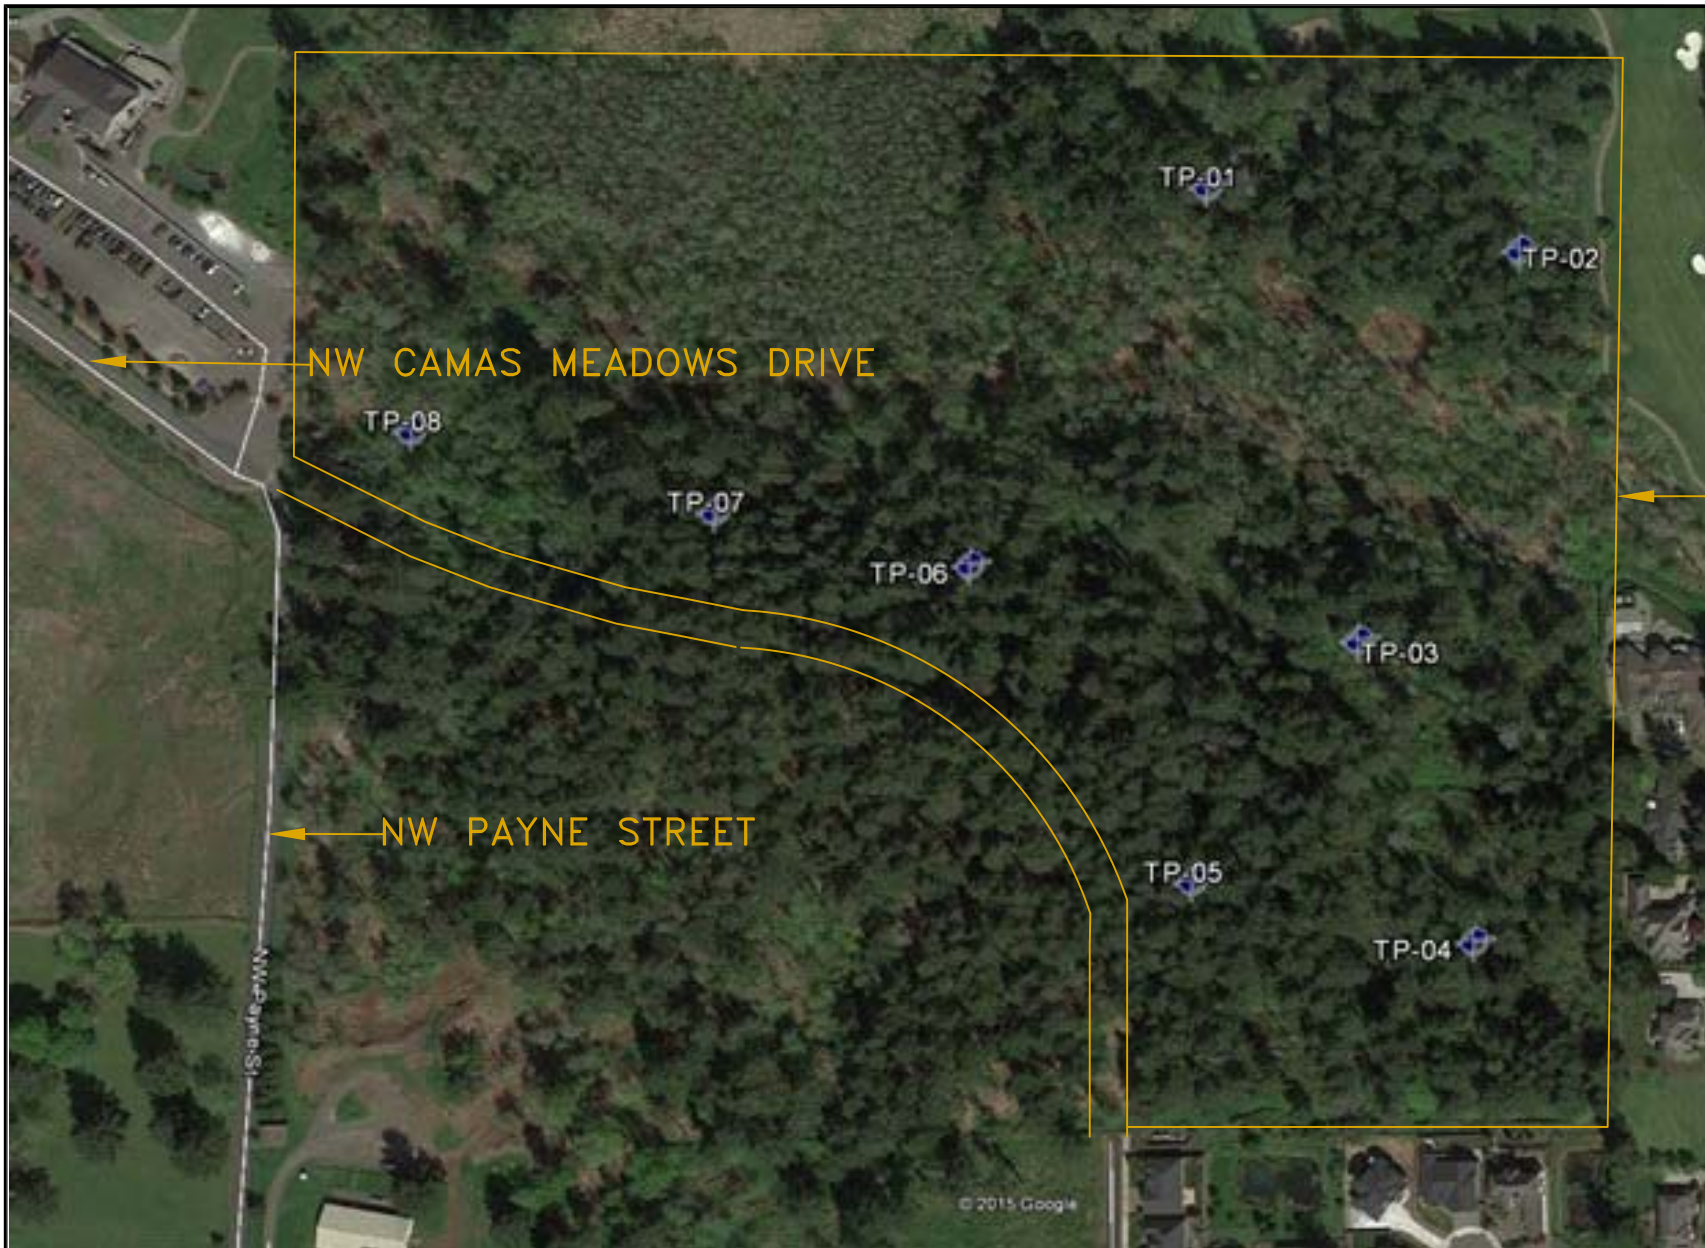
FIGURE  
2

APPROXIMATE  
SUBJECT  
SITE  
BOUNDARY

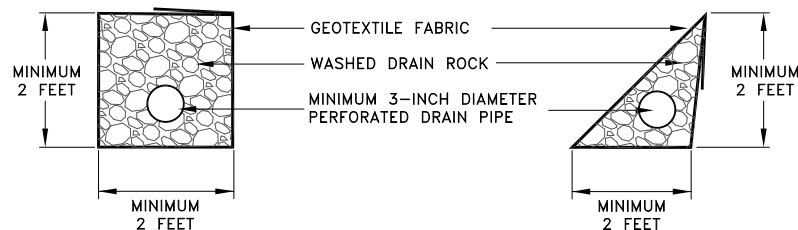
FIGURE 3
-------------

# TYPICAL CUT AND FILL SLOPE CROSS-SECTION

## DRAIN SPECIFICATIONS

GEOTEXTILE FABRIC SHALL CONSIST OF MIRAFI 140N OR APPROVED EQUIVALENT WITH AOS BETWEEN No. 70 AND No. 100 SIEVE.

WASHED DRAIN ROCK SHALL BE OPEN-GRADED ANGULAR DRAIN ROCK WITH LESS THAN 2 PERCENT PASSING THE No. 200 SIEVE AND A MAXIMUM PARTICLE SIZE OF 3 INCHES.

## TYPICAL DRAIN SECTION DETAIL

- NOTES:
1. DRAWING IS NOT TO SCALE.
  2. SLOPES AND PROFILES SHOWN ARE APPROXIMATE.
  3. DRAWING REPRESENTS TYPICAL FILL AND CUT SLOPE SECTION, AND MAY NOT BE SITE-SPECIFIC.

Concentrated drainage or water flow over the face of slopes should be prohibited, and adequate protection against erosion is required. Fill slopes should be constructed by placing fill material in maximum 12-inch level lifts, compacting as described in Section 5.2, *Engineered Structural Fill* and horizontally benching where appropriate. Fill slopes should be overbuilt, compacted, and trimmed at least two feet horizontally to provide adequate compaction of the outer slope face. Proper cut and fill slope construction is critical to overall project stability and should be observed by an experienced geotechnical engineer.

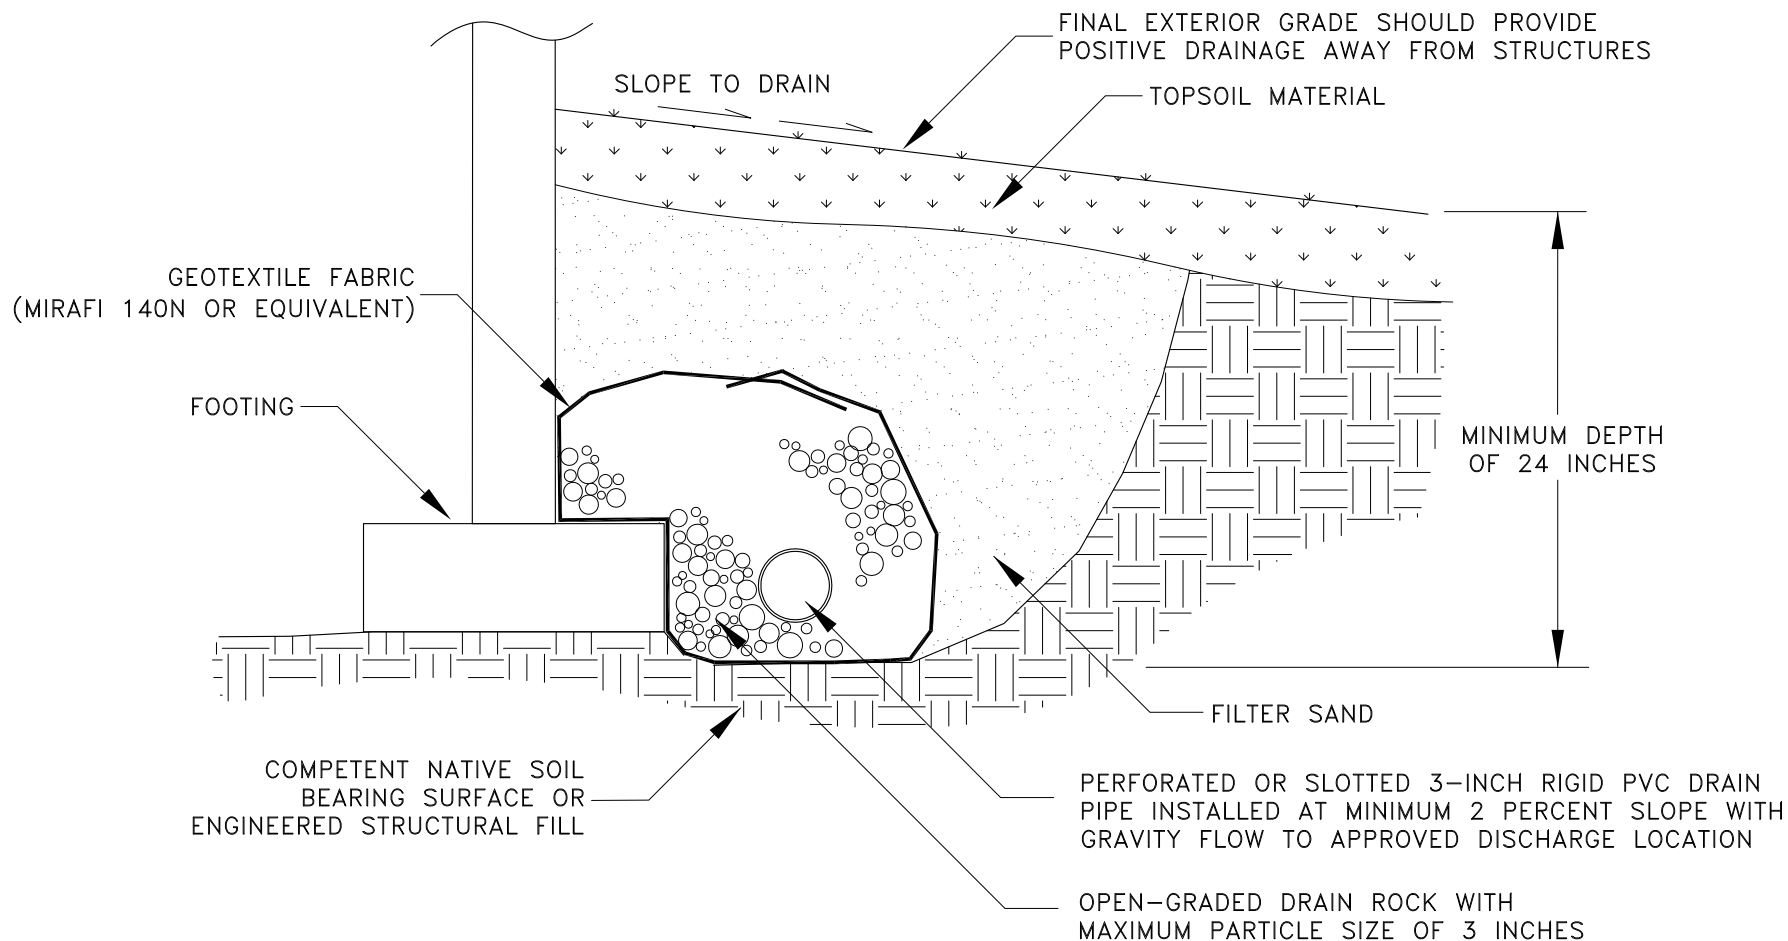
FIGURE  
5

# TYPICAL PERIMETER FOOTING DRAIN DETAIL

NOTES:  
 1. DRAWING IS NOT TO SCALE.  
 2. DRAWING REPRESENTS TYPICAL FOOTING DRAIN DETAIL AND MAY NOT BE SITE-SPECIFIC.

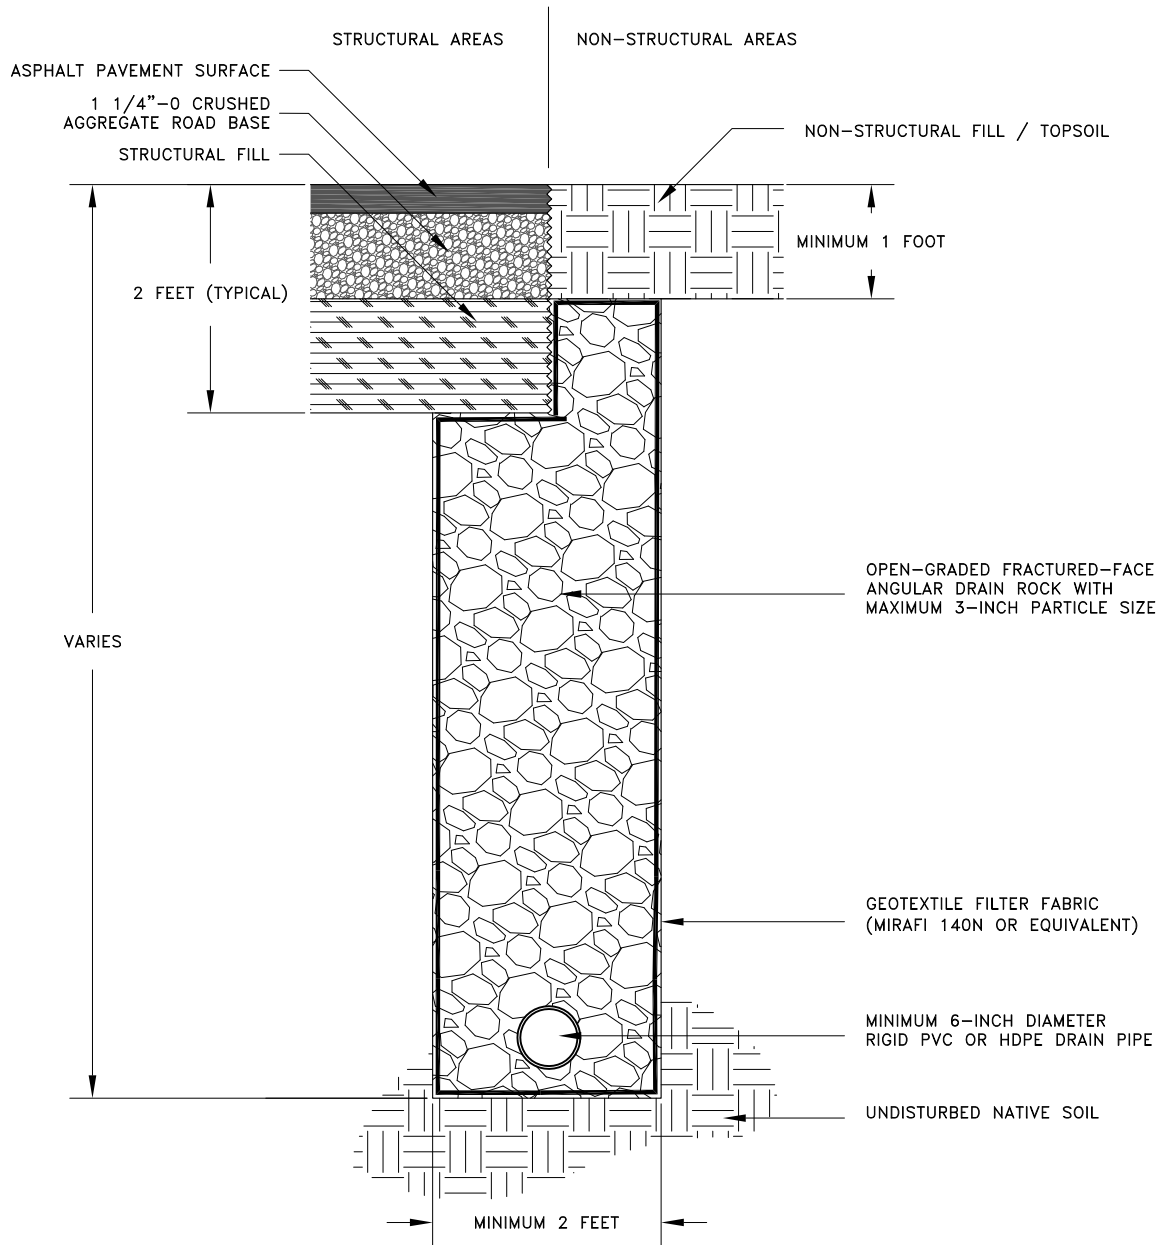
# TYPICAL PERFORATED DRAIN PIPE TRENCH DETAIL

NOTE: LOCATION, INVERT ELEVATION, DEPTH OF TRENCH, AND EXTENT OF PERFORATED PIPE REQUIRED MAY BE MODIFIED BY THE GEOTECHNICAL ENGINEER DURING CONSTRUCTION BASED UPON FIELD OBSERVATION AND SITE-SPECIFIC SOIL CONDITIONS.

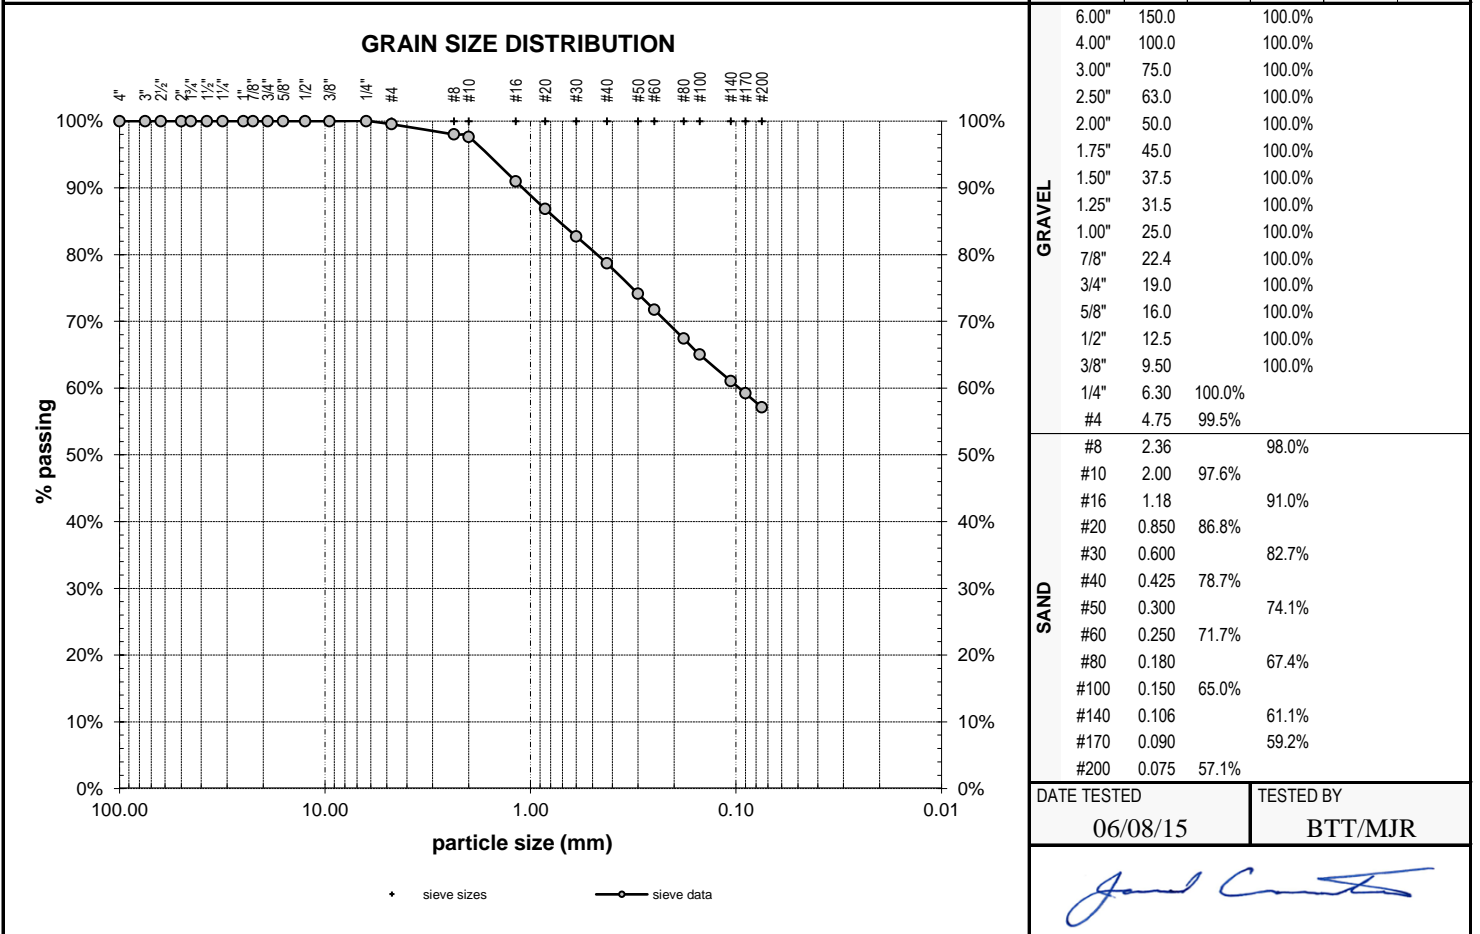
<b>LABORATORY TEST DATA</b>	
<b>LABORATORY EQUIPMENT</b> Rainhart "Mary Ann" Sifter 637	<b>TEST PROCEDURE</b> ASTM D6913, D422

<b>ADDITIONAL DATA</b> initial dry mass (g) = 158.3 as-received moisture content = 36.4% liquid limit = 44 plastic limit = 28 plasticity index = 16 fineness modulus = n/a coefficient of curvature, $C_c$ = n/a coefficient of uniformity, $C_u$ = n/a effective size, $D_{(10)}$ = n/a $D_{(30)}$ = n/a $D_{(60)}$ = 0.097 mm	<b>SIEVE DATA</b> % gravel = 0.5% % sand = 42.4% % silt and clay = 57.1%
--	---

Analytical laboratory testing conducted upon representative soil samples obtained from test pits TP-3 (sandy SILT) and TP-6 (sandy FAT CLAY) indicate approximately 57 to 63 percent by weight passing the No. 200 sieve and in situ moisture content ranging from 32

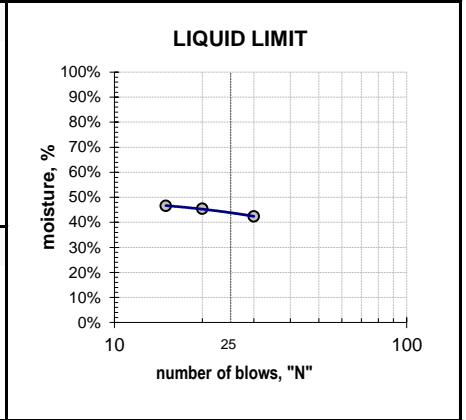
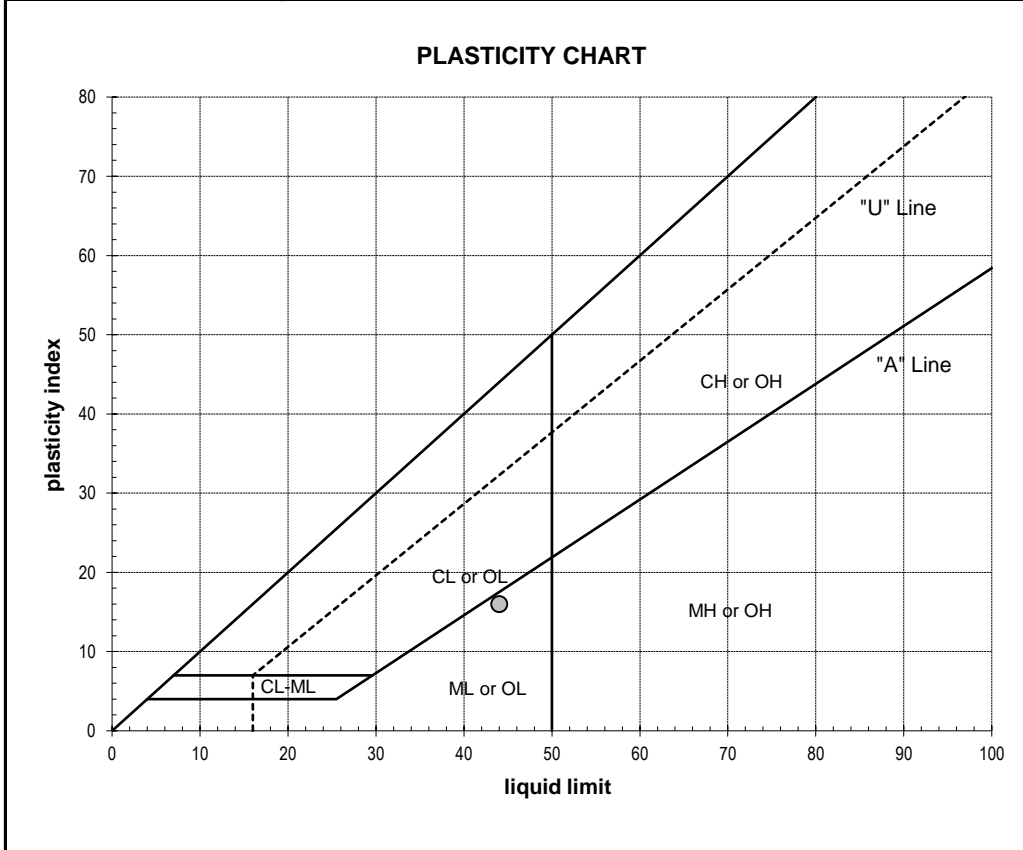
ATTERBERG LIMITS	LIQUID LIMIT DETERMINATION			
	1	2	3	4
liquid limit = 44	wet soil + pan weight, g = 33.30	33.31	33.93	
plastic limit = 28	dry soil + pan weight, g = 29.59	29.37	29.72	
plasticity index = 16	pan weight, g = 20.83	20.70	20.68	
	N (blows) = 30	20	15	
	moisture, % = 42.4 %	45.4 %	46.6 %

SHRINKAGE	PLASTIC LIMIT DETERMINATION			
	1	2	3	4
shrinkage limit = n/a	wet soil + pan weight, g = 27.85	27.97		
shrinkage ratio = n/a	dry soil + pan weight, g = 26.28	26.35		
	pan weight, g = 20.69	20.50		
	moisture, % = 28.1 %	27.7 %

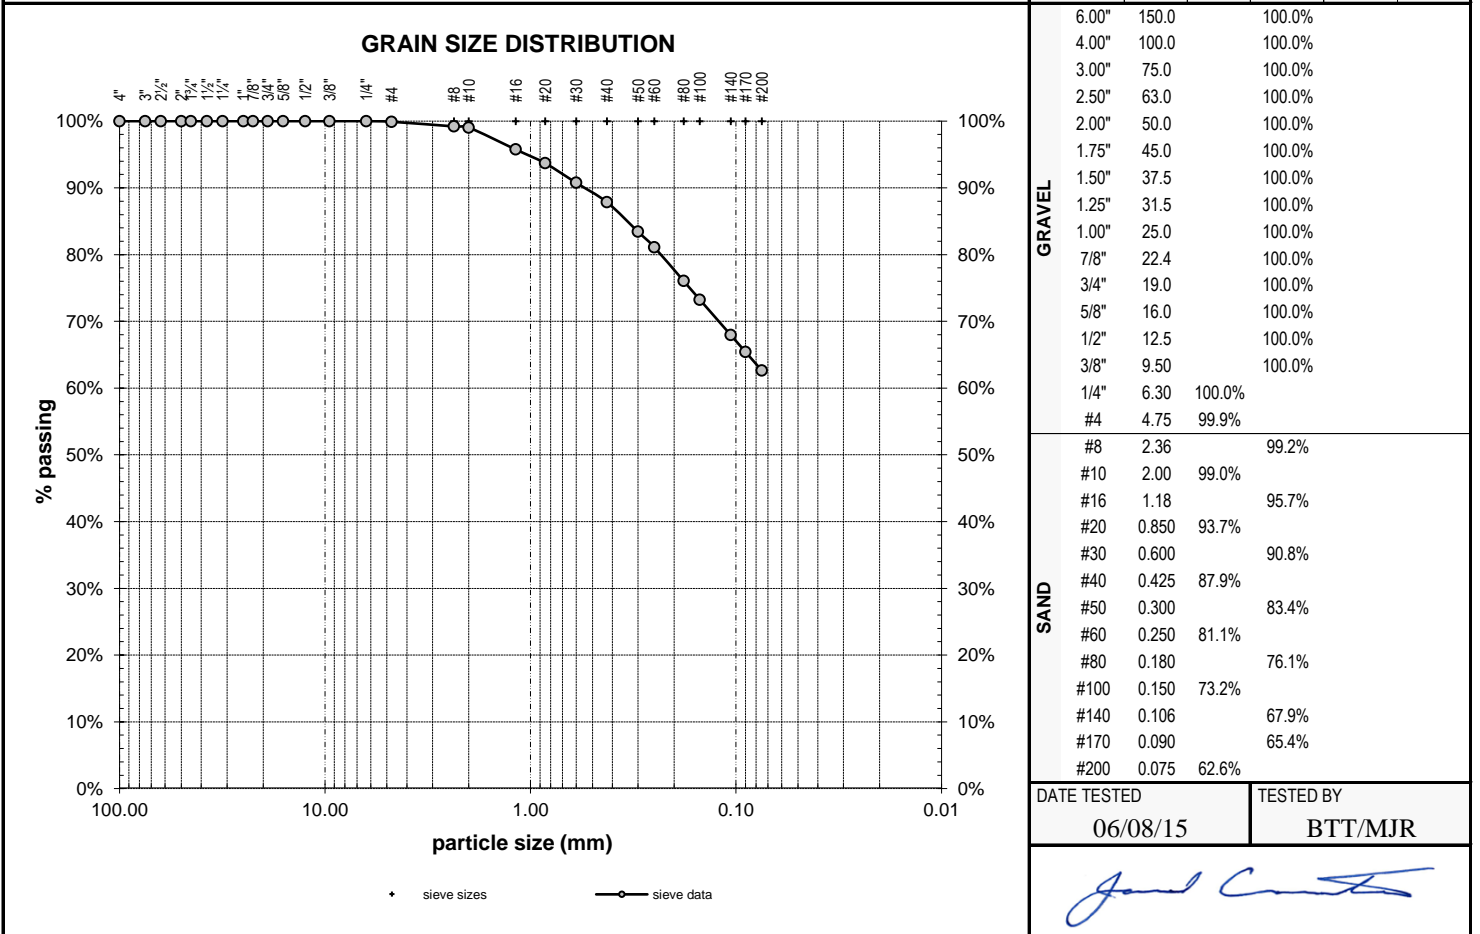
<b>LABORATORY TEST DATA</b>	
LABORATORY EQUIPMENT Rainhart "Mary Ann" Sifter 637	TEST PROCEDURE ASTM D6913, D422

<b>ADDITIONAL DATA</b> initial dry mass (g) = 173.4 as-received moisture content = 32.3% liquid limit = 51 plastic limit = 26 plasticity index = 25 fineness modulus = n/a coefficient of curvature, $C_c$ = n/a coefficient of uniformity, $C_u$ = n/a effective size, $D_{(10)}$ = n/a $D_{(30)}$ = n/a $D_{(60)}$ = n/a	<b>SIEVE DATA</b> % gravel = 0.1% % sand = 37.3% % silt and clay = 62.6%
---	---

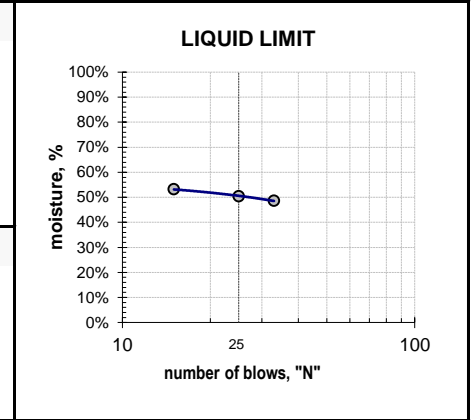
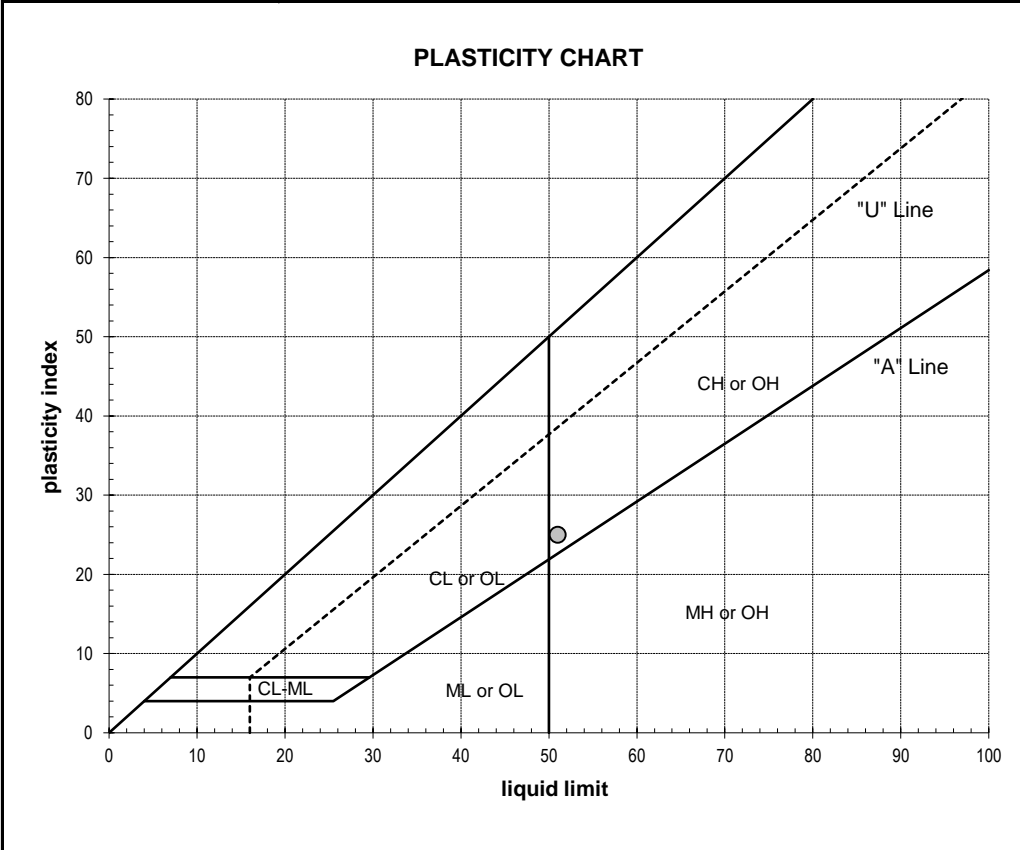
<b>ATTERBERG LIMITS</b>	<b>LIQUID LIMIT DETERMINATION</b>			
liquid limit = 51	①	②	③	④
plastic limit = 26	wet soil + pan weight, g = 34.63	34.09	37.32	
plasticity index = 25	dry soil + pan weight, g = 30.07	29.61	31.60	
	pan weight, g = 20.69	20.73	20.85	
	N (blows) = 33	25	15	
	moisture, % = 48.6 %	50.5 %	53.2 %

<b>SHRINKAGE</b>	<b>PLASTIC LIMIT DETERMINATION</b>			
shrinkage limit = n/a	①	②	③	④
shrinkage ratio = n/a	wet soil + pan weight, g = 27.64	27.63		
	dry soil + pan weight, g = 26.18	26.21		
	pan weight, g = 20.69	20.82		
	moisture, % = 26.6 %	26.4 %

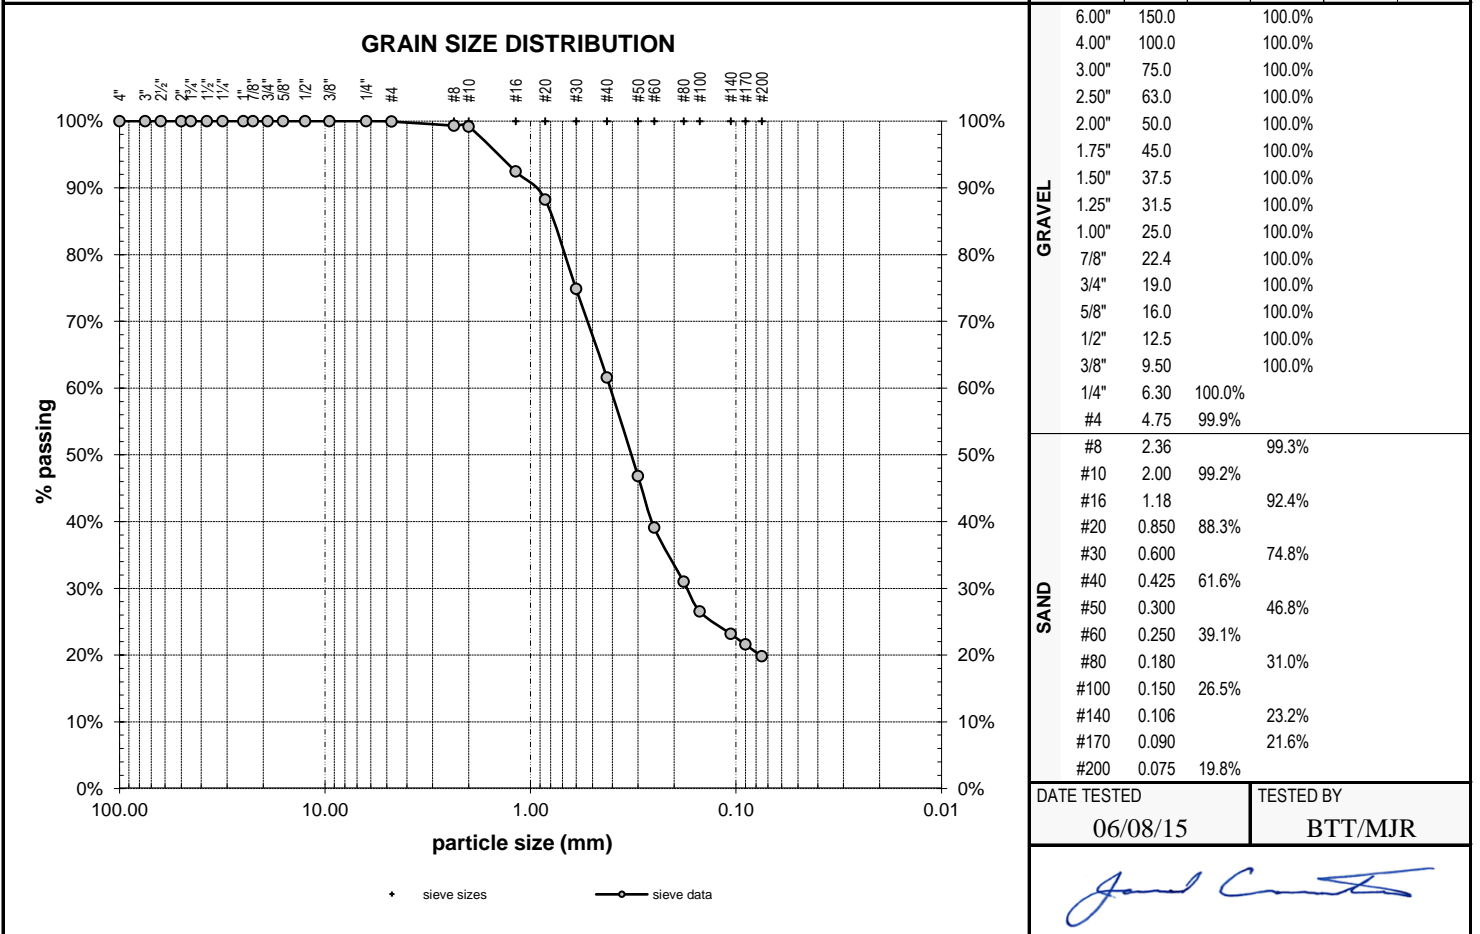
<b>LABORATORY TEST DATA</b>	
LABORATORY EQUIPMENT Rainhart "Mary Ann" Sifter 637	TEST PROCEDURE ASTM D6913, D422

<b>ADDITIONAL DATA</b> initial dry mass (g) = 151.9 as-received moisture content = 42.6% liquid limit = 43 plastic limit = 25 plasticity index = 18 fineness modulus = n/a coefficient of curvature, $C_c$ = n/a coefficient of uniformity, $C_u$ = n/a effective size, $D_{(10)}$ = n/a $D_{(30)}$ = 0.173 mm $D_{(60)}$ = 0.410 mm	<b>SIEVE DATA</b> % gravel = 0.1% % sand = 80.1% % silt and clay = 19.8%
---	---

Analytical laboratory testing conducted upon representative soil samples obtained from test pit TP-8 indicate approximately 8 to 20 percent by weight passing the No. 200 sieve and in situ moisture content ranging from 33 to 43 percent. Atterberg test results indicated a liquid limit ranging from 43 to 46 percent and a plasticity index of 18 percent. Soil Type 2 is classified as SC, clayey SAND and GP-GM, poorly-graded GRAVEL with silt and sand according to USCS specifications and A-2-7(0) according to AASHTO specifications.

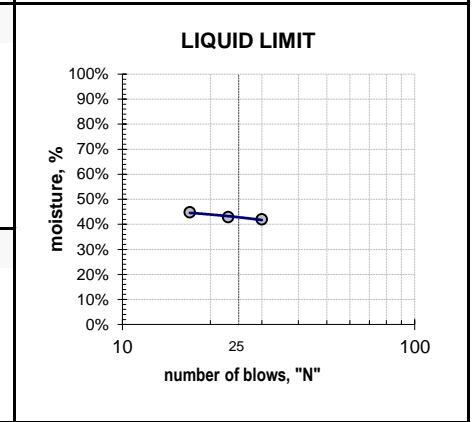
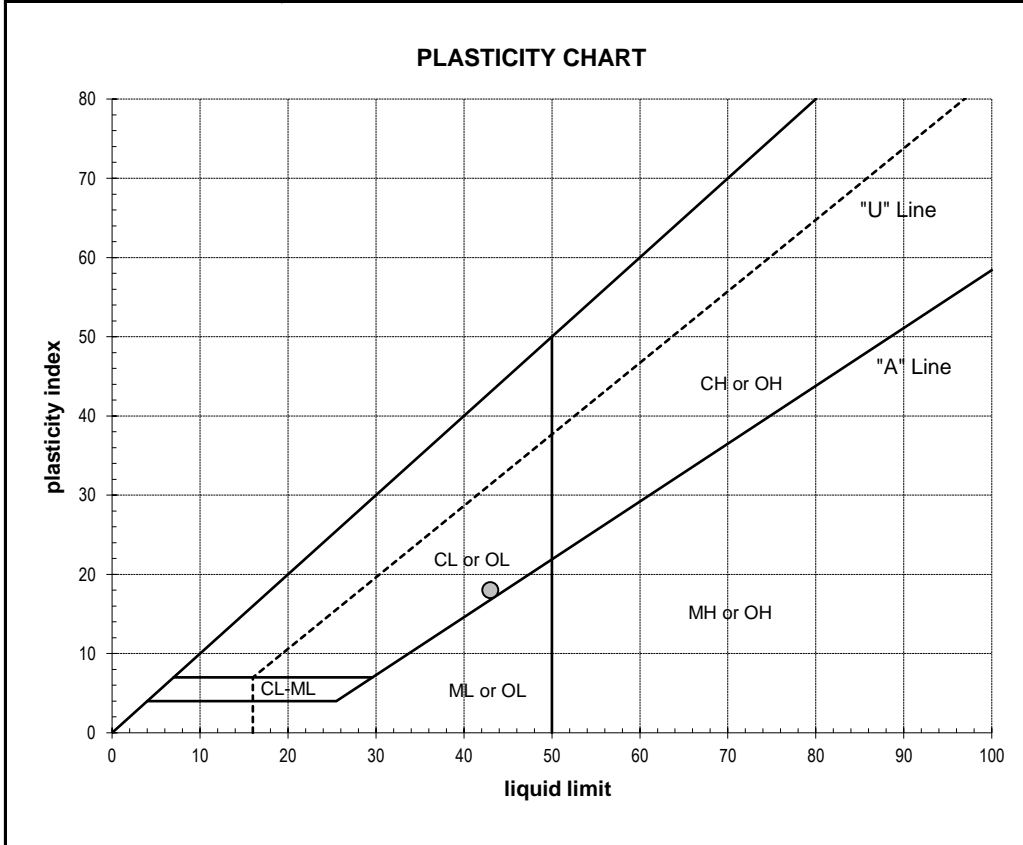
①	②	③	④	wet soil + pan weight, g =	39.55	37.83	35.98		dry soil + pan weight, g =	33.98	32.70	31.23		pan weight, g =	20.69	20.73	20.63		N (blows) =	30	23	17		moisture, % =	41.9 %	42.9 %	44.8 %	
	①	②	③	④																											
wet soil + pan weight, g =	39.55	37.83	35.98																												
dry soil + pan weight, g =	33.98	32.70	31.23																												
pan weight, g =	20.69	20.73	20.63																												
N (blows) =	30	23	17																												
moisture, % =	41.9 %	42.9 %	44.8 %																												
plastic limit = 25																															
plasticity index = 18

①	②	③	④	wet soil + pan weight, g =	27.97	28.28			dry soil + pan weight, g =	26.54	26.79			pan weight, g =	20.74	20.77			moisture, % =	24.7 %	24.8 %		
	①	②	③	④																						
wet soil + pan weight, g =	27.97	28.28																								
dry soil + pan weight, g =	26.54	26.79																								
pan weight, g =	20.74	20.77																								
moisture, % =	24.7 %	24.8 %																								
shrinkage ratio = n/a

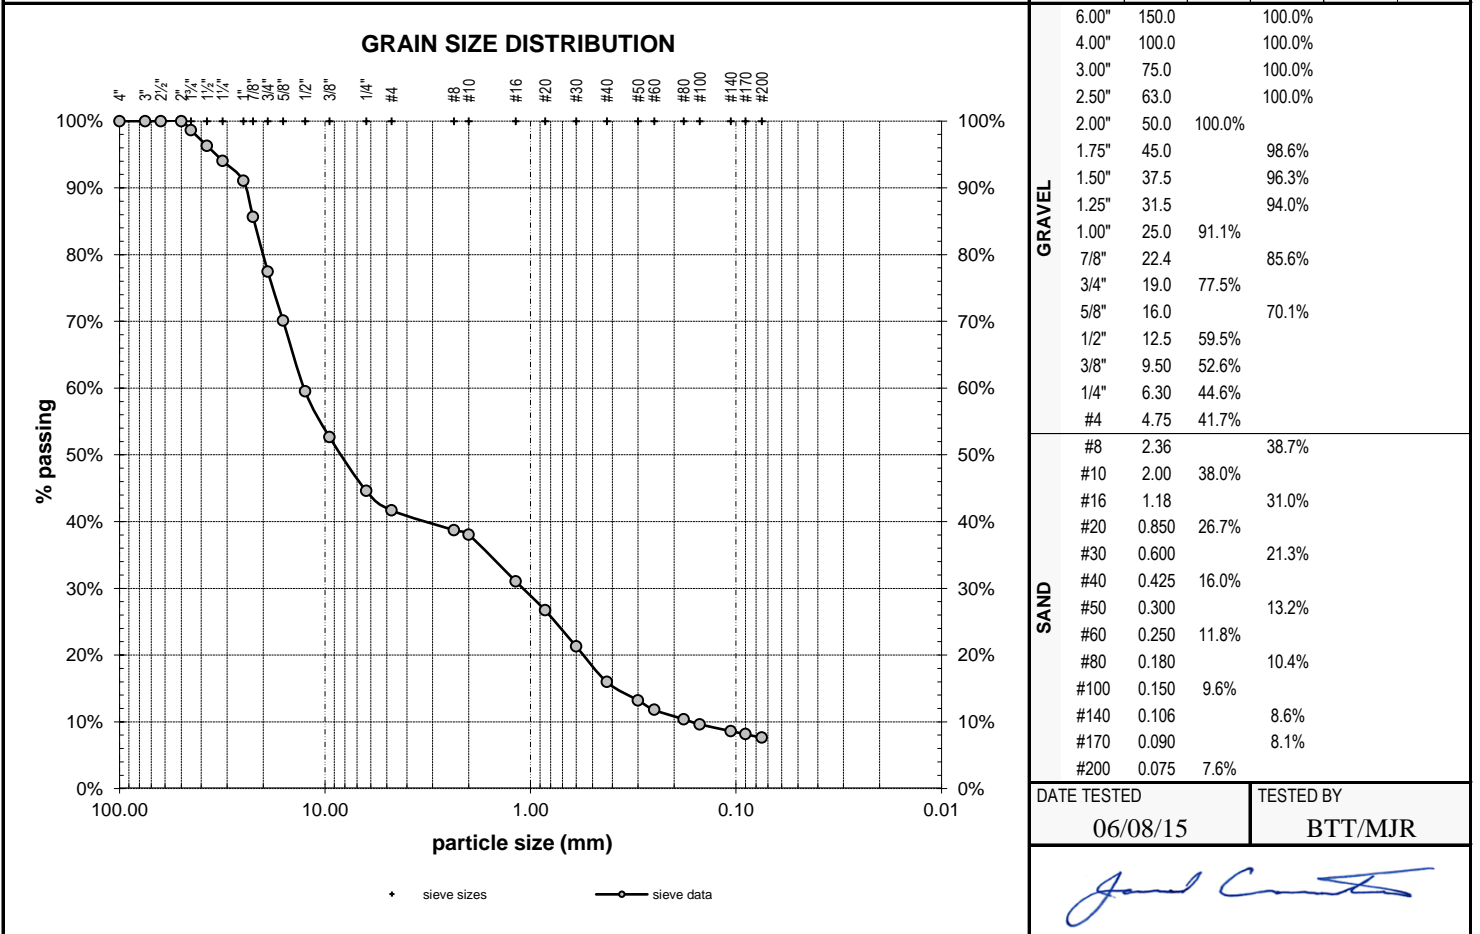
<b>LABORATORY TEST DATA</b>	
<b>LABORATORY EQUIPMENT</b>	<b>TEST PROCEDURE</b>
Rainhart "Mary Ann" Sifter 637	ASTM D6913, D422

<b>ADDITIONAL DATA</b>	<b>SIEVE DATA</b>
initial dry mass (g) = 3089.1 as-received moisture content = 33.2% liquid limit = 46 plastic limit = 28 plasticity index = 18 fineness modulus = n/a	coefficient of curvature, $C_c$ = 0.57 coefficient of uniformity, $C_u$ = 76.93 effective size, $D_{(10)}$ = 0.164 mm $D_{(30)}$ = 1.091 mm $D_{(60)}$ = 12.637 mm
	% gravel = 58.3% % sand = 34.1% % silt and clay = 7.6%

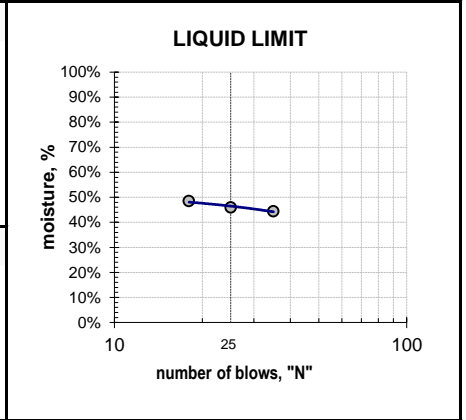
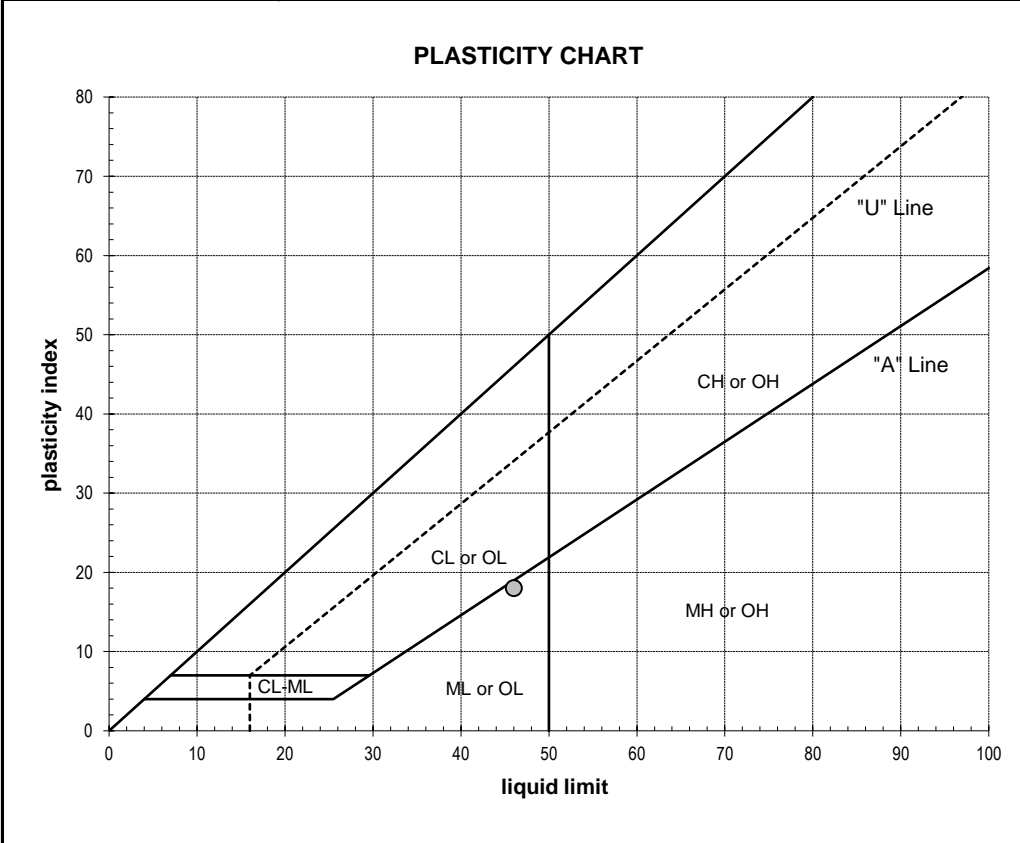
<b>ATTERBERG LIMITS</b>  liquid limit = 46 plastic limit = 28 plasticity index = 18	<b>LIQUID LIMIT DETERMINATION</b>				
		①	②	③	④
	wet soil + pan weight, g =	39.57	37.55	37.51	
	dry soil + pan weight, g =	33.76	32.29	32.08	
	pan weight, g =	20.69	20.82	20.87	
N (blows) =	35	25	18		
moisture, % =	44.5 %	45.9 %	48.4 %

<b>SHRINKAGE</b>  shrinkage limit = n/a shrinkage ratio = n/a	<b>PLASTIC LIMIT DETERMINATION</b>				
		①	②	③	④
	wet soil + pan weight, g =	27.57	27.51		
	dry soil + pan weight, g =	26.11	26.06		
	pan weight, g =	20.82	20.80		
moisture, % =	27.6 %	27.6 %

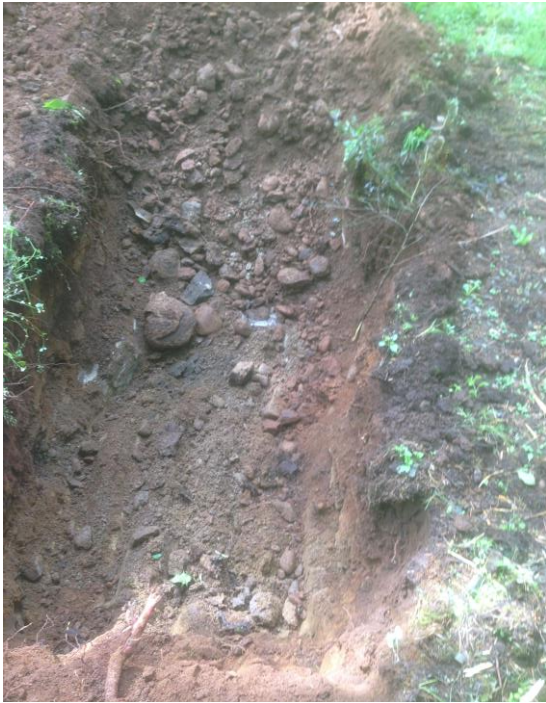
Shallow conglomerate bedrock in Test Pit TP-1

Weathered and competent conglomerate bedrock was encountered in all test pits at various depths. The conglomerate bedrock encountered generally resembled the descriptions of the unnamed Pleistocene to Pliocene, semi-consolidated, pebble to cobble conglomerate (QTc) and the Hyaoclastic sandstone member of the Troutdale formation (Ttff). The bedrock consisted of angular to sub-rounded clasts of various sizes cemented in a matrix of sand, silt, and clay. The bedrock was very dense and excavator refusal was noted at various depths as indicated in Table 1 in Section 5.7, *Excavation*.

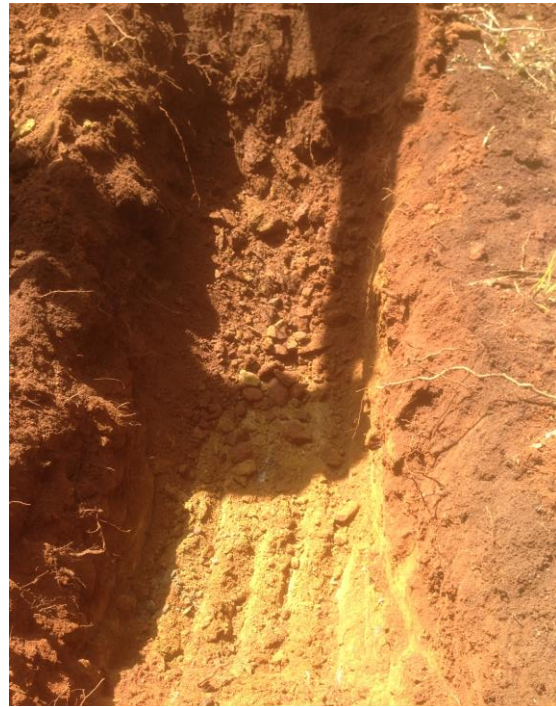
Shallow hyaoclastic sandstone bedrock in Test Pit TP-3

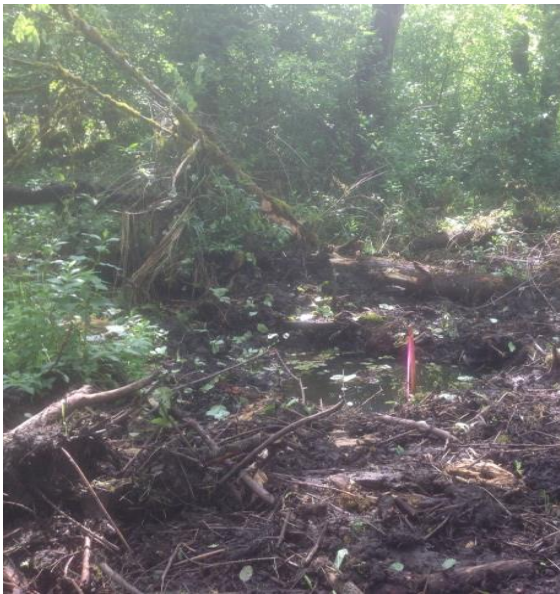
Shallow groundwater near Test Pit TP-1

Groundwater was encountered in test pits TP-1 and TP-8 at depths of 2.5 feet and 15 feet below ground surface, respectively. Standing water was observed at the ground surface elevation in the wetland which occupies the central north portion of the site. According to *Clark County Maps Online*, the static aquifer elevation in the vicinity of the subject site ranges from 190 to 210 feet amsl. These elevations correspond to an approximate depth to groundwater between 0 and 20 feet below ground surface.

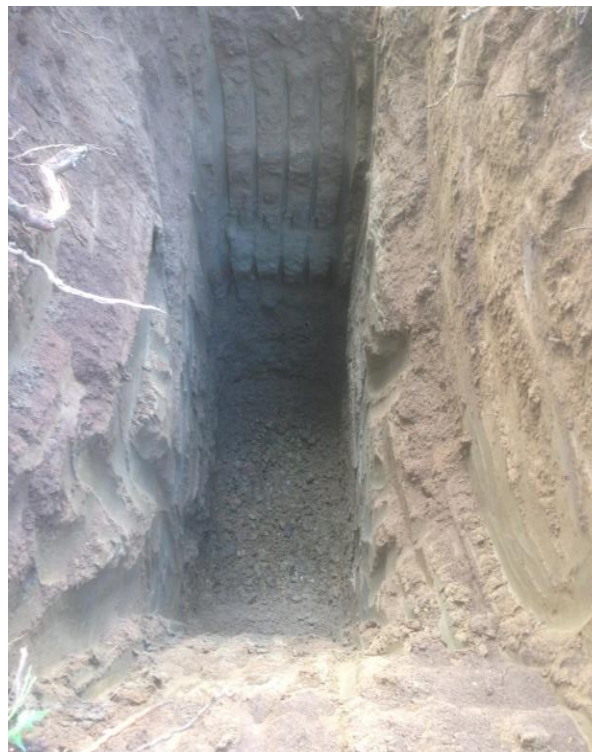
Deeper conglomerate bedrock encountered in Test Pit TP-8
