Heritage Trailhead Parking Lot Expansion at NE Goodwin Road City Project: P-911

Application for Shoreline Conditional Use Permit and Type II Site Land Use Application

Submitted By:
City of Camas
Public Works Department
616 NE 4th Avenue
Camas, Washington 98607

July 24, 2017

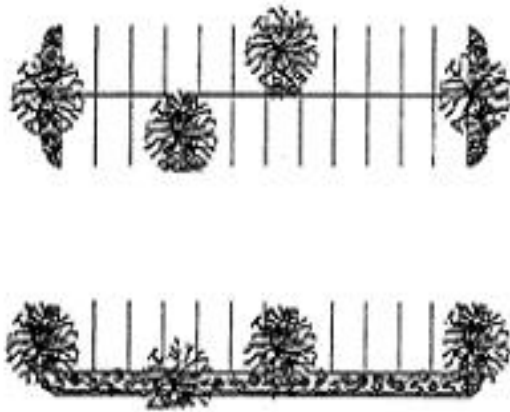
Figure 18.13-1 Parking Lot Planting Islands

- A. Parking areas are to be landscaped at all perimeters.*
- B. All parking areas shall provide interior landscaping for shade and visual relief.*
- C. Parking lots shall have a minimum ratio of one tree per six double-loaded stalls or one tree per three single-loaded stalls (See Figure 18.13-1).*

Response: Due to the sensitive areas surrounding the proposed parking lot, including protected White Oaks and archeological areas, the applicant proposes to make the parking lot more compact by not installing the landscaping islands. Most of the site area will be preserved as a natural area achieving the objective of providing shade and visual relief.

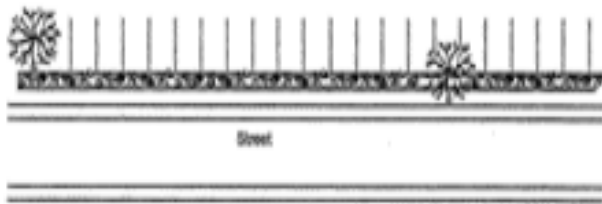
Figure 18.13-2 Parking Lot Landscape Divider Strip

- D. Planter strips (medians) and tree wells shall be used within parking areas and around the Perimeter to accommodate trees, shrubs and groundcover.
- E. Planter areas shall provide a five-foot minimum width of clear planting space.
- F. Wheel stops should be used adjacent to tree wells and planter areas to protect landscaping from car overhangs.
- G. Curbed planting areas shall be provided at the end of each parking aisle to protect parked vehicles.
- H. No more than fifteen parking spaces shall be located in a row without a landscaped divider strip (See Figure 18.13-2).

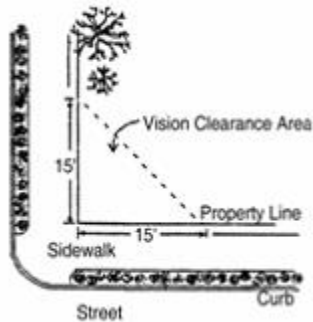
Figure 18.17.030-1 Vision Clearance

- A. *On all corner lots no vehicle, fence, wall, hedge, or other obstructive structure or planting shall impede visibility between a height of forty-two inches and ten feet above the sidewalk or fourteen feet above the street.*

- B. The triangular area shall be formed by measuring fifteen feet along both street property lines beginning at their point of intersection. The third side of the triangle shall be a line connecting the end points of the first two sides of the triangle. See Figures 18.17.030-1 and 18.17.030-2.

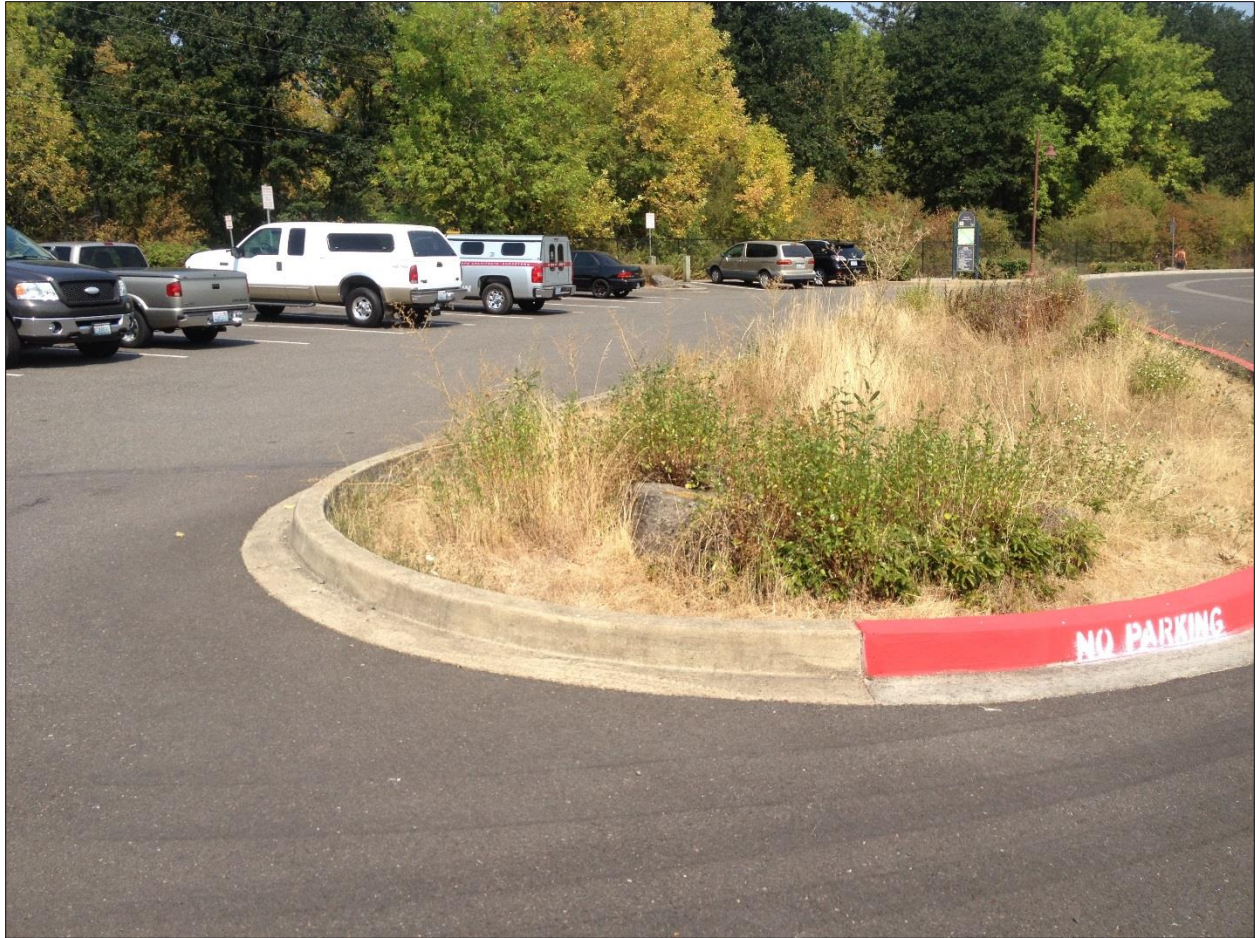
Photograph 1. View to the northeast, showing the existing parking lot. The beginning of the Heritage Trail can be seen in the background, marked by sign. Photograph taken August 26, 2015.

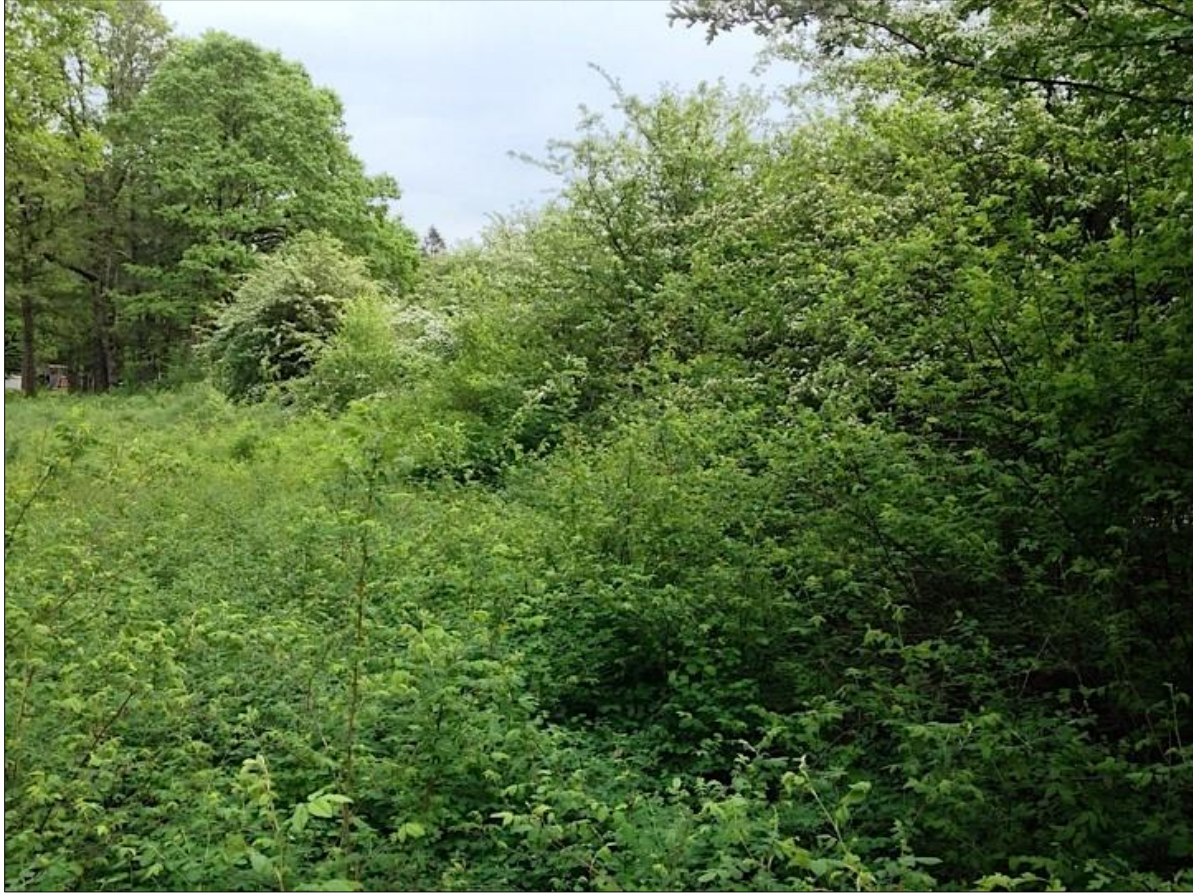
Photograph 2. View to the east, towards the project site. The dense thicket of English hawthorn growing along the existing fence line can be seen in bloom, right and center. Low growing shrubs (common snowberry and cluster rose), typical of the wetland buffer between wetland C1 and the project site, can be seen in the foreground. The oak stand can be seen in the upper left corner. Photograph taken April 26, 2016.

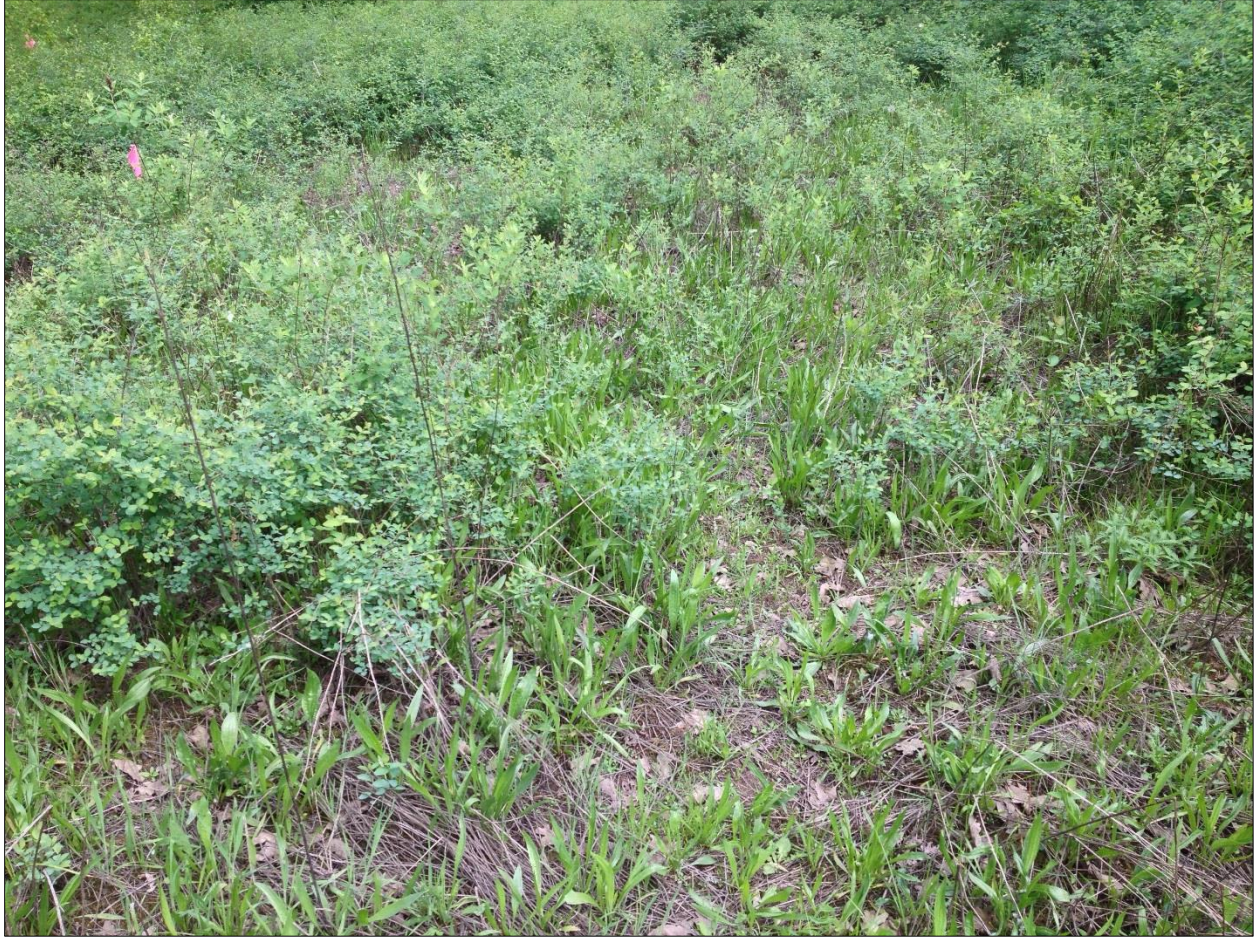
Photograph 3. Typical vegetation in the project site. An area of low shrubs dominated by common snowberry can be seen at the top, and an example of the herbaceous area, dominated by annual grasses and weedy forbs (English plantain in this location) can be seen at the bottom. Photograph taken May 25, 2017.

The project site itself lacks mature trees, with the exception of 6 small, ornamental street trees along NW Alexandra Lane. The site is comprised of three vegetation types (Photograph 3 and 5): a portion of the dense stand of English hawthorn; sparse herbaceous vegetation, consisting of a mixture of non-native annual grasses and disturbance tolerant forbs, such as selfheal (*Prunella vulgaris*), oxeye daisy (*Leucanthemum vulgare*), and English plantain (*Plantago lanceolata*); and areas of low shrubby vegetation dominated by common snowberry.

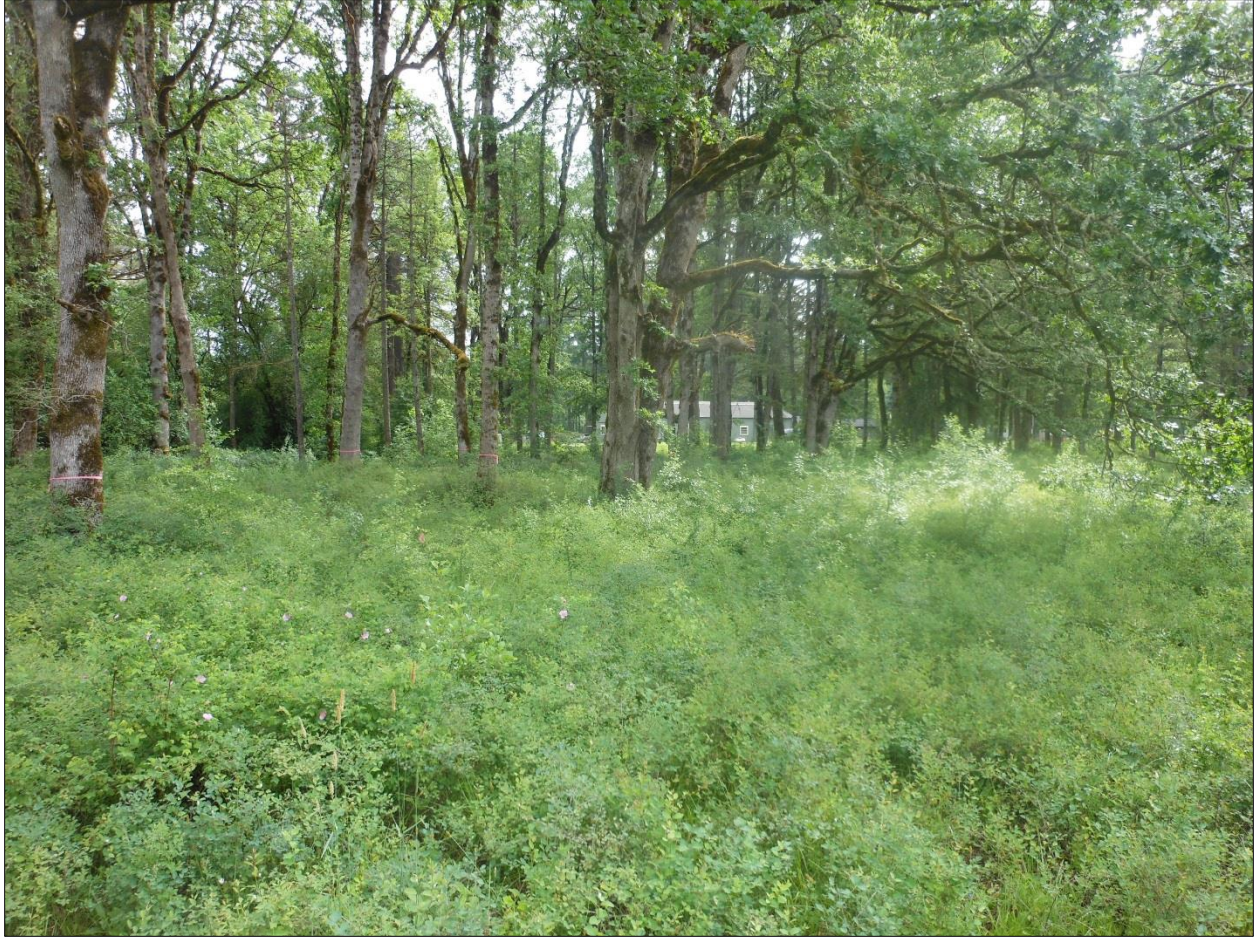
Photograph 4. View to the northeast from the project site towards the oak stand. Common snowberry forms a low shrub layer. Photograph taken May 25, 2017.

A stand of Oregon white oaks (*Quercus garryana*) with an understory dominated by snowberry is present in the northeast portion of the parcel (Photograph 4).

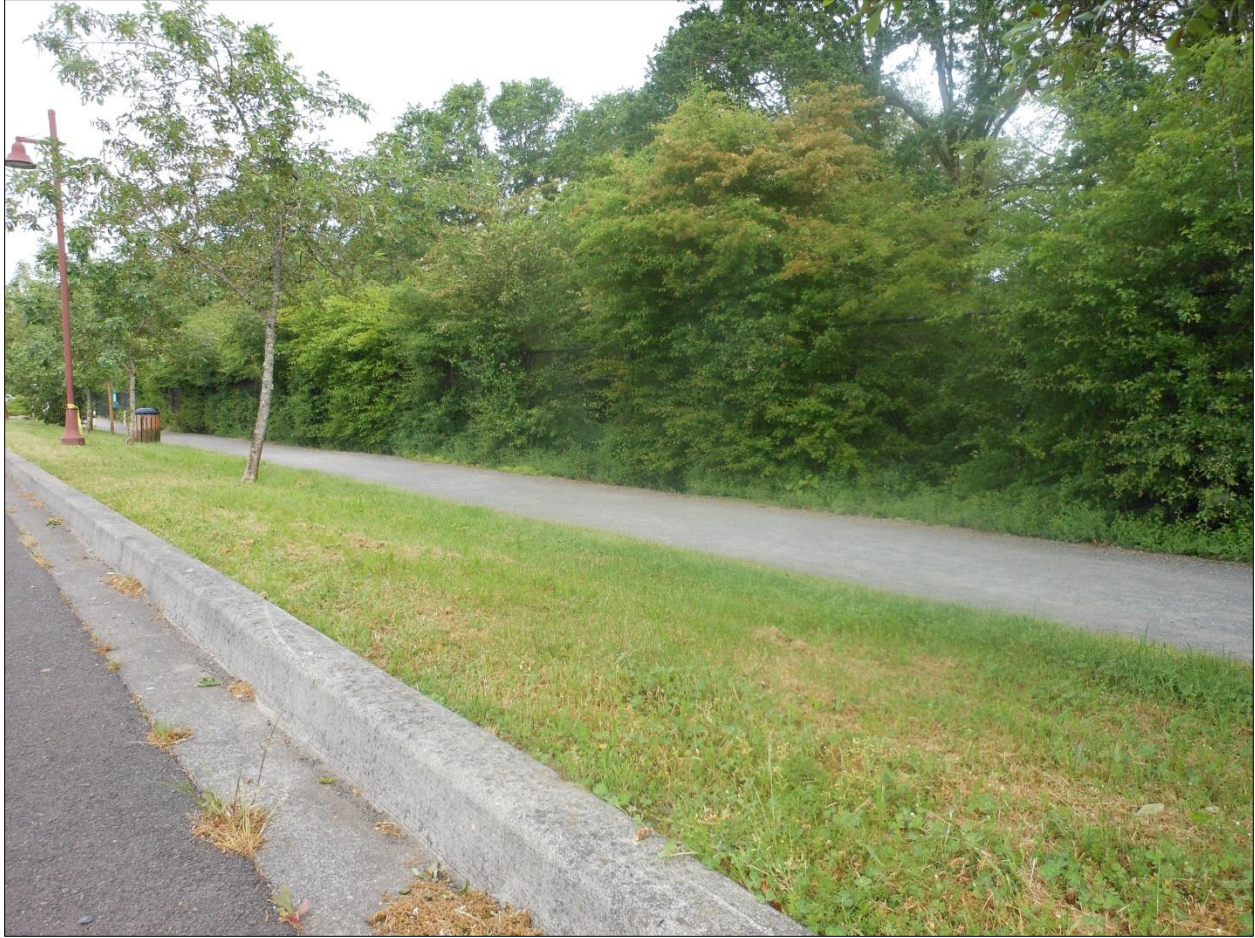
Photograph 5. View to the west along NW Alexandra Lane and the Heritage Trail, showing the approximate location where driveways accessing the proposed parking lot would be located. The English hawthorn thicket can be seen along the edge of the path, with the oak stand in the background. Typical street trees for this stretch of NW Alexandra Lane (small ornamental ash and cherry species) can be seen to the left. Photograph taken May 25, 2017.

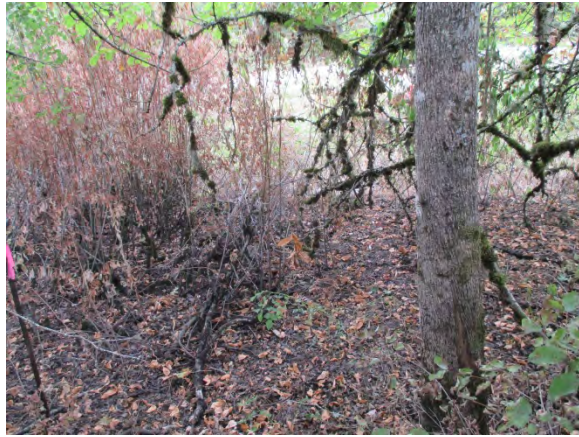
1. Wetland C1.

Wetland C1 is a very small (0.044 acres or 1,950 sq. ft.) scrub-shrub slope wetland located south of NE Goodwin Road and in the southwest corner of the parcel (Photograph 1). The wetland occupies a gentle slope abutting the roadside ditch (Photographs 2 and 3). Based on site topography, truncated soil profiles, and proximity to the roadside ditch, the land surface appears to have been graded in the past, possibly associated with earlier road construction or ditch excavation. The boundary of Wetland C1 is based on changes in elevation on the slope (slope breaks) and changes in dominant plant species.

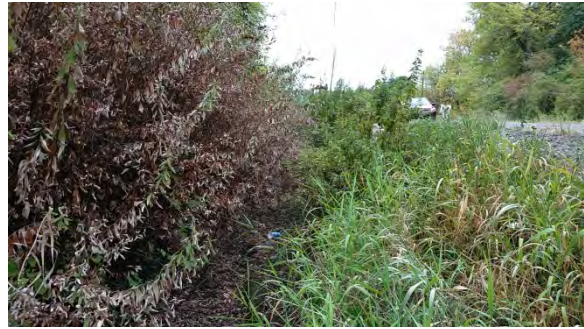
2. Ditch along NE Goodwin Road, looking west from parcel.

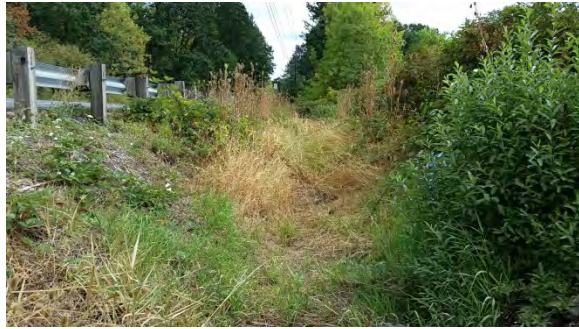
3. Ditch along NE Goodwin Road, looking east towards parcel.

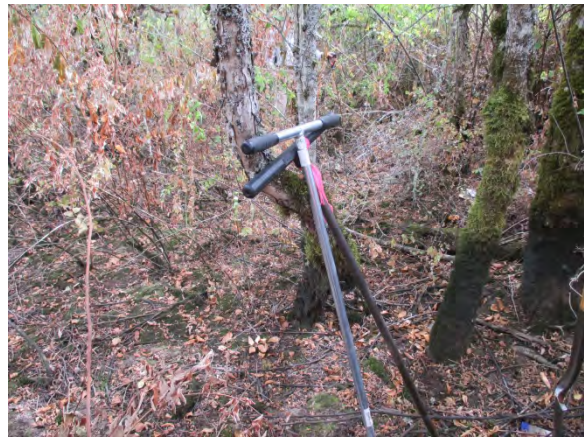
4. Upland associated with Wetland C1 (to right).

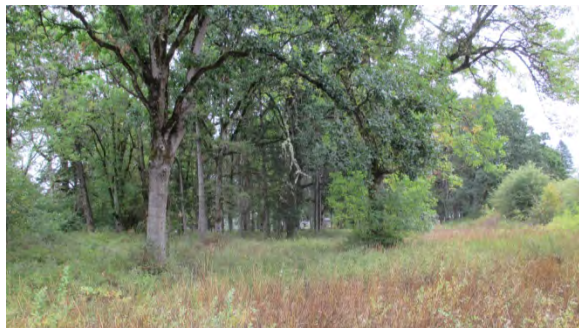
5. Garry oak (Oregon white oak) uplands at the site, looking southeast.

Southward from the wetland margin described above are areas of European hawthorn (*Crataegus monogyna*) and scattered Douglas fir (*Pseudotsuga menziesii*). Farther yet to the south is oak savanna vegetation (Photograph 5), with an open canopy composed of Oregon white oak (*Quercus garryana*, approximately 40 percent by stem count) Douglas fir (approximately 40 percent), and Oregon ash (20 percent). The understory is also rather open and dominated by snowberry and sword fern (*Polystichum munitum*), and smaller amounts of Himalayan blackberry. Part of this oak savanna landscape contains an open meadow consisting of a mixture of grasses and disturbance tolerant forbs, such as selfheal (*Prunella vulgaris*) and English plantain (*Plantago lanceolata*); white moth mullein (*Verbascum blattaria*) and graceful cinquefoil (*Potentilla gracilis*) are locally common. Numerous small Oregon white oak, Oregon ash, and Douglas fir seedlings are present in the oak savanna and open area—often growing side by side (Photograph 6). Such a mixture is not consistent with the typical moisture requirements or habitat associations of these species, and their presence may represent a response to changing hydrology (less moisture) at the site. In the southernmost portion of the parcel, a narrow fringe of Douglas spirea and clustered rose (*Rosa pisocarpa*) is present along the southern fence. This area appears higher in elevation, possibly a result of the construction prism for the adjoining parking lot. Although these species are typically wetland associates, they also are common in disturbed areas open to sunlight – which appears to be the case here.

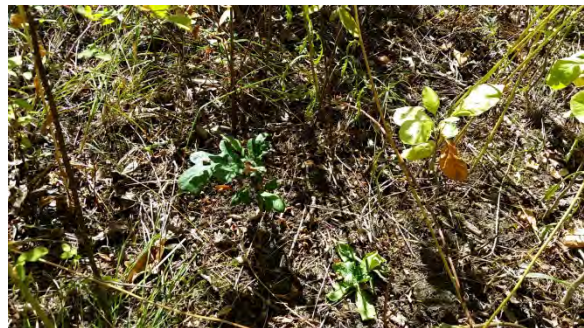
6. Garry oak (Oregon white oak) and Oregon ash growing together.

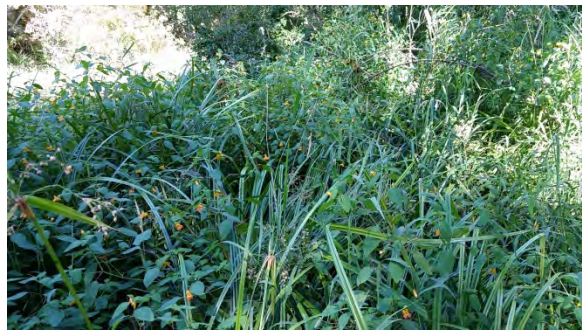
7. Wetland along Lacamas Creek.

Two other wetlands were identified within 300 feet of the site: LHT-1 and Lacamas Creek 1 (Photograph 7). These wetlands were not formally delineated. A preliminary wetland assessment was made based on existing reports for the vicinity and the Clark County wetland inventory, supplemented by field observations. A summary of the characteristics of these wetlands is provided in Table 4.

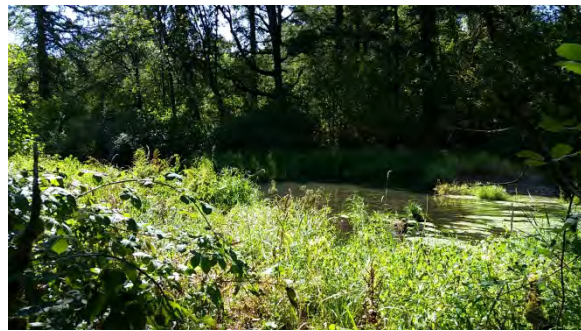
8. Lacamas Creek.
