# **UNION SELF STORAGE CRITICAL AREAS REPORT AND MITIGATION PLAN (REVISION)**

**Tax Parcel 176190000  
6250 NW Friberg-Strunk Street  
Camas, Washington  
USACE No. NWS-2017-845**

**Revised Date: November 6, 2017**

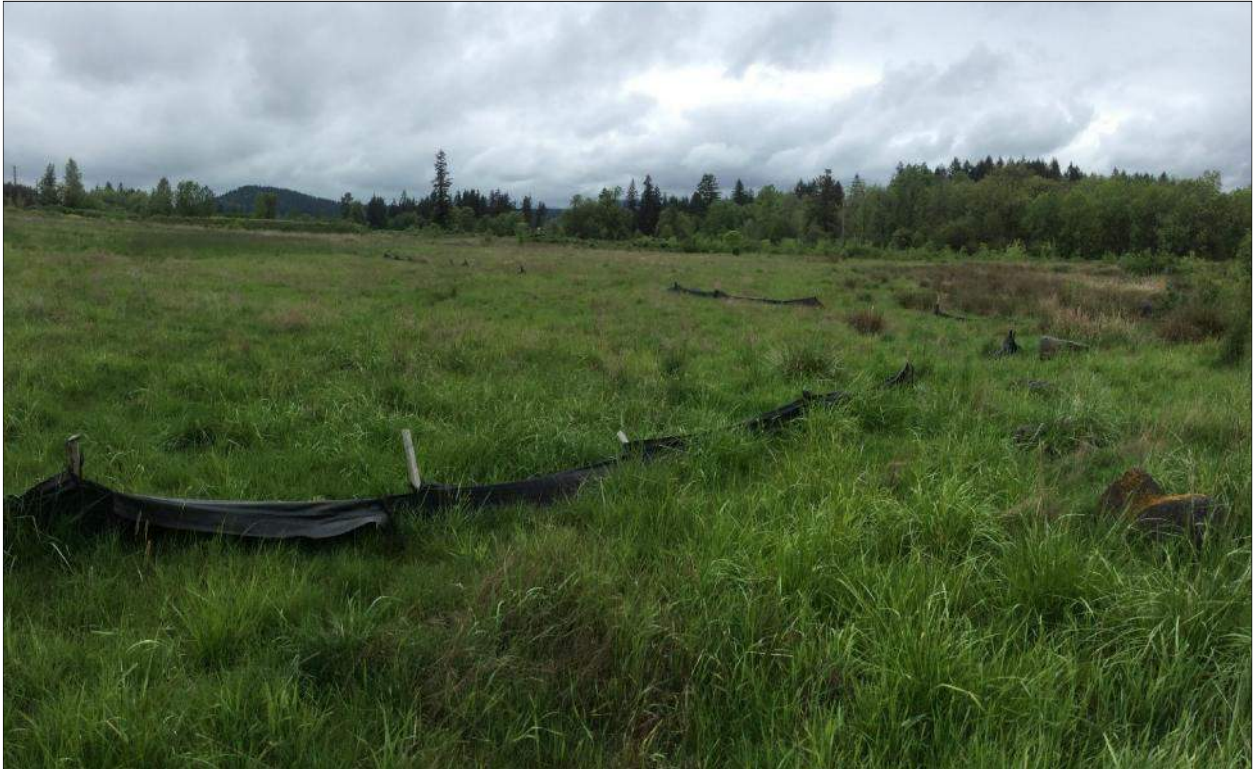
**Figure 2. Photo of emergent slope wetlands taken from the south side of the project area facing northeast. (Photo 1; February 10, 2017).**

The dominant plant species noted within the wetlands includes meadow foxtail (*Alopecurus pratensis* – FAC), redtop grass (*Agrostis gigantea* – FAC), reed canarygrass (*Phalaris arundinacea* – FACW), common velvetgrass (*Holcus lanatus* – FAC), and quackgrass (*Elymus repens* – FAC). Scattered areas of Douglas spirea (*Spiraea douglasii* – FAC) and Oregon ash (*Fraxinus latifolia* – FACW) seedlings were also observed in the east portion of the wetlands.

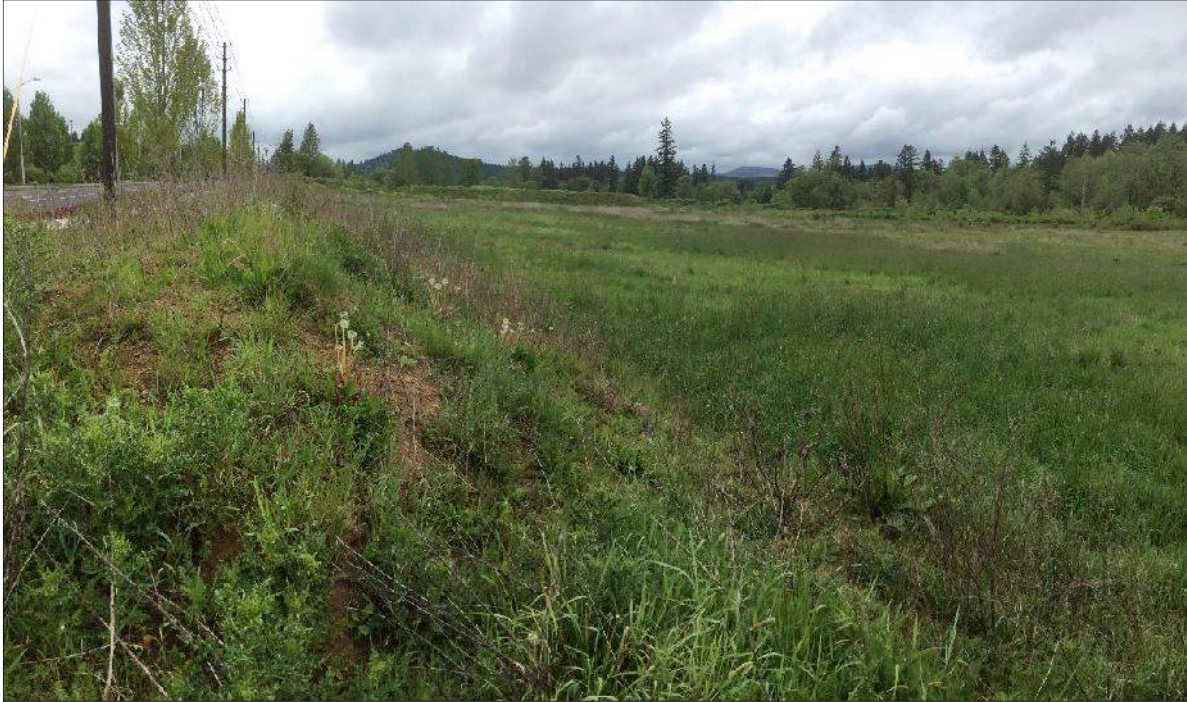
**Figure 3. Photo of imported fill slope and uplands within the west portion of the project area. Photo is taken facing north along the east side of NW Friberg-Strunk Street. (Photo 2; February 10, 2017).**

Soils within the non-wetland areas generally match the description of the non-hydric Dollar soil series. No primary or secondary wetland indicators were observed in the non-wetland portions of the site.

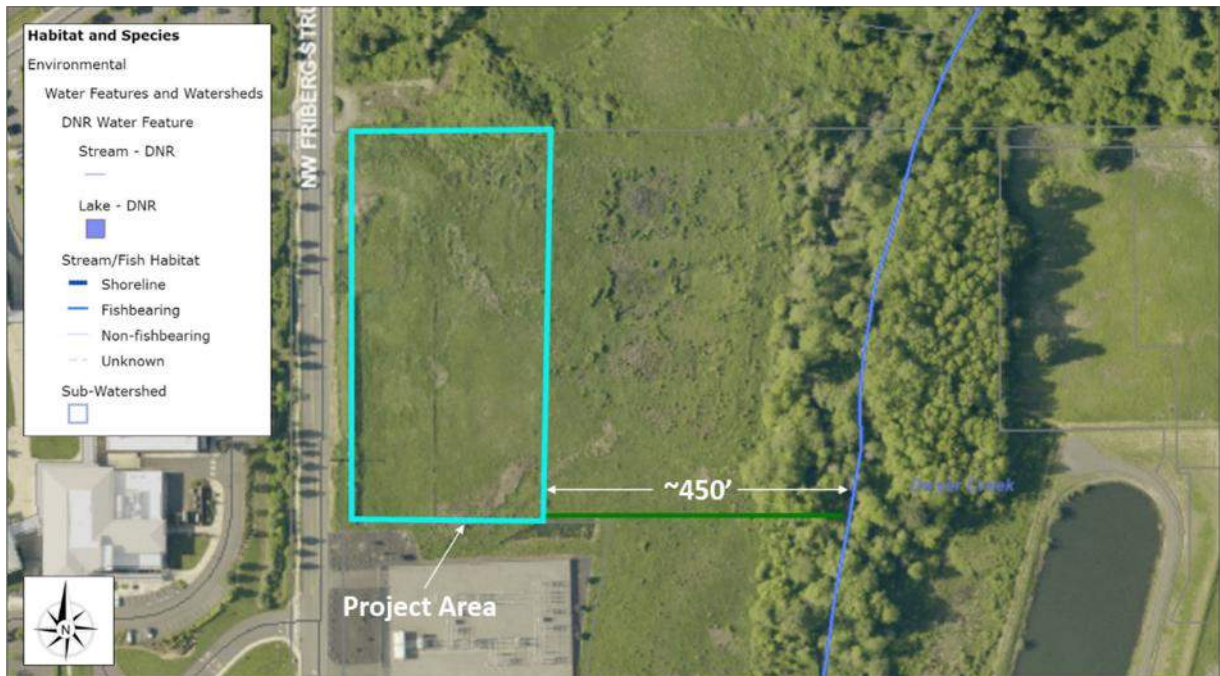
**Figure 4. Project area vicinity DNR FPARS mapping from the Clark County GIS.**

The Washington Department of Fish and Wildlife PHS on the Web website and Clark County GIS does not show any areas of Priority Habitats and Species on the project site or in the immediate vicinity off-site. The nearest mapped PHS area is associated with Dwyer Creek, a DNR Type F tributary stream to Lacamas Creek. The stream is located approximately 450 feet to the east of the southeast property corner of the project site according to the GIS. No other regulated PHS was observed during the field visit.

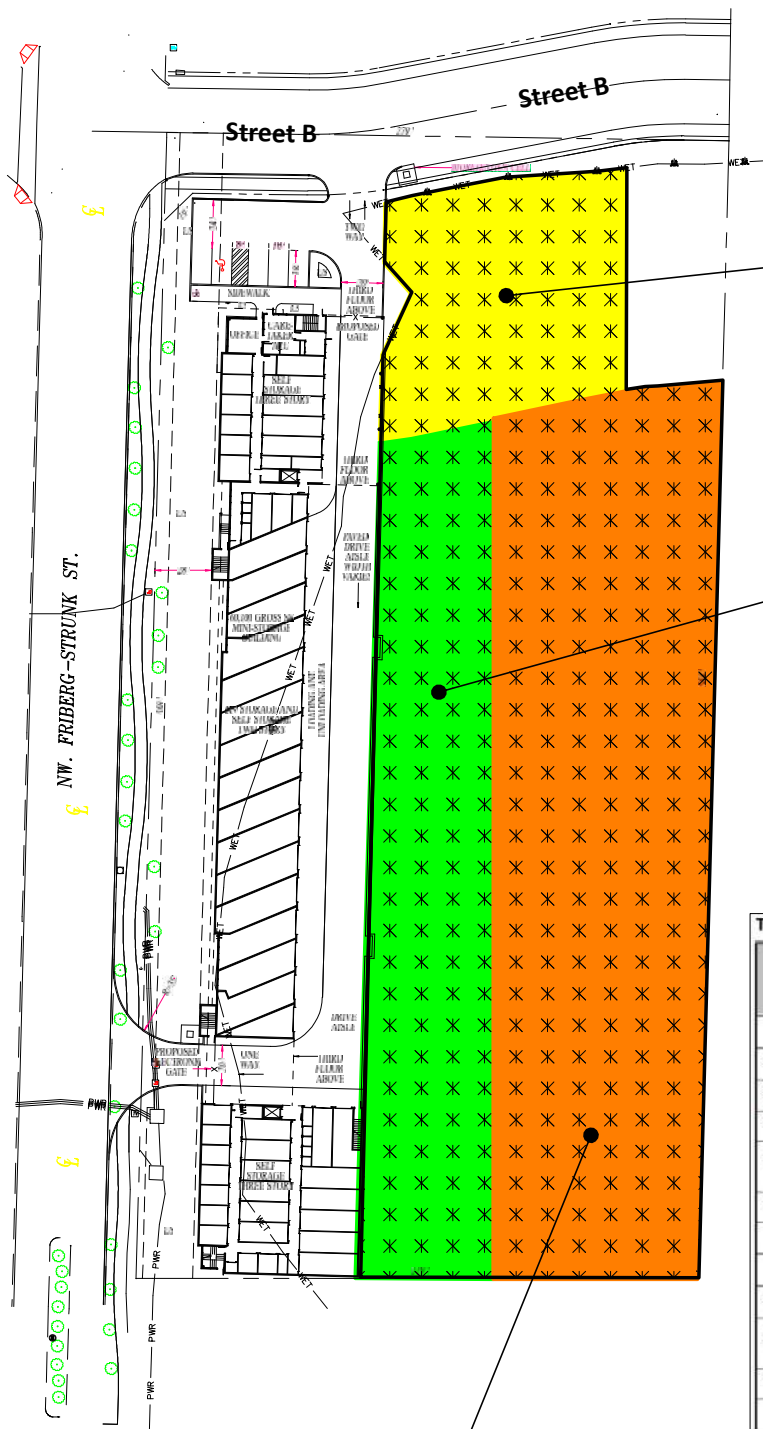
**Mitigation Area 1. Wetland Enhancement Area (City of Camas)**  
**Mitigation Area for Permanent Wetland Buffer Impacts**  
**13,474 sf / 0.30 ac.**

**Mitigation Area 2. Wetland Enhancement Area**  
**Mitigation Area for Permanent Wetland Buffer Impacts**  
**25,820 sf / 0.59 ac.**  
**(See Note 1)**

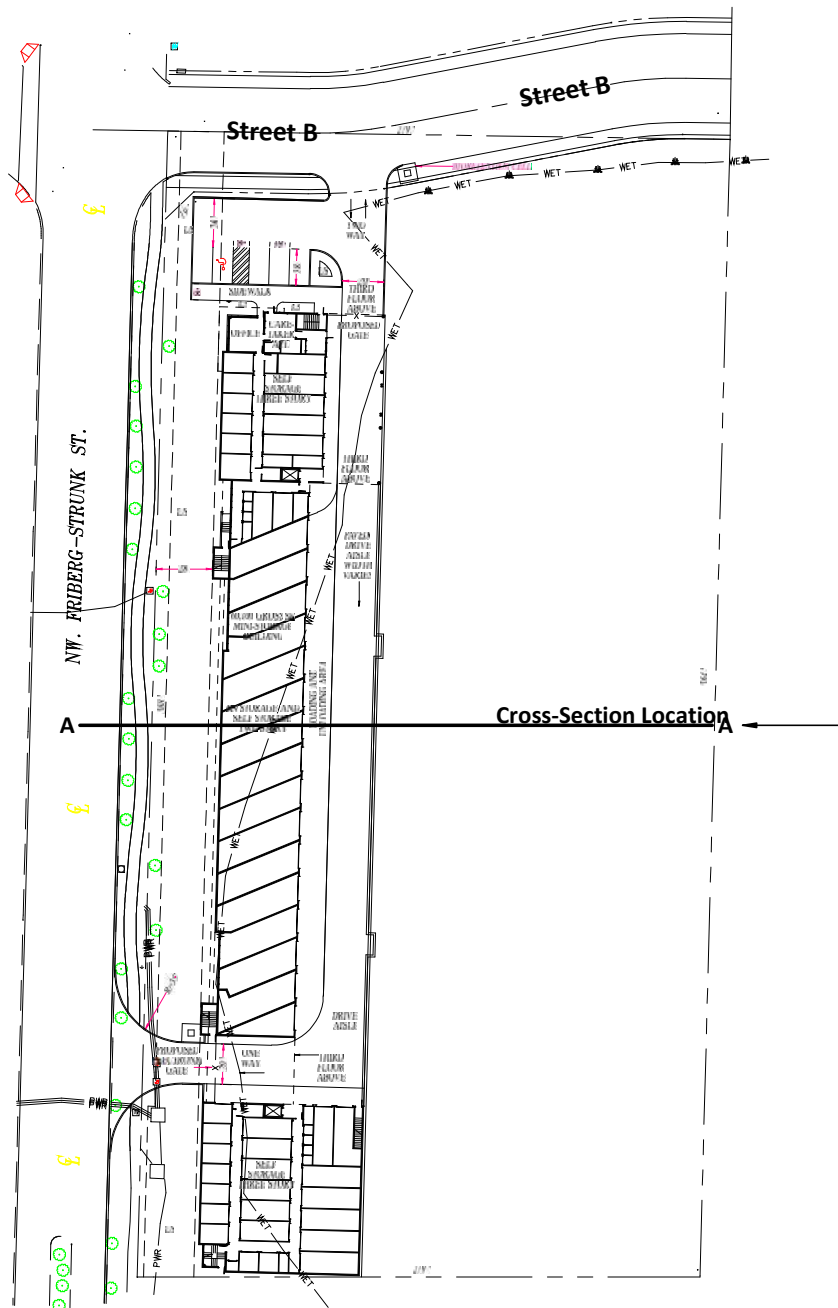
**Cross-Sectional View from Friberg-Strunk Rd. to East Property Line  
(Provided by Olson Engineering)**
