Dawson's Ridge Density Transfer Subdivision

FISH & WILDLIFE HABITAT CONSERVATION AREAS - REVISED PRELIMINARY MITIGATION PLAN

Camas, Washington

August 22, 2017

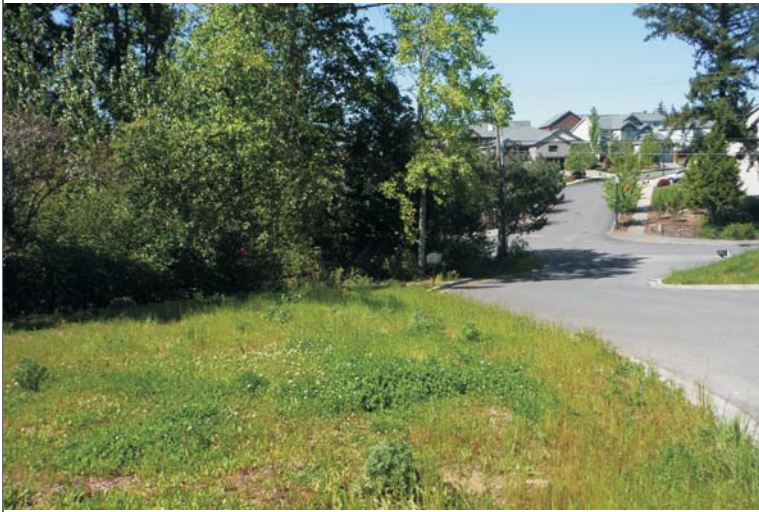
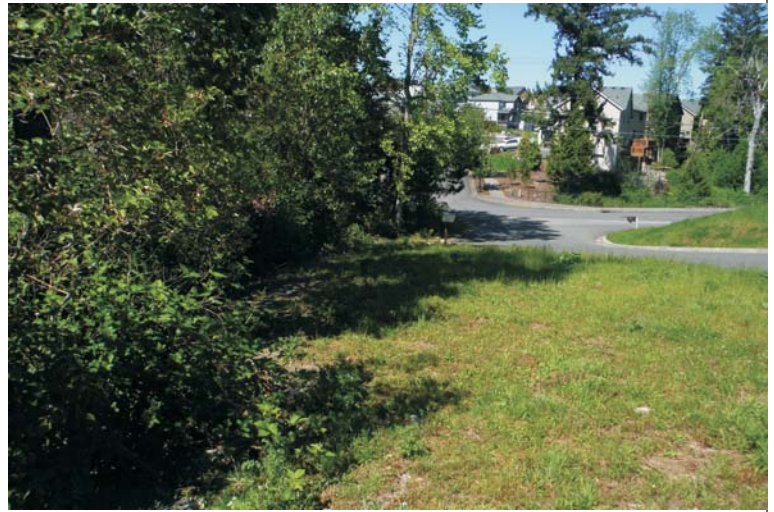
Existing Habitat Conditions - Proposed Sidewalk

The Applicant is proposing the construction of a sidewalk along the west edge of the existing access road and cul-de-sac as shown in Figure 5. The northern portion of the sidewalk will be constructed within the riparian habitat buffer (75') for Deer Creek (Fig. 6). The proposed sidewalk will impact 654 ft² of the riparian habitat buffer (Fig. 6). Currently, vegetation in this area is dominated by blackberry and grass that is maintained (mowed) periodically as seen in the photographs of this area (Photo-Sheet 1). Due to the periodic mowing the habitat value for this area is low.

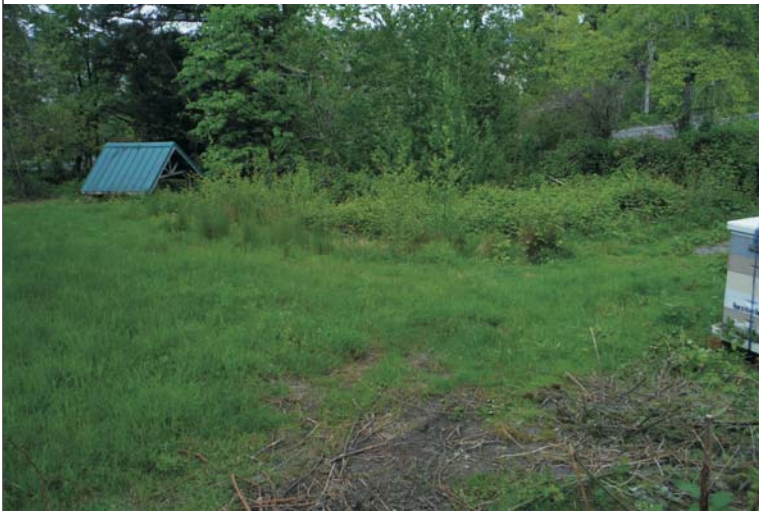
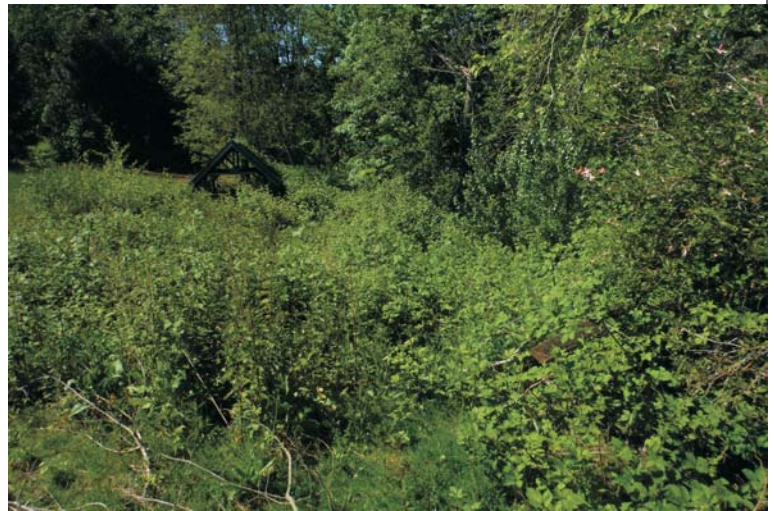
Existing Habitat Conditions - Proposed Outfall

The Applicant is proposing the installation of a stormwater outfall within the 25-foot riparian buffer of the Type Ns stream near the existing site access road as shown in Figure 6. The proposed outfall will impact 185 ft² of riparian habitat buffer (Fig. 6). Currently, vegetation in this area is dominated by blackberry as seen in the photographs of this area (Photo-Sheet 1). Due to the lack of plant diversity in the impact area, the habitat value for this area is low.

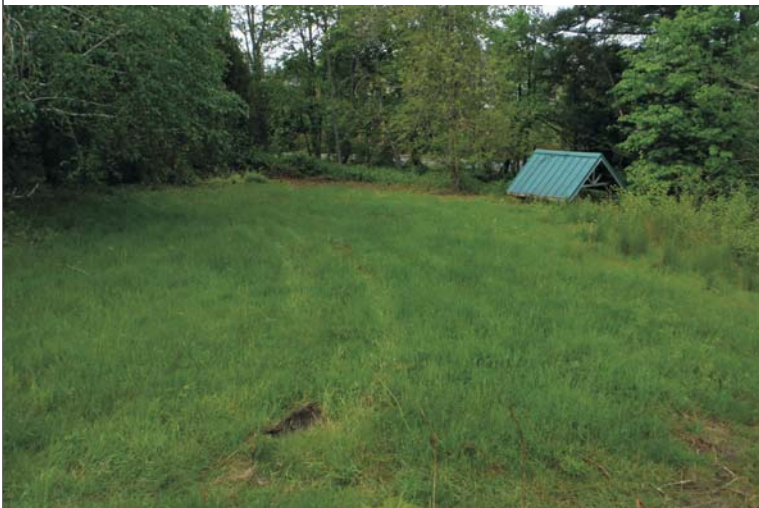
Existing Habitat Conditions - Proposed Mitigation Area

To compensate for the riparian habitat buffer impacts (1,847 ft²) for the riparian buffer impacts outlined above, the Applicant will enhance the area shown in Figure 6. The enhancement area (3,694 ft²) is located adjacent to the riparian buffers for both Deer Creek and the Type Ns stream. The goal of the mitigation is to compensate for the loss of 1,847 ft² of riparian buffer habitat at a minimum of a 2:1 ratio. Currently, the proposed enhancement area is an open grassland plant community that is mowed periodically. The enhancement of this area will consist of planting native trees which will add diversity and structure to the riparian buffer. The proposed planting plan is specified below.

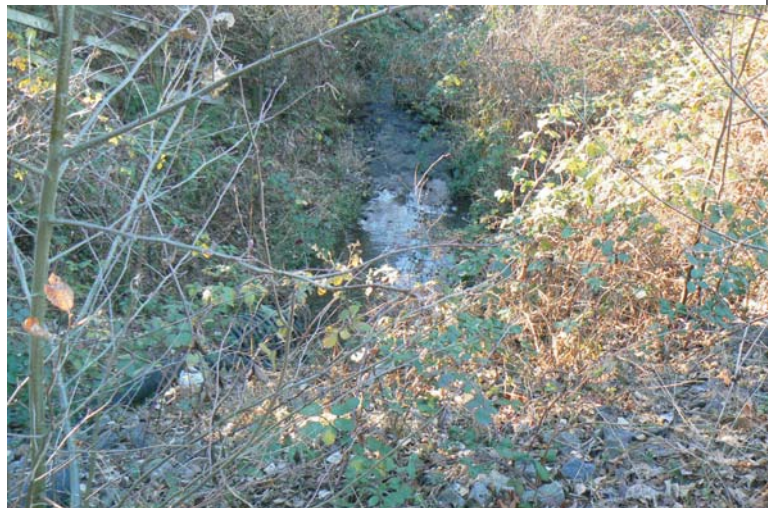
Existing Habitat Conditions - Deer Creek

Deer Creek is a perennial Type F stream that occurs along the northern property boundary. This stream is located in a shallow, forested, incised ravine dominated by red alder (*Alnus rubra*), western red cedar (*Thuja plicata*) and black cottonwood (*Populus balsamifera*). The stream flows west for a short distance, near the northeast corner of the study site, before crossing to the south side of NW McIntosh Road. From this point, the stream flows in a westerly direction adjacent to NW McIntosh Road until the intersection with Brady Road. At the intersection with Brady Road, the stream flows south on the east side of Brady Road, crosses under SR- 14, and discharges into the Columbia River. The stream averaged a channel width of 3-4 feet with an estimated flow rate of 1.67 cubic feet per second (cfs). Type F streams (fish-bearing, non-anadromous) are protected by a 75-foot riparian buffer as per CMC16.61.040(D) (Fig. 5).
