WETLAND REPORT

Camp Lacamas Step Sewer Project City of Camas Project WS-681E

Prepared for:

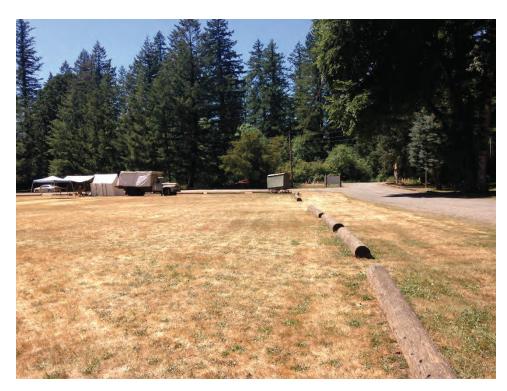
Photograph 1: View northwest across camp lawn toward NE Goodwin Road. Proposed sewer alignment to be located in gravel road on right and connection to sewer main in NE Goodwin Road near the sign board. Photograph taken July 28, 2017.

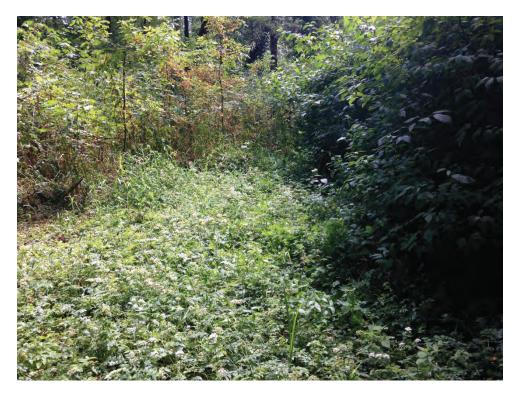
Photograph 3: View looking east, showing Wetland K-1. Emergent area, dominated by water parsley in foreground and center. Photograph taken July 28, 2017.

A very small (0.026 acre or 1,112 square feet) palustrine scrub-shrub/emergent (PSS/PEM) depressional wetland with a forested fringe (Wetland K-1; Photographs 3 and 4) is present approximately 40 feet northeast of the project alignment, at the closest point. This wetland is located in a depression at the toe of a steep slope (approximately 30%) that separates the developed camp area on the upper terrace from the forested and relatively undisturbed lower terrace along Lacamas Creek. This wetland could be occupying the bottom of an old, abandoned gravel pit, but this is uncertain.

Hydrology for Wetland K-1 appears to be driven by a high water table associated with Lacamas Creek and having restricted drainage because of the shallow bedrock. Areas of surface water ponding and saturated soils were observed during the June 20, 2017 site visit (Photograph 3). Soil was moist, but not saturated, during the July 28 delineation. Secondary indicators, including water-stained leaves (B9), geomorphic position (D2), and FAC-neutral vegetation (D5) were observed during the July visit. The presence of these primary and secondary indicators of wetland hydrology meets the wetland hydrology criteria.

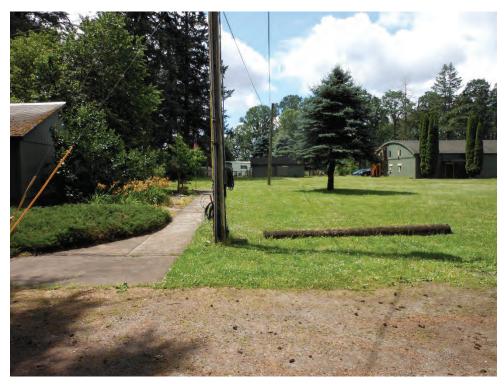
Photograph 4: View looking southwest across camp lawn. Proposed sewer alignment to be right and parallel to the sidewalk and extend to the restroom (green building at back, center). The area beyond the blue spruce (*Picea pungens*) in the foreground is outside of Shoreline jurisdiction. Photograph taken July 28, 2017.

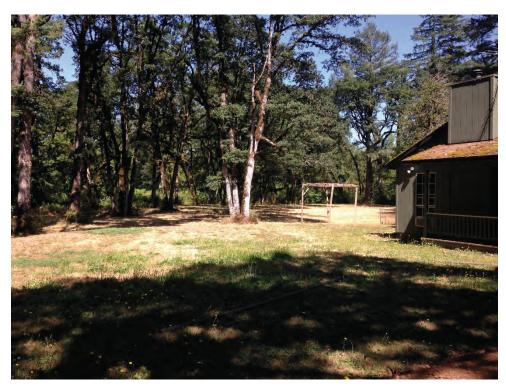
Photograph 5: View along the west side of the caretaker's house. Proposed sewer alignment to pass close to the building in the lawn beneath the Oregon white oaks (*Quercus garryana*). The septic tank to be modified is buried at the corner of the building. Photograph taken July 28, 2017.

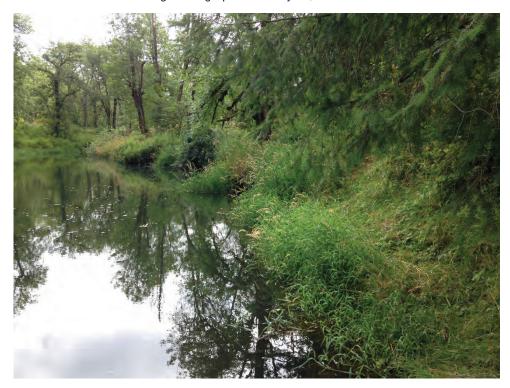
Photograph 6: View looking east along the south bank of Lacamas Creek, approximately 160 feet north of the project, adjacent to the parcel. Photograph taken July 28, 2017.

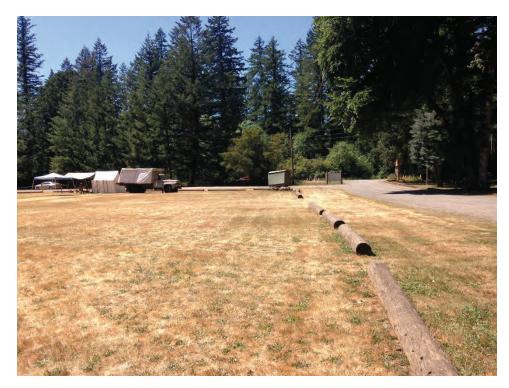
Photograph 1: View northwest across camp toward NE Goodwin Road. Photograph taken July 28, 2017.

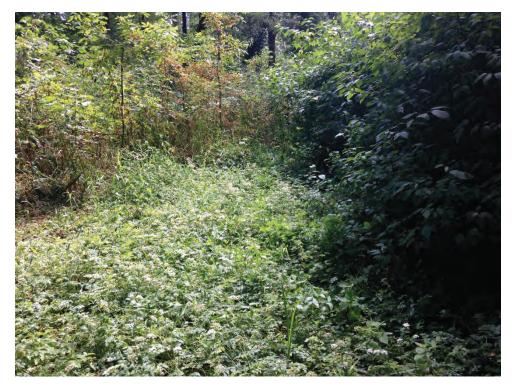
Photograph 3: View looking east, showing Wetland K-1. Emergent area, dominated by water parsley in foreground and center. Photograph taken July 28, 2017.

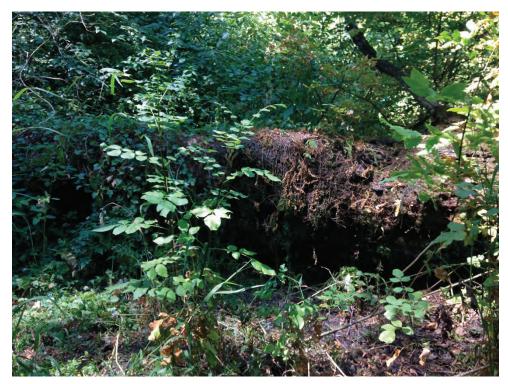
Photograph 4: View looking northwest from the southeast corner of Wetland K-1 showing emergent wetland vegetation (foreground), scrub-shrub vegetation dominated by red osier dogwood (left), and Oregon ash in the forest fringe (right). A windthrow tip-up can be seen in the center. Photograph taken July 28, 2017.

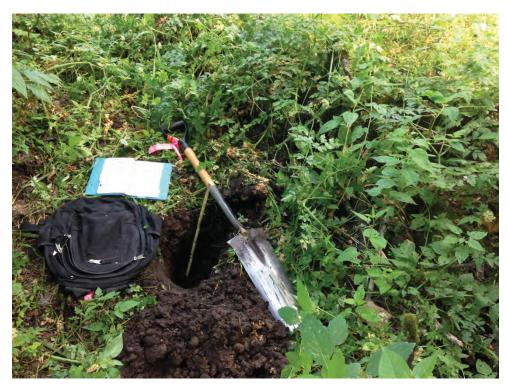
Photograph 5: Wetland plot (Plot 2) in Wetland K-1, showing sample pit and emergent wetland vegetation. Photograph taken July 28, 2017.

Soils observed in Wetland K-1 have a very dark gray (2.5Y3/1) gravelly loam surface horizon (0-12 inches) with 2 percent dark yellowish brown (10YR4/6) and 2 percent brown (10YR4/3) concentrations in the matrix (Data Form K-1 Plot 2, Appendix C). From 12 to 14 inches, the limit of the soil pit, was weather bedrock (Troutdale Formation) that was very difficult to excavate. The texture was extremely gravelly sandy loam with a brown to strong brown

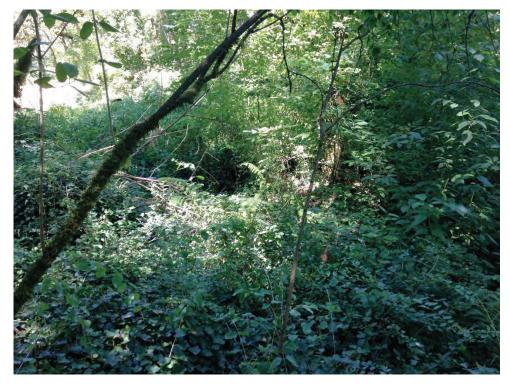
Photograph 6: View looking east into the wetland from the top of the steep slope behind the restroom. Upland vegetation dominated by English ivy, common snowberry, and highbush cranberry can be seen in the foreground. Photograph taken July 28, 2017.

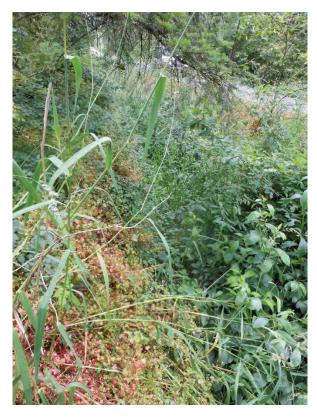
Photograph 7: View of ditch along south side of NE Goodwin Road in vicinity of where sewer line is planned to bored under ditch. Photograph taken June 20, 2017.

One roadside ditch (Photographs 7 and 8) was identified in the study area, along NE Goodwin Road. In the vicinity of the project, this ditch is excavated in upland based on USDA NRCS soil mapping (non-hydric soils); corroboration of the same based on the site review, and non-hydrophytic vegetation. Ditches excavated in upland are exempt from City wetland regulations (SMP 16.53.010.C.2); therefore, the ditch was not delineated and no buffer is required. The ditch likely carries seasonal stormwater drainage. The project will not impact this ditch; the sewer line will be bored underneath it and construction will implement relevant Best Management Practices (silt fencing, equipment storage, etc.).

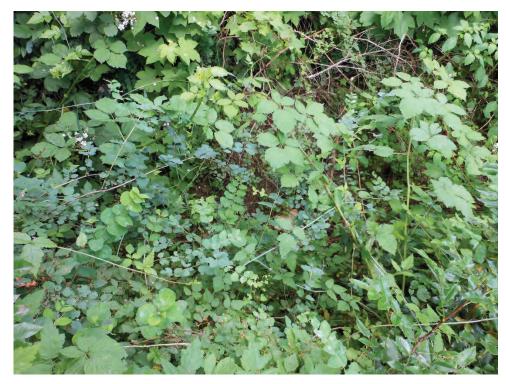
Photograph 8: Vegetation in ditch along south side of NE Goodwin Road in vicinity of where sewer line is planned to bored under ditch.. Photograph taken July 28, 2017.

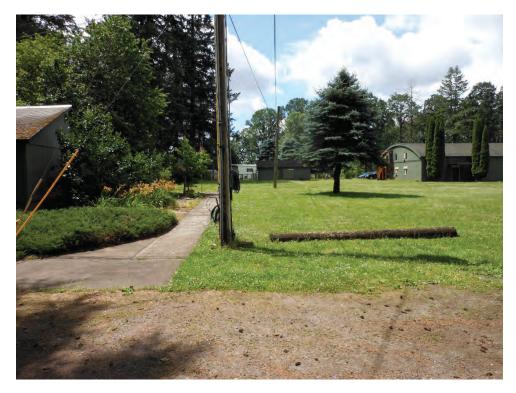
Photograph 1: View looking southwest across camp lawn. Proposed sewer alignment to be right and parallel to the sidewalk and extend to the restroom (green building at back, center). The area beyond the blue spruce (*Picea pungens*) in the foreground is outside of Shoreline jurisdiction. Photograph taken July 28, 2017.
