WETLAND DETERMINATION REPORT

SOUTHEAST 40TH SITE

October 18, 2007

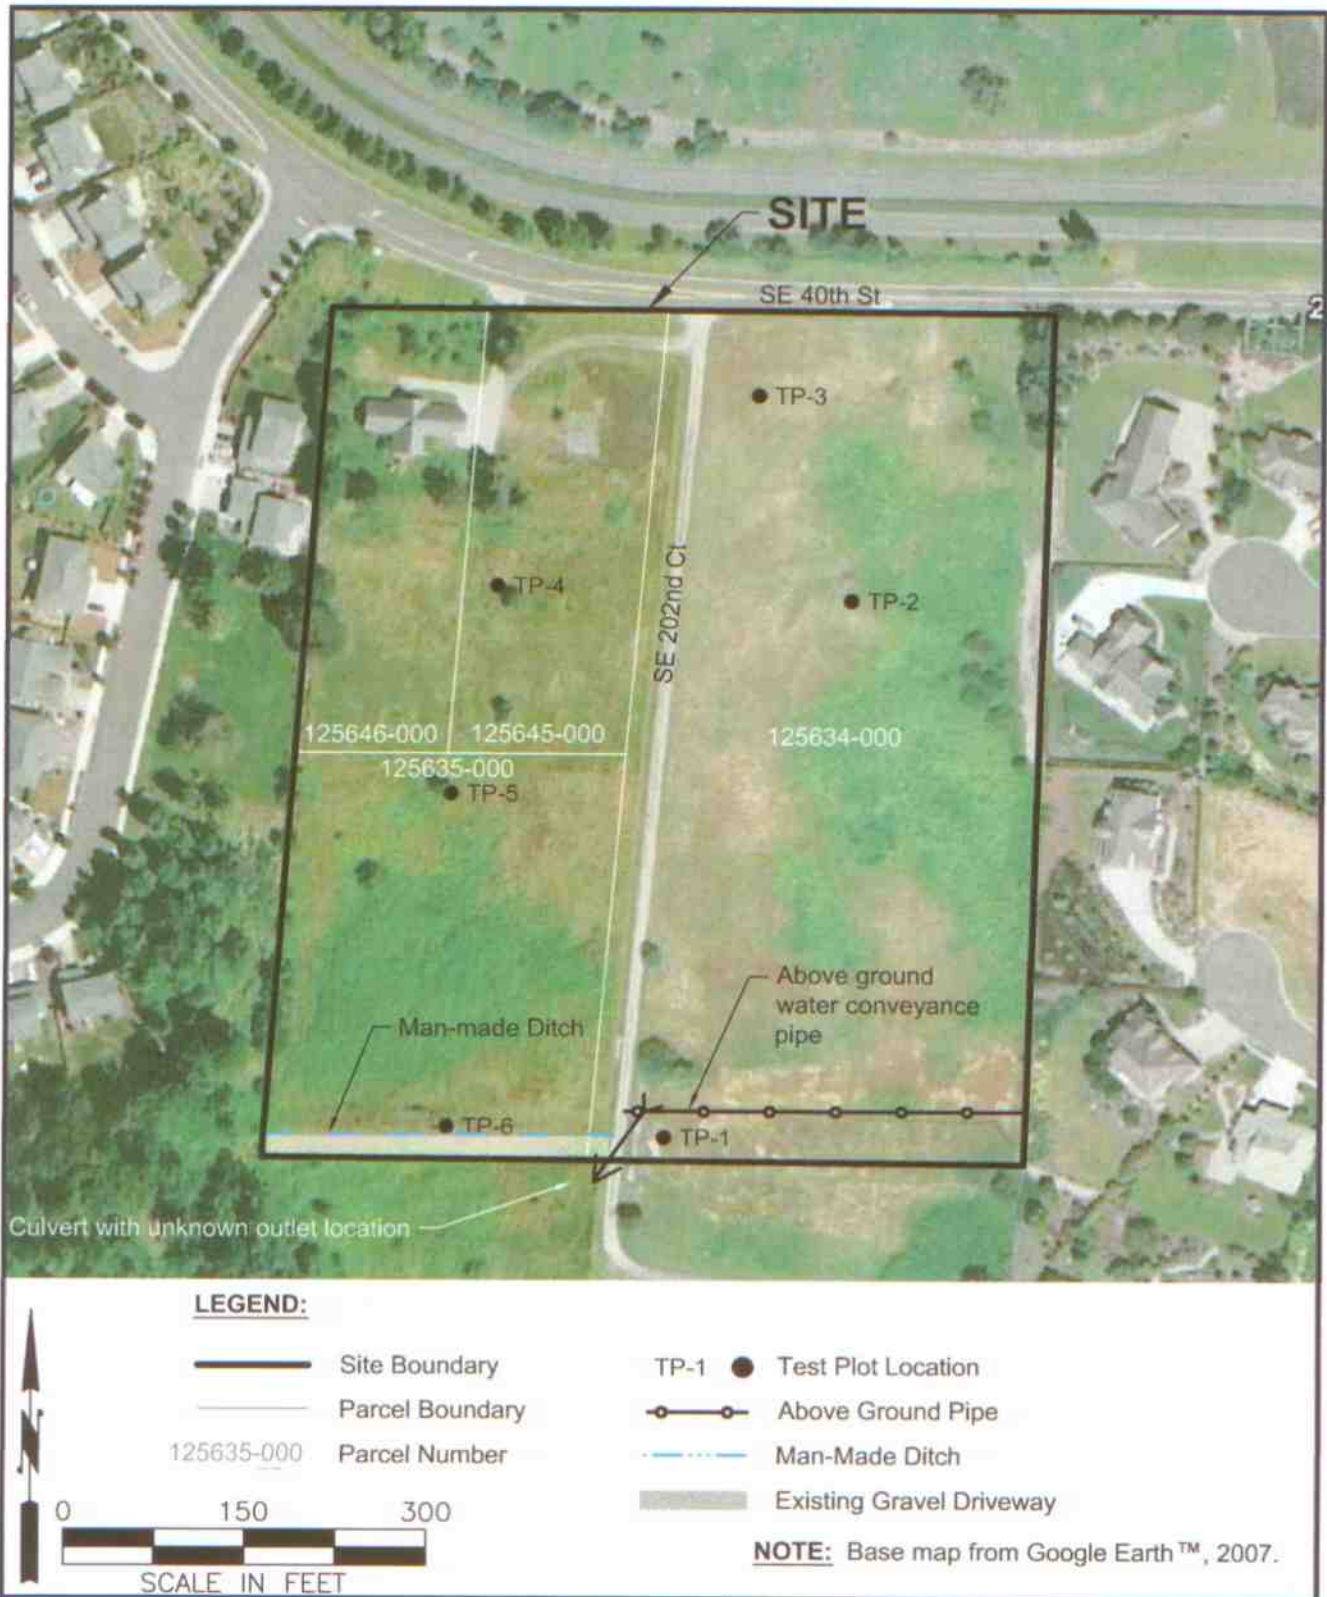
Figure 2
AERIAL SITE MAP
SE 40th Street
Stan Firestone
City of Camas, Clark County, Washington
Section 8, Township 1N, Range 3E, W.M.

Much of the subject site is pastureland with a few scattered trees. Site topography generally slopes south and west, with the lowest point being a man-made ditch in the southwestern region of the site. A single family residence is located in the northwestern region of the site (Figure 2). Surrounding land uses include residential homes to the east and west, NE 40th Street to the north and a functionally isolated wetland to the south. The residence is accessed by a paved driveway from Southeast 40th Street and a gravel driveway off of 202nd Court. A private road, 202nd Court, bisects the property and runs the entire length of the property from north to south. An above-ground water conveyance pipe, located near the southern property boundary in the eastern parcel, transports water draining from a neighboring development to the east. The pipe is approximately 320 feet long on-site, extending from the eastern property boundary to 202nd Court.

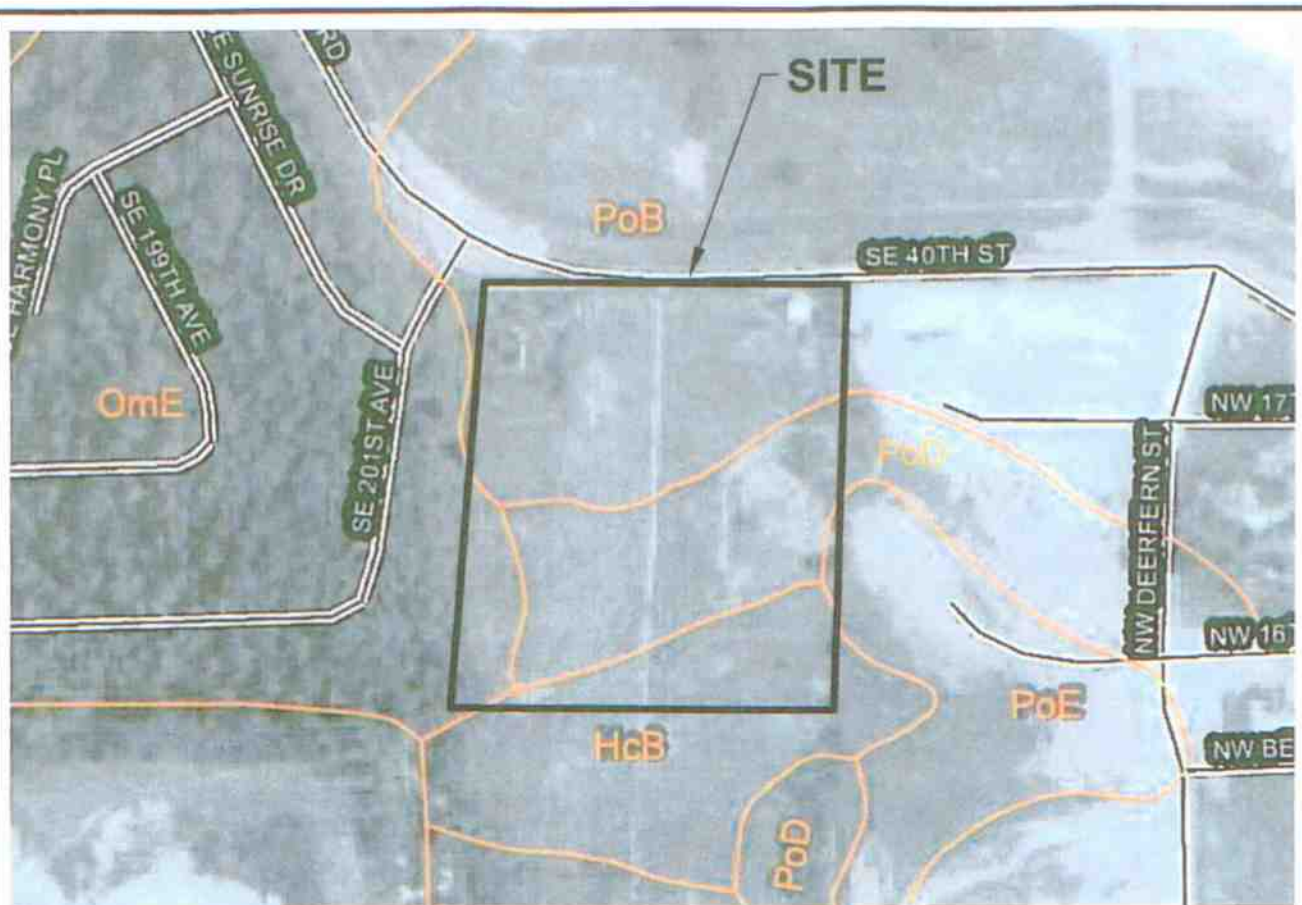
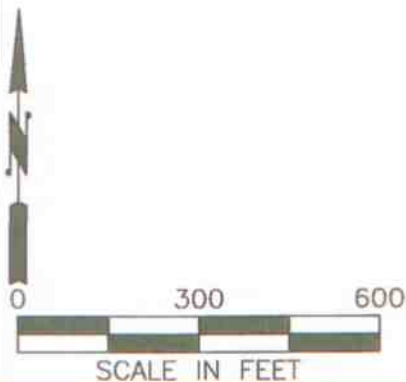
Figure 3
 SOIL SURVEY MAP
 SE 40th Street
 Stan Firestone
 City of Camas, Clark County, Washington
 Section 8, Township 1N, Range 3E, W.M.

On-site soil types are mapped as Hesson clay loam, 0-8 percent slopes (HcB), Olympic stony clay loam, 3-30 percent slopes (OmE) and Powell silt loam, 8-20 percent slopes (PoD; Figure 3). Hesson clay loam is a well drained soil occurring on high ridges along mountain foot slopes. Olympic stony clay loam is a well drained soil that occurs on ridgetops, on long side slopes, and on short slopes along drainage. Powell silt loam is a somewhat poorly drained soil that occurs on long, smooth side slopes below ridges and on foot slopes (NRCS 2006). None of the soils mapped on-site by the NRCS are listed as hydric in Clark County.

Soils observed on-site generally agreed with the mapped soil series. No hydric soils were located on-site during site investigation.

PoB - Powell silt loam, 0 to 8 percent slopes. Not hydric.
 PoD - Powell silt loam, 8 to 20 percent slopes. Not hydric.
 PoE - Powell silt loam, 20 to 30 percent slopes. Not hydric.
 HcB - Hesson clay loam, 8 to 20 percent slopes. Not hydric.
 OmE - Olympic stony clay loam, 3 to 30 percent slopes. Not hydric.

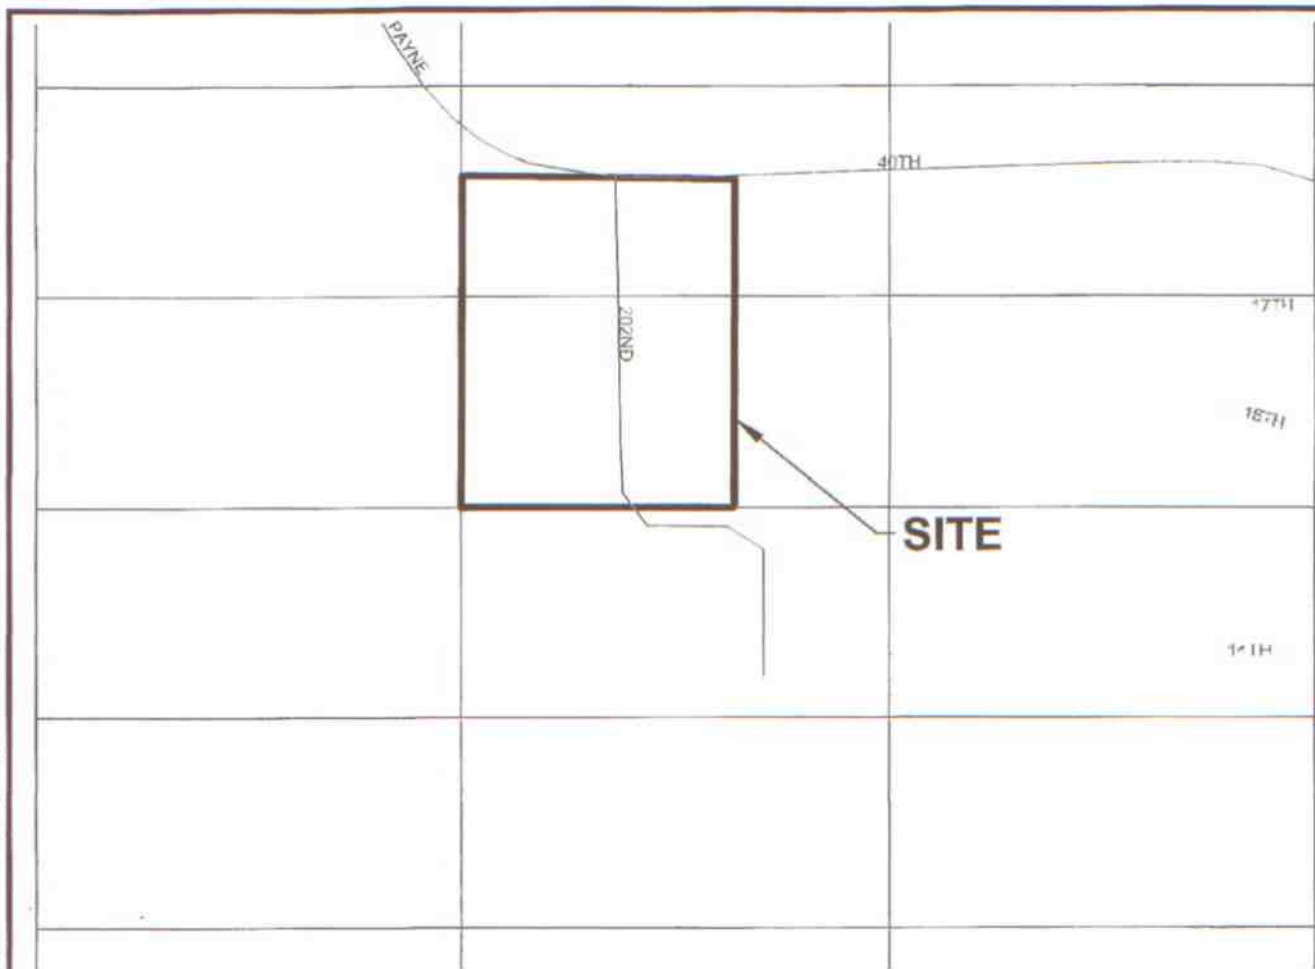
Figure 4
NATIONAL WETLANDS INVENTORY MAP
SE 40th Street
Stan Firestone
City of Camas, Clark County, Washington
Section 8, Township 1N, Range 3E, W.M.

The National Wetlands Inventory (NWI) map did not show any wetlands on or adjacent to the subject site. ELS agrees that no wetlands are located on-site (Figure 4). As a cautionary note, National Wetlands Inventory map information should be used with discretion because they are used to gather general wetland information about a regional area; therefore, they are limited in accuracy for smaller sites because of their large scale.

No mapped wetlands indicated on site by US Fish & Wildlife Service.

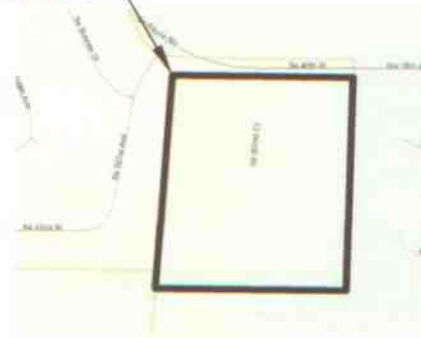
Clark County Wetland and Hydric Soils Inventory

The Clark County Wetland Inventory maps does not show any wetlands on or adjacent to the subject site. ELS agrees no wetland were located on-site (Figure 5).

No Wetlands Mapped On-site

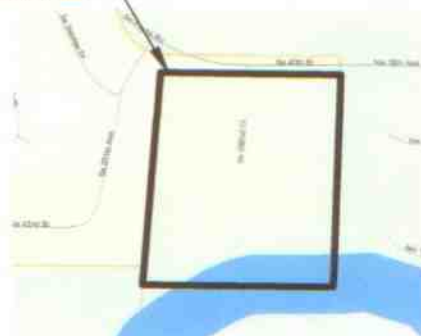
Clark County Species-Habitat

The Clark County Priority Species-Habitat map shows a Riparian Habitat Conservation Area designated within the buffer of the mapped stream (Figure 5). ELS does not concur with the location of the mapped stream as shown encroaching within the site boundary. It is possible that a type Ns stream is located south of the site; ELS has not conducted field reconnaissance outside the site boundaries.

Riparian Habitat
Conservation Area

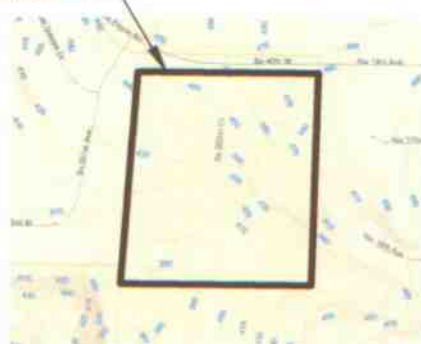
Topographic
Contours

NOTE: Map provided on-line by Clark County, Washington at
web address: <http://gis.clark.wa.gov/gishome/property>
