CRITICAL AREAS DETERMINATION

August 2018

Lacamas Creek Sewer Pump Station
Camas, Washington

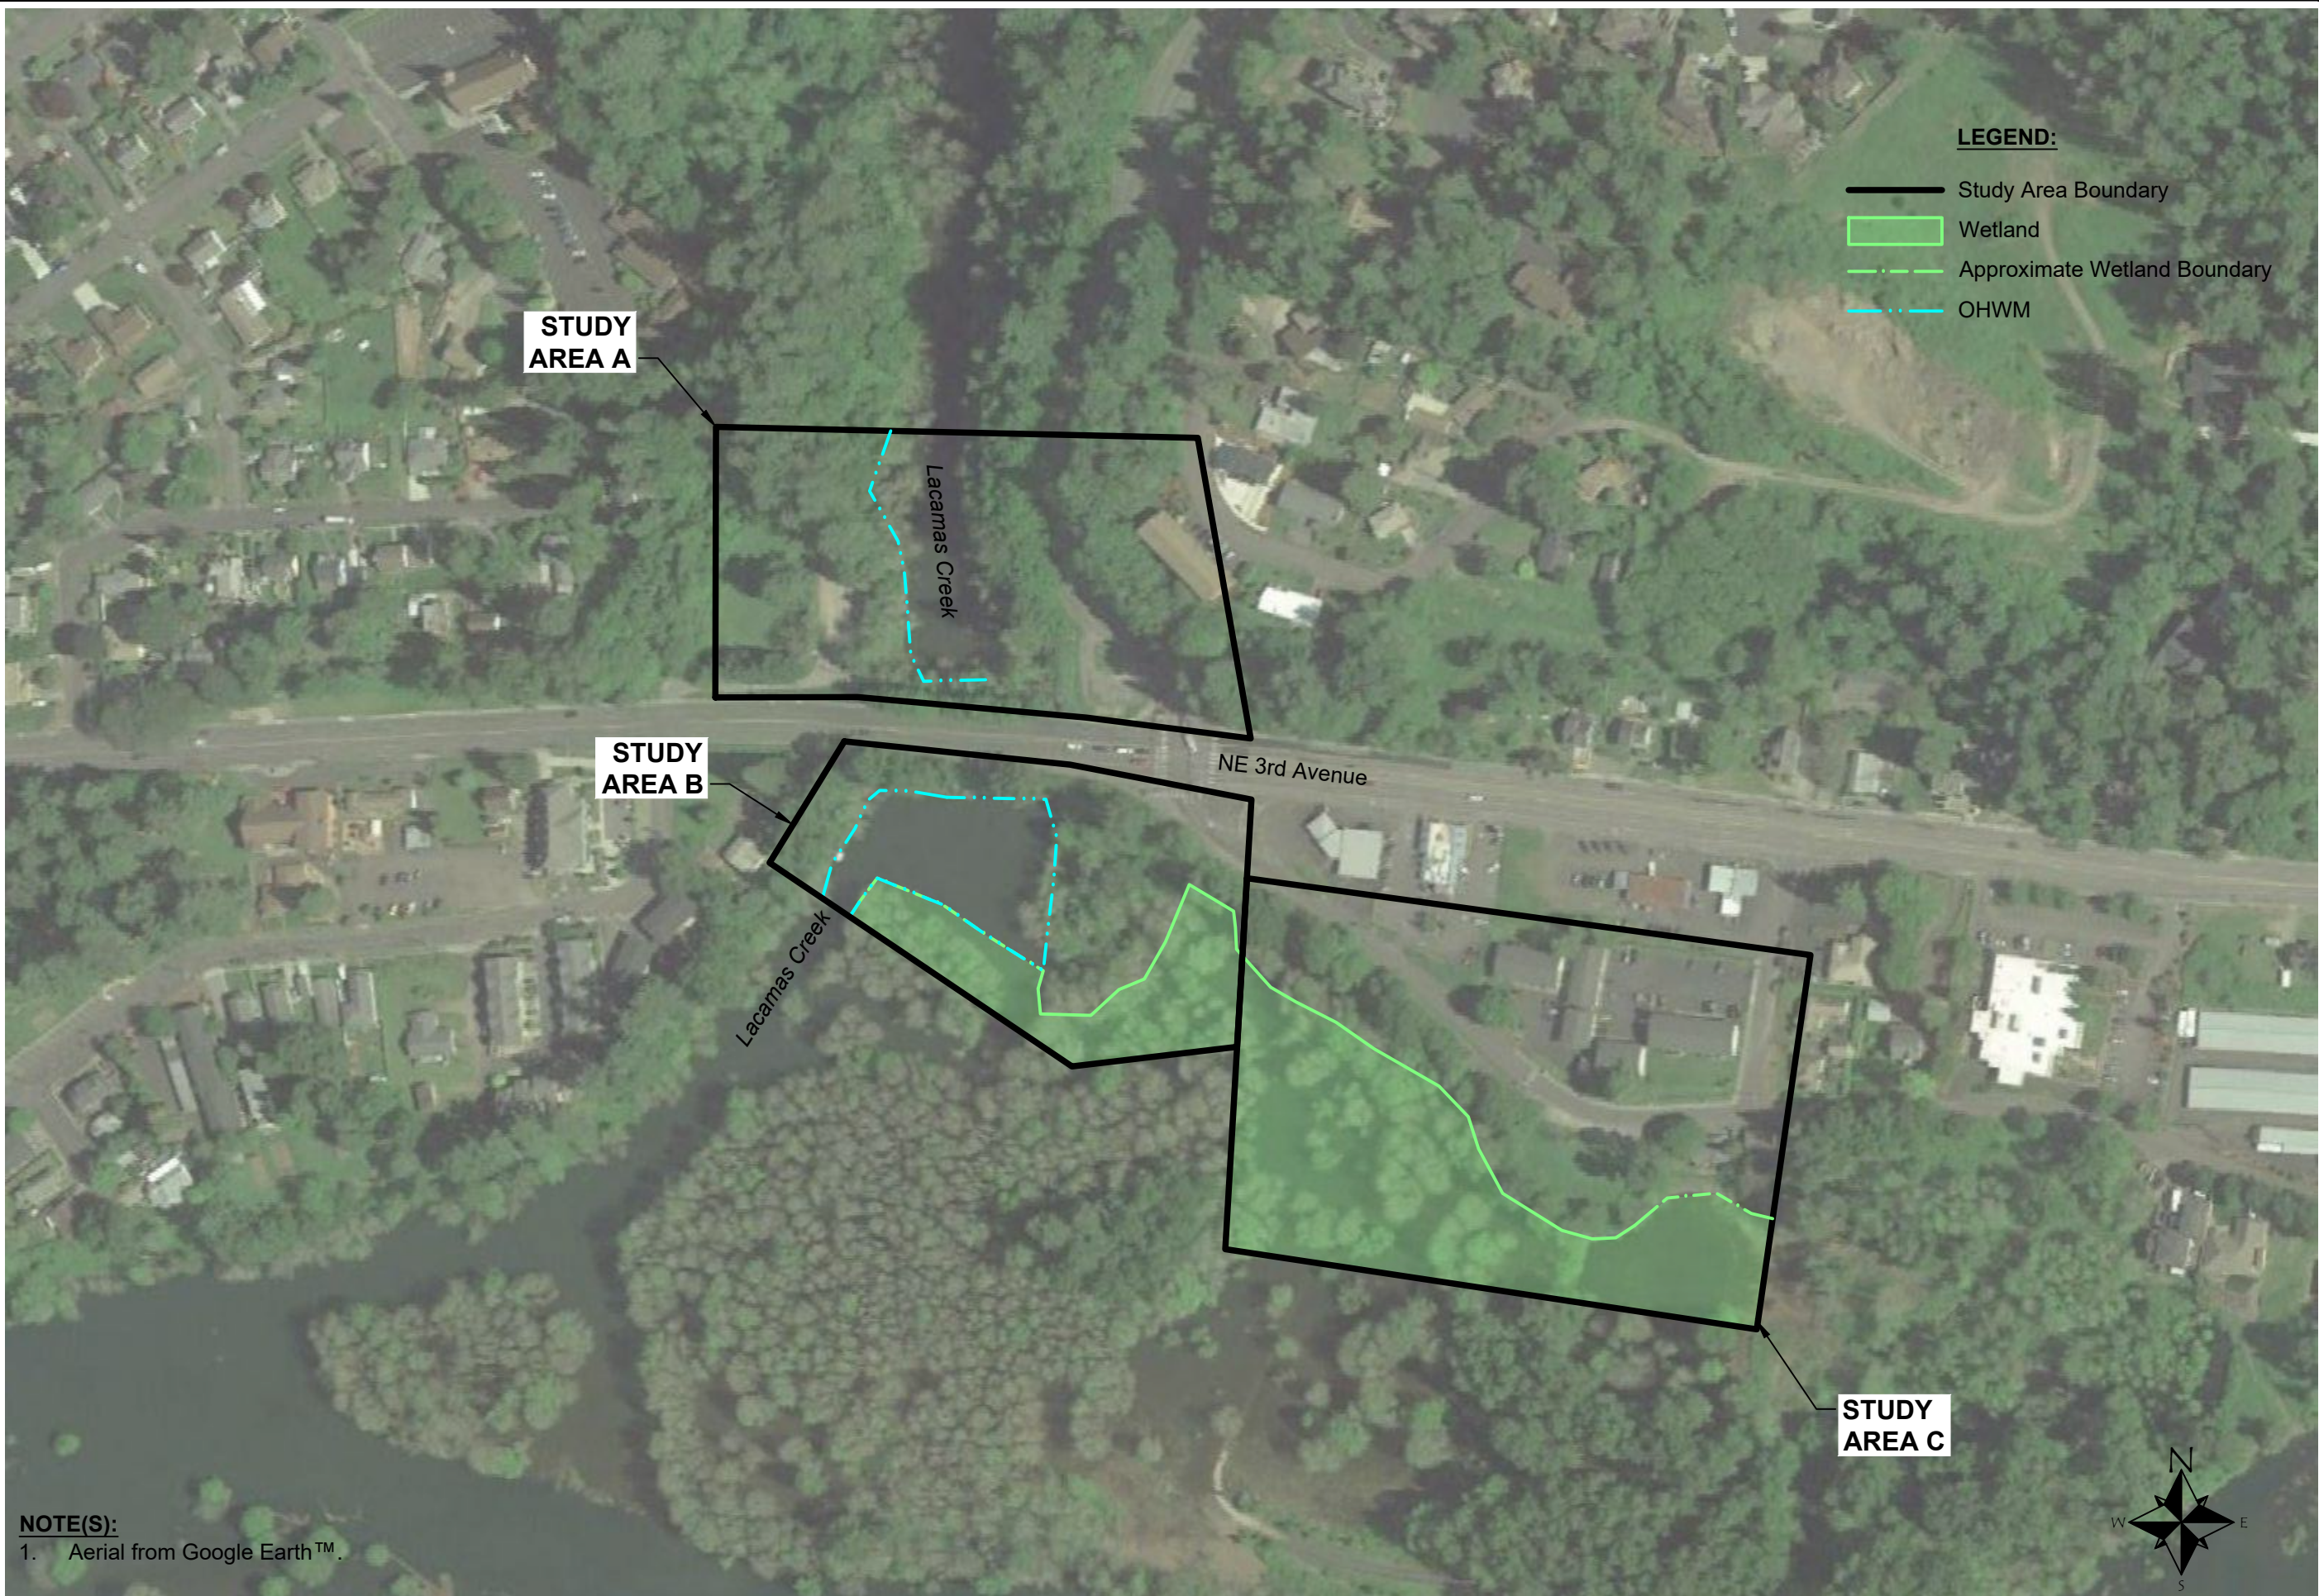
NOTE(S): 1. Aerial from Google Earth™.		LEGEND: Study Area Boundary Wetland Approximate Wetland Boundary OHWM	
PURPOSE: Construct new pump station		PROPOSED: Fill	
ADJACENT PROPERTY OWNERS:		SITE MAP OVERVIEW	
DATUM: NAD83		APPLICANT: Wallis Engineering	
PROJECT NAME: Lacamas Creek Sewer Pump Station		IN Lacamas Creek	
REFERENCE #: Not Yet Assigned		NEAR: Camas	
SITE LOCATION ADDRESS:		COUNTY: Clark	
		STATE: WA	
		SHEET 2 OF 14	
		DATE: 10/4/18

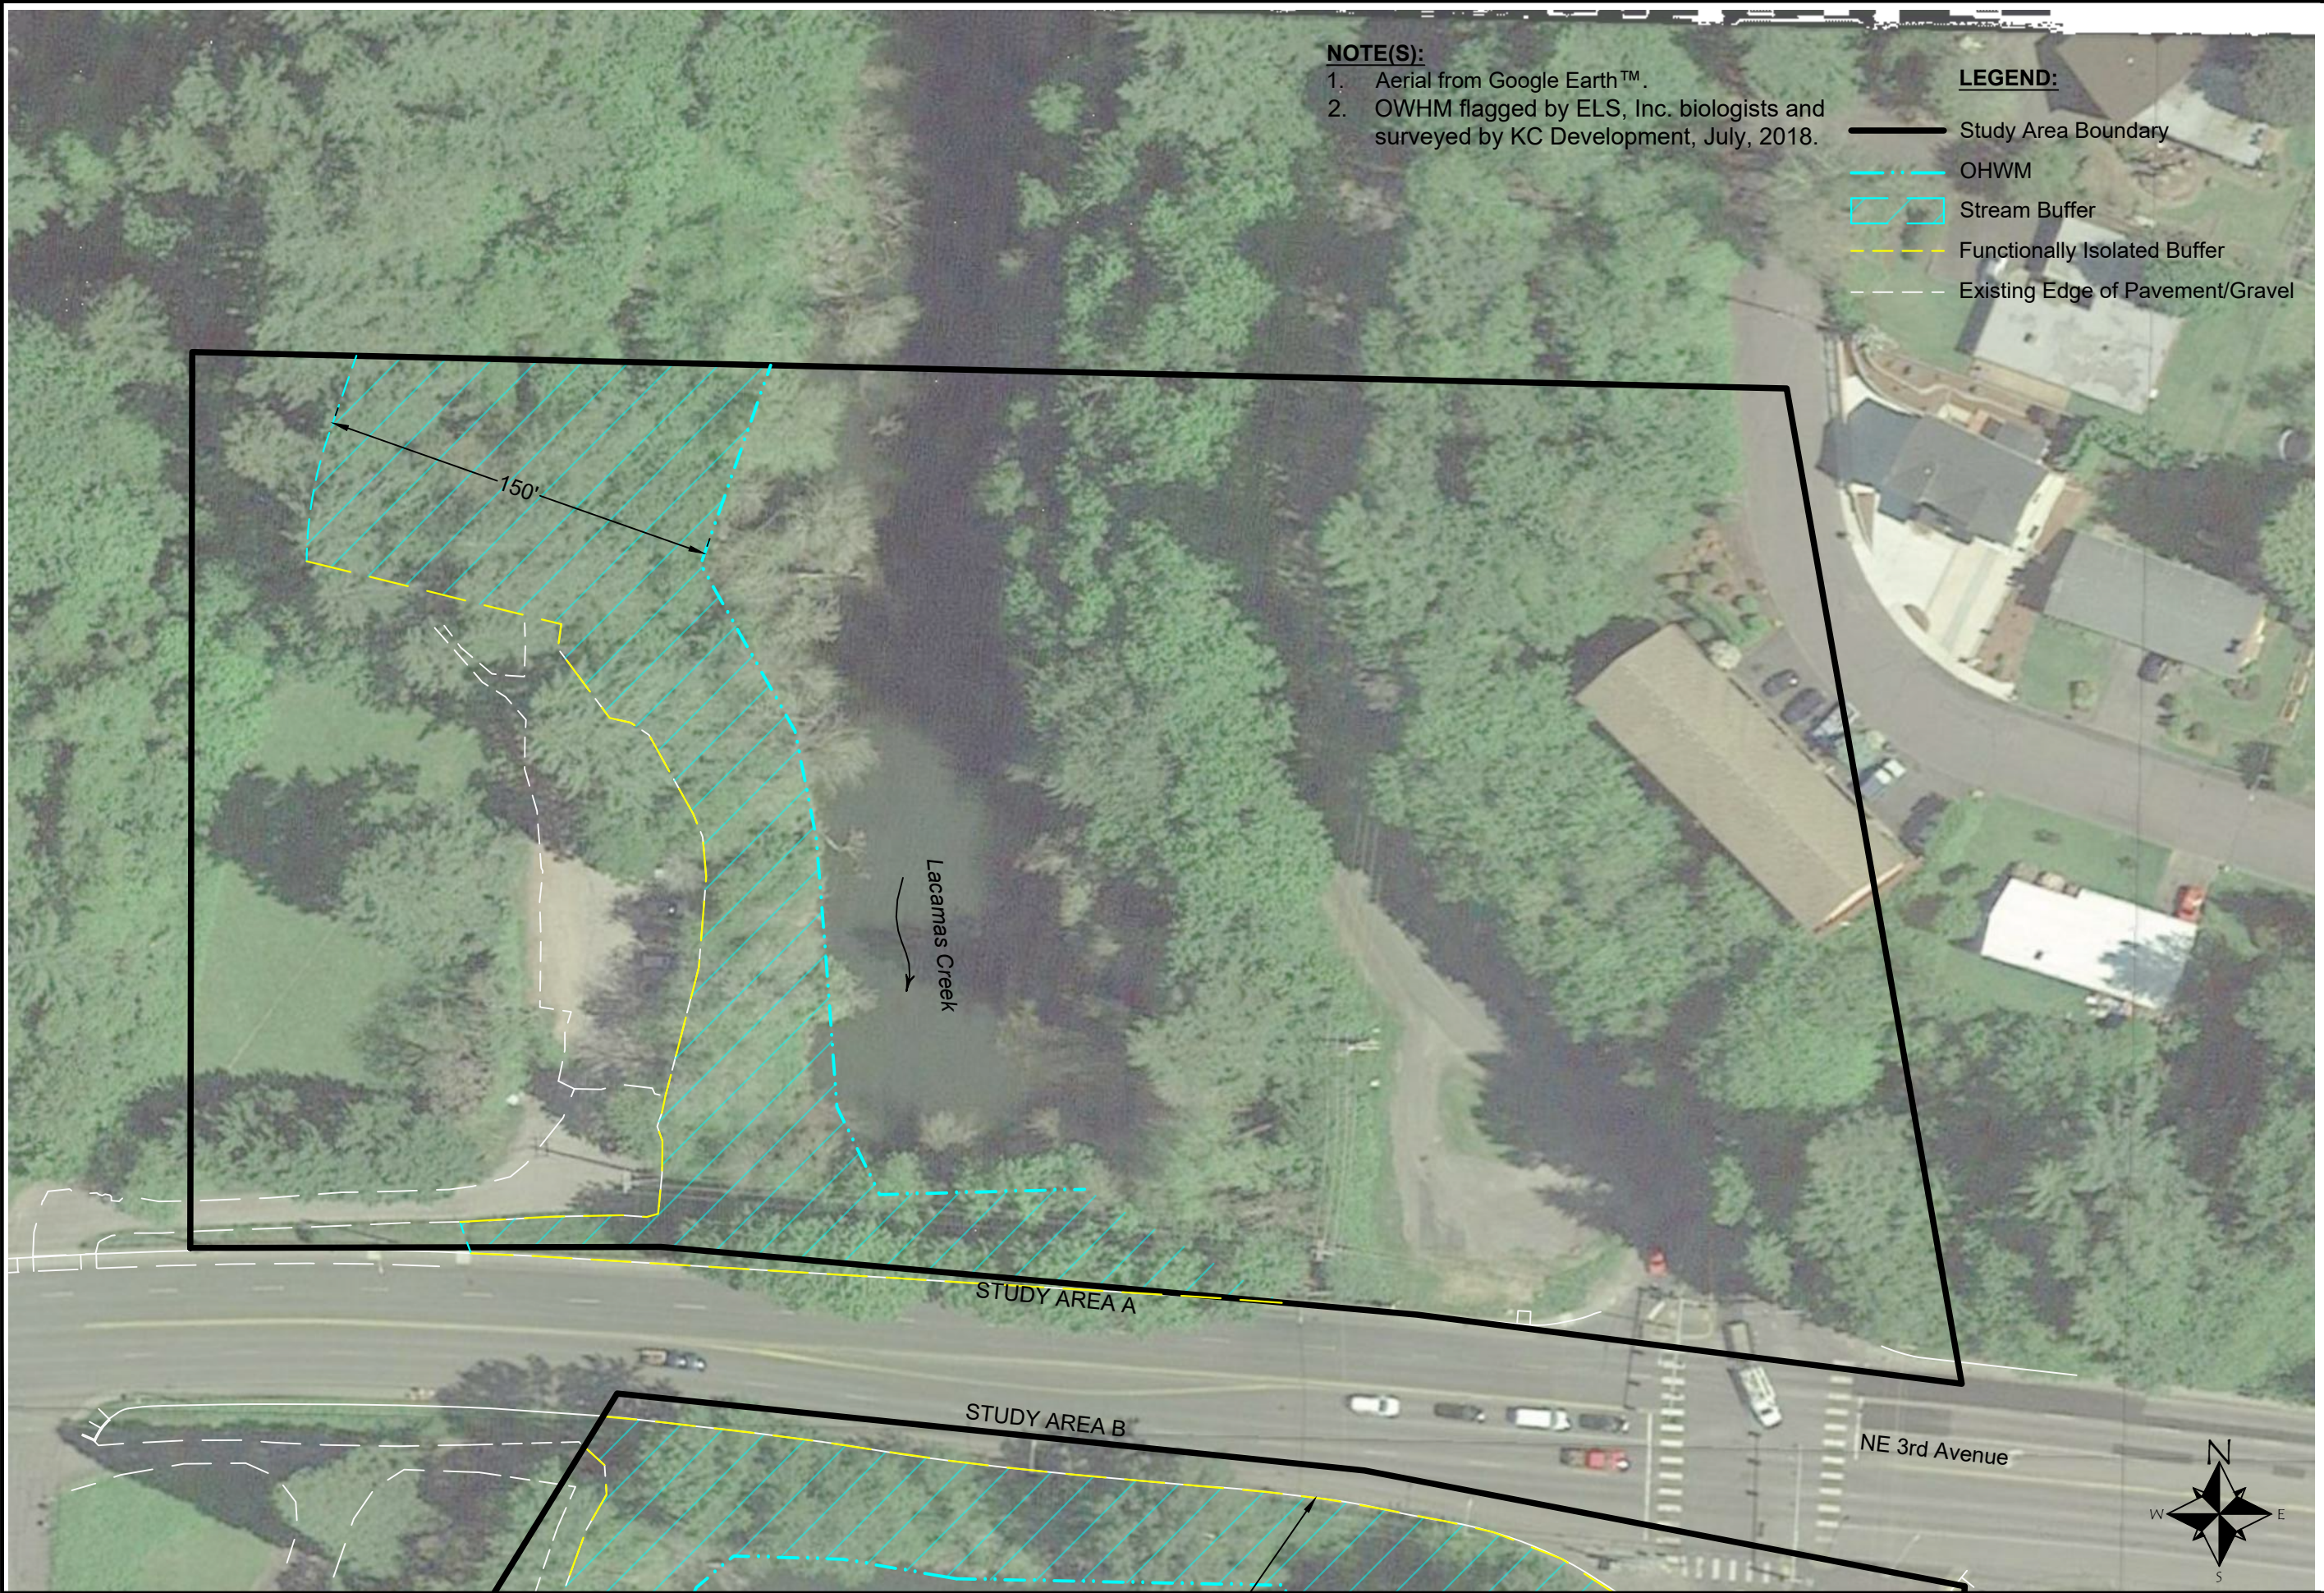
PURPOSE: Construct new pump station	SITE MAP - STUDY AREA A	PROPOSED: Fill
APPLICANT: Wallis Engineering	PROJECT NAME: Lacamas Creek Sewer Pump Station	IN Lacamas Creek
DATUM: NAD83	REFERENCE #: Not Yet Assigned	NEAR: Camas
ADJACENT PROPERTY OWNERS:	SITE LOCATION ADDRESS:	COUNTY: Clark
		STATE: WA
		SHEET 3 OF 14
		DATE: 10/4/18

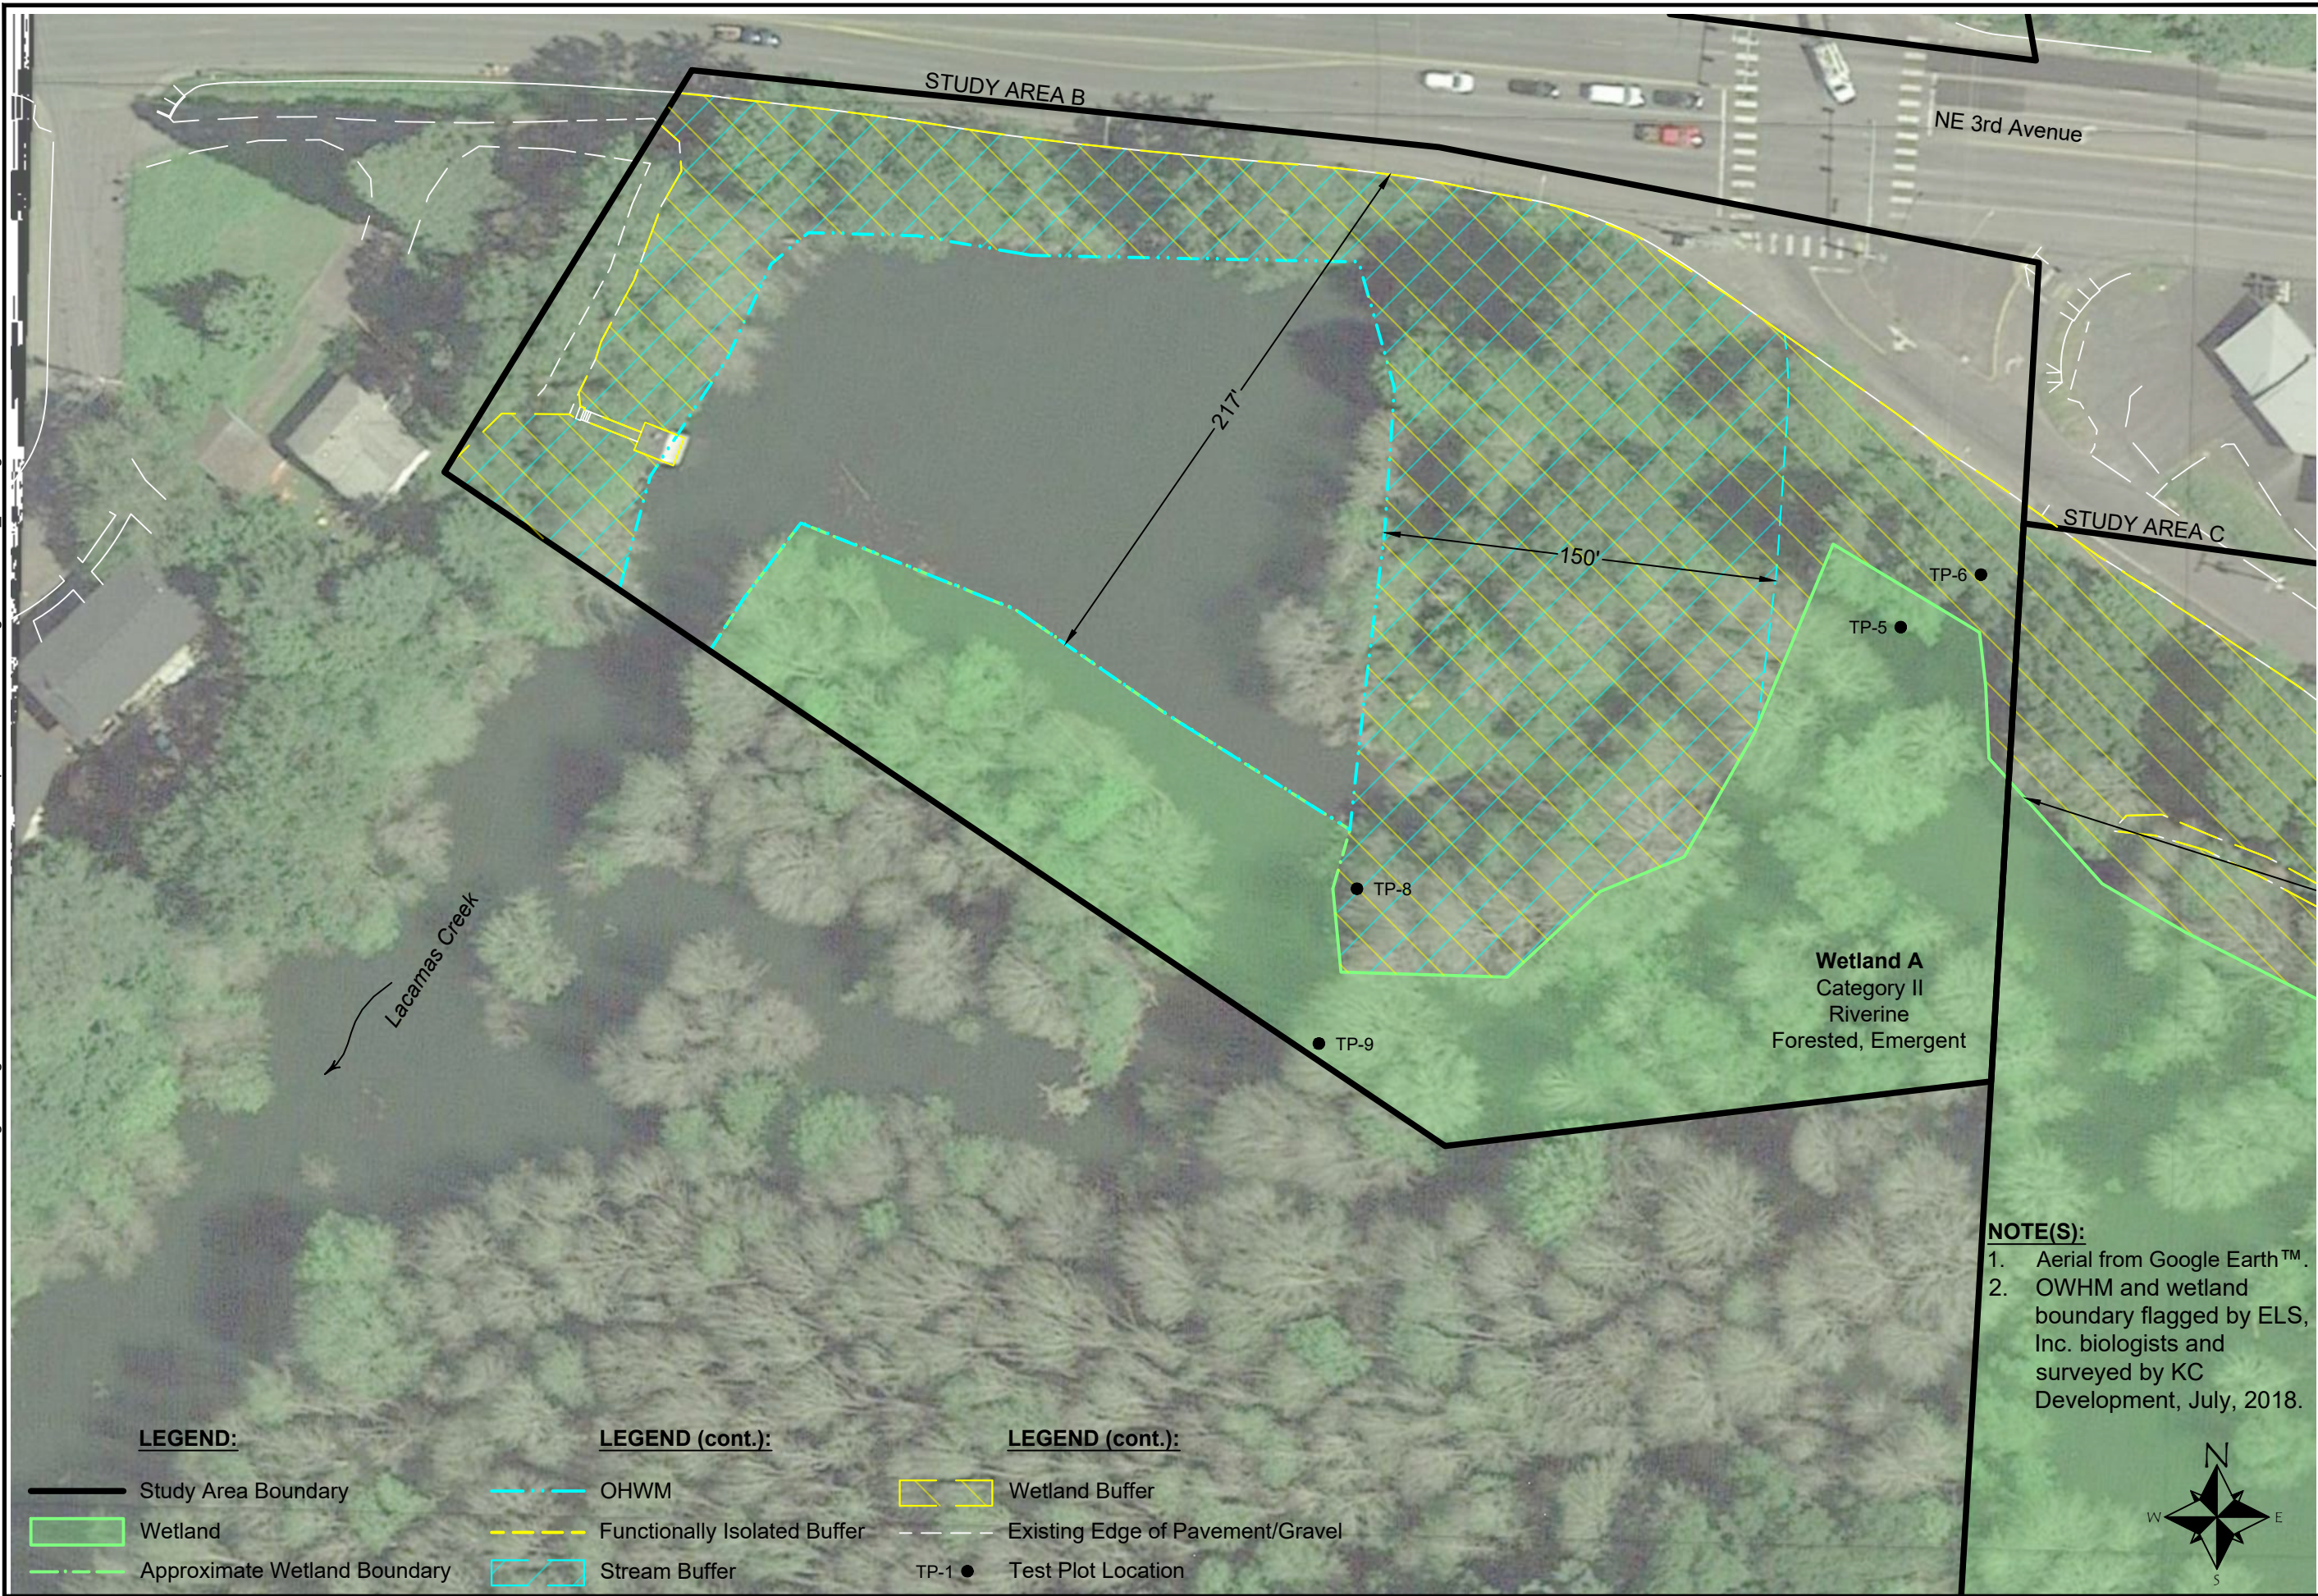
PURPOSE: Construct new pump station	SITE MAP - STUDY AREA B	PROPOSED: Fill
APPLICANT: Wallis Engineering	PROJECT NAME: Lacamas Creek Sewer Pump Station	IN Lacamas Creek
REFERENCE #: Not Yet Assigned	SITE LOCATION ADDRESS:	NEAR: Camas
DATUM: NAD83		COUNTY: Clark
ADJACENT PROPERTY OWNERS:		STATE: WA
		SHEET 4 OF 14
		DATE: 10/4/18

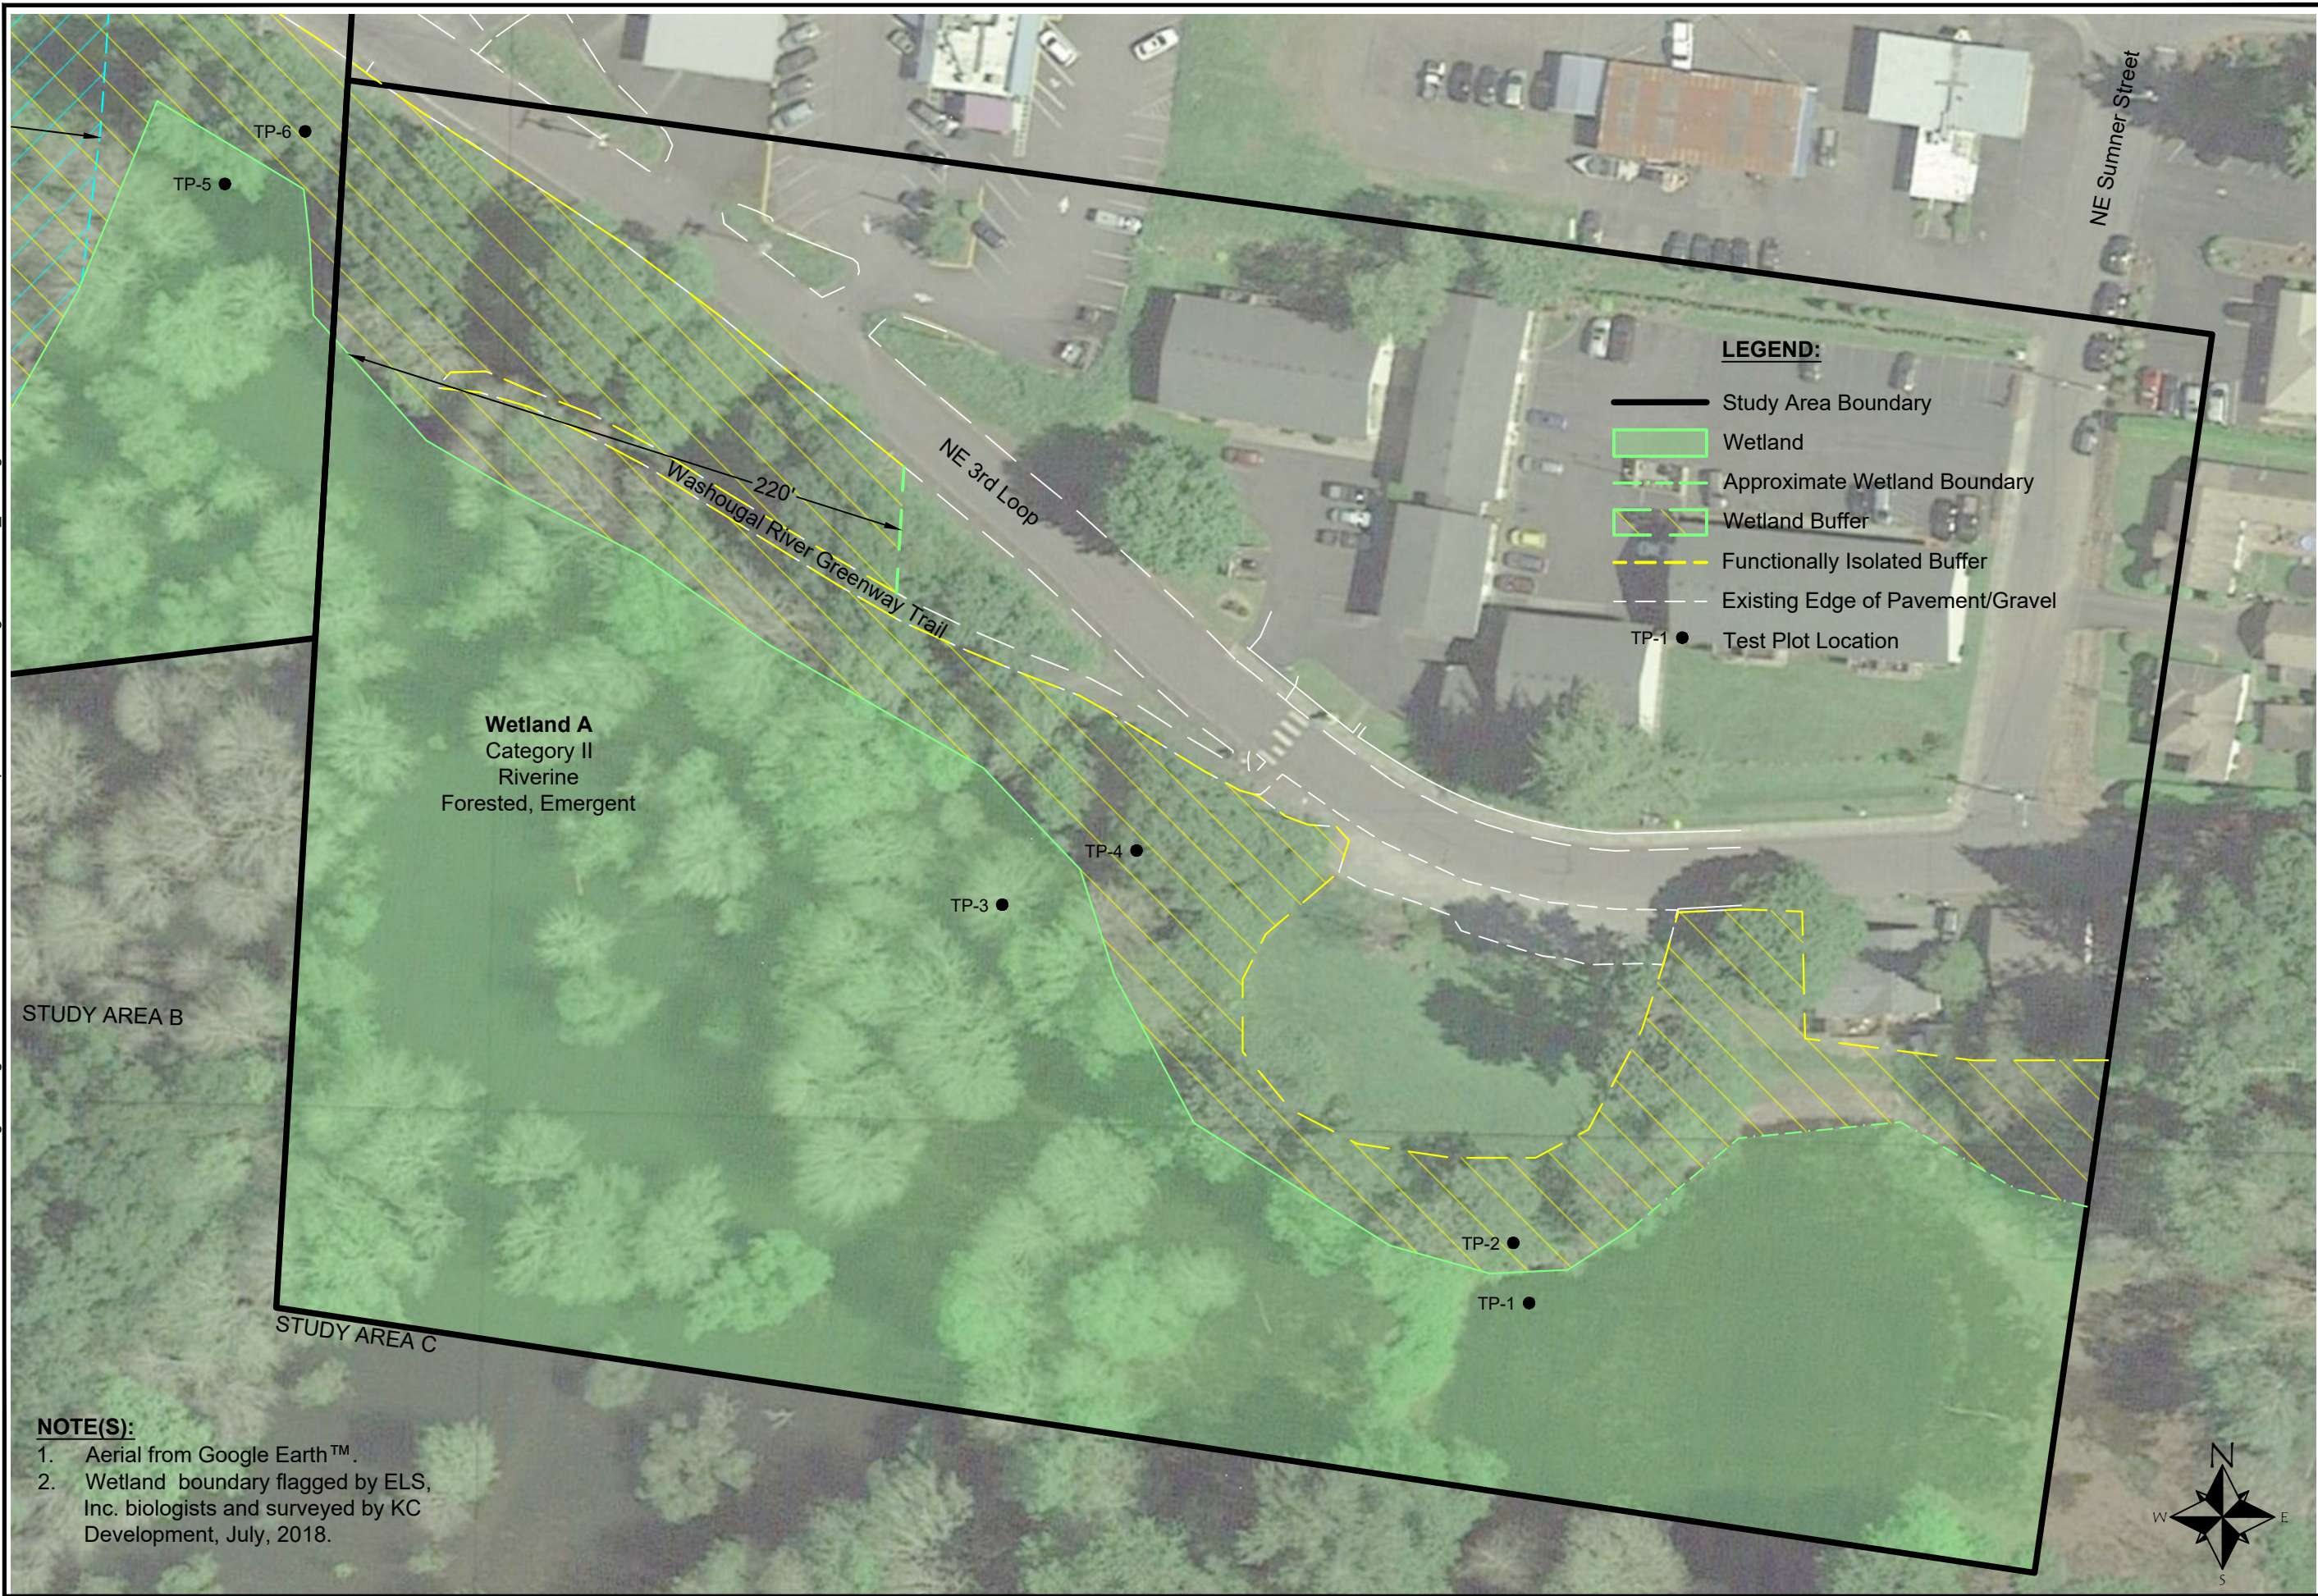
PURPOSE: Construct new pump station	SITE MAP - STUDY AREA C	PROPOSED: Fill
APPLICANT: Wallis Engineering	PROJECT NAME: Lacamas Creek Sewer Pump Station	IN Lacamas Creek
DATUM: NAD83	REFERENCE #: Not Yet Assigned	NEAR: Camas
ADJACENT PROPERTY OWNERS:	SITE LOCATION ADDRESS:	COUNTY: Clark
		STATE: WA
		SHEET 5 OF 14
		DATE: 10/4/18

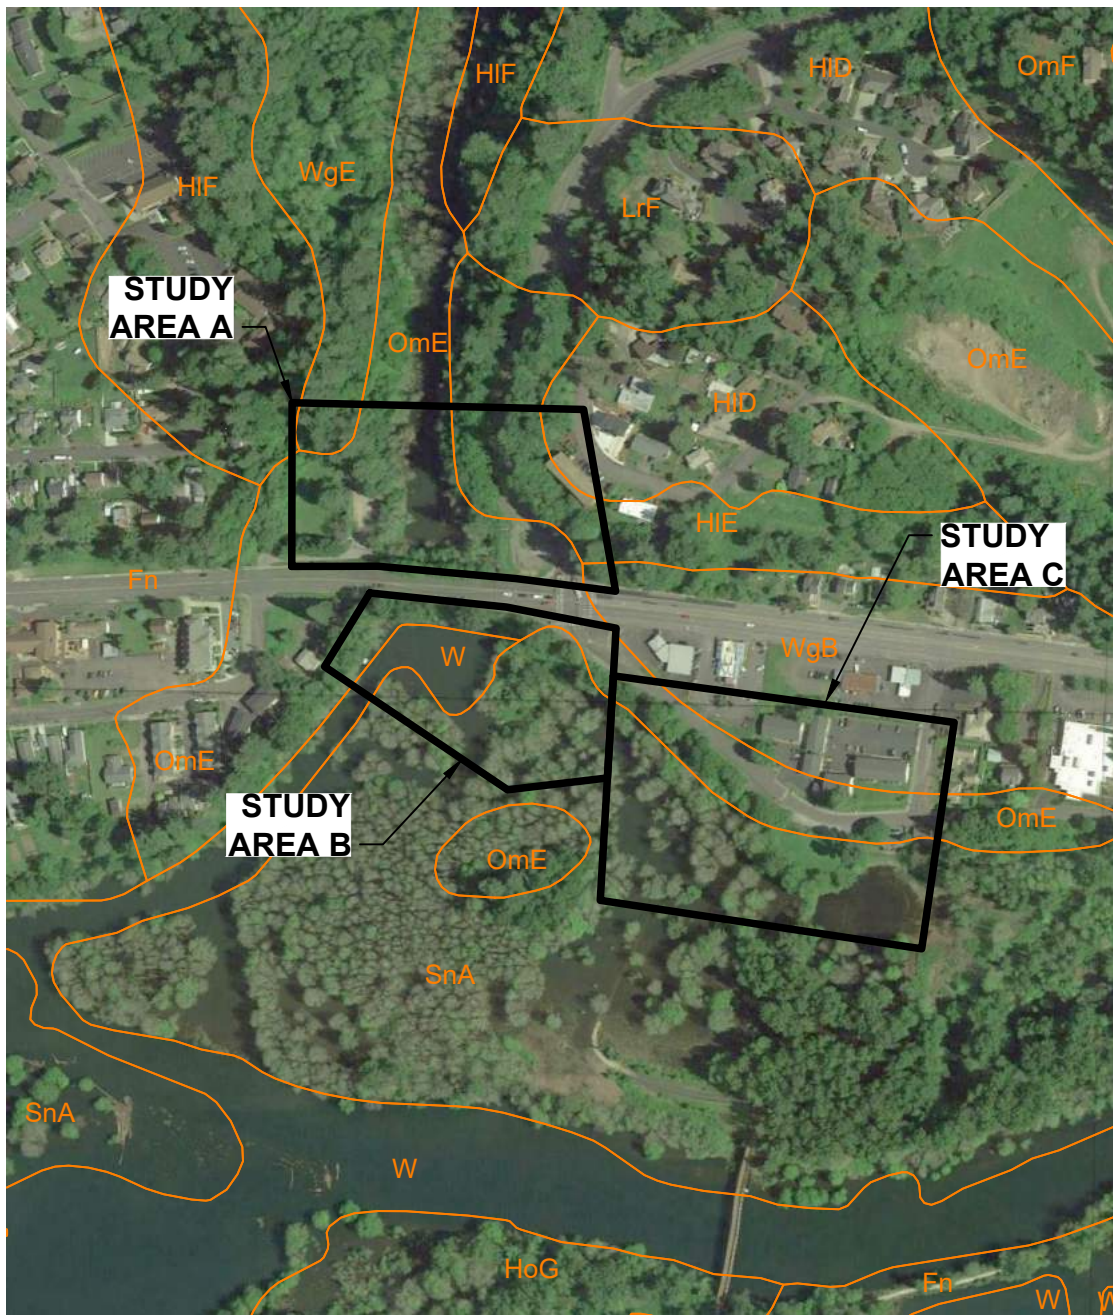
- HID** Hillsboro loam, 15 to 20 percent slopes. Not hydric.
- HIE** Hillsboro loam, 20 to 30 percent slopes. Not hydric.
- HIF** Hillsboro loam, 30 to 50 percent slopes. Not hydric.
- OmE** Olympic stony clay loam, 3 to 30 percent slopes. Not hydric.
- SnA** Suavie silt loam, sandy substratum, 0 to 3 percent slopes. **Hydric.**
- W** Water
- WgB** Washougal gravelly loam, 0 to 8 percent slopes. Not hydric.
- WgE** Washougal gravelly loam, 8 to 30 percent slopes. Not hydric.

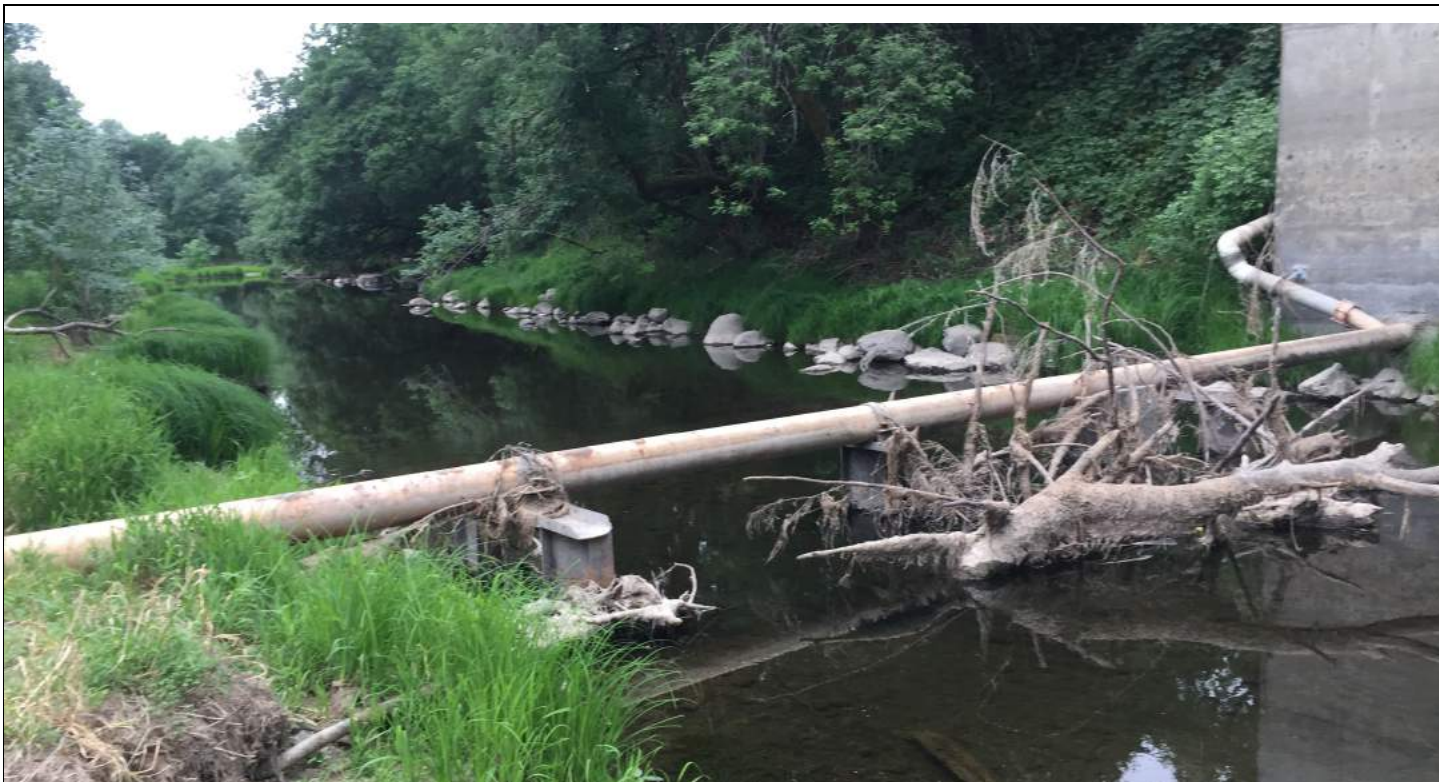
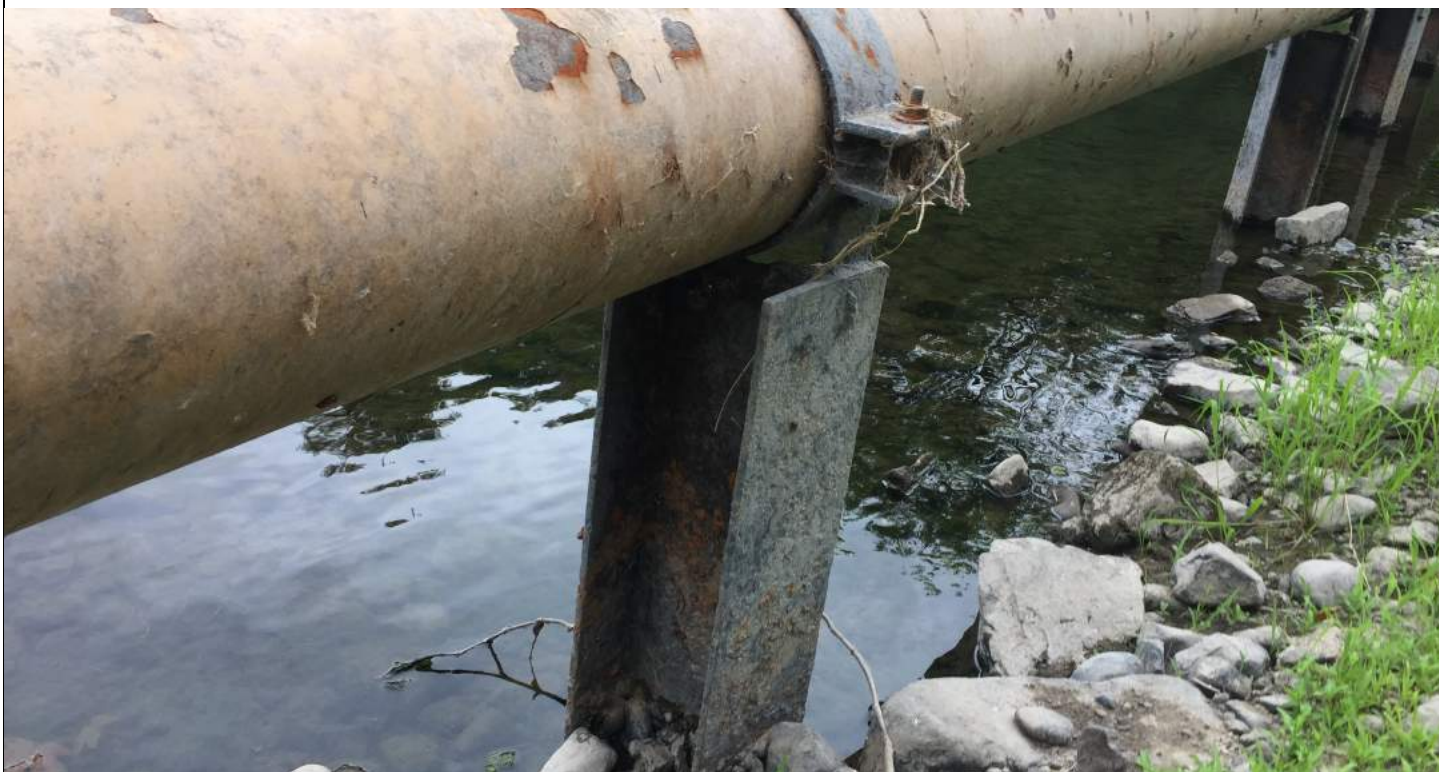
Photoplate 1
Site Photos
Lacamas Creek Sewer Pump Station
City of Camas
Camas, Clark County, Washington

Above: View west of the pump station, suspended pipe, and steel piling to be removed. July 19, 2018.

Below: Close up of suspended pipe and steel piling to be removed. July 19, 2018.

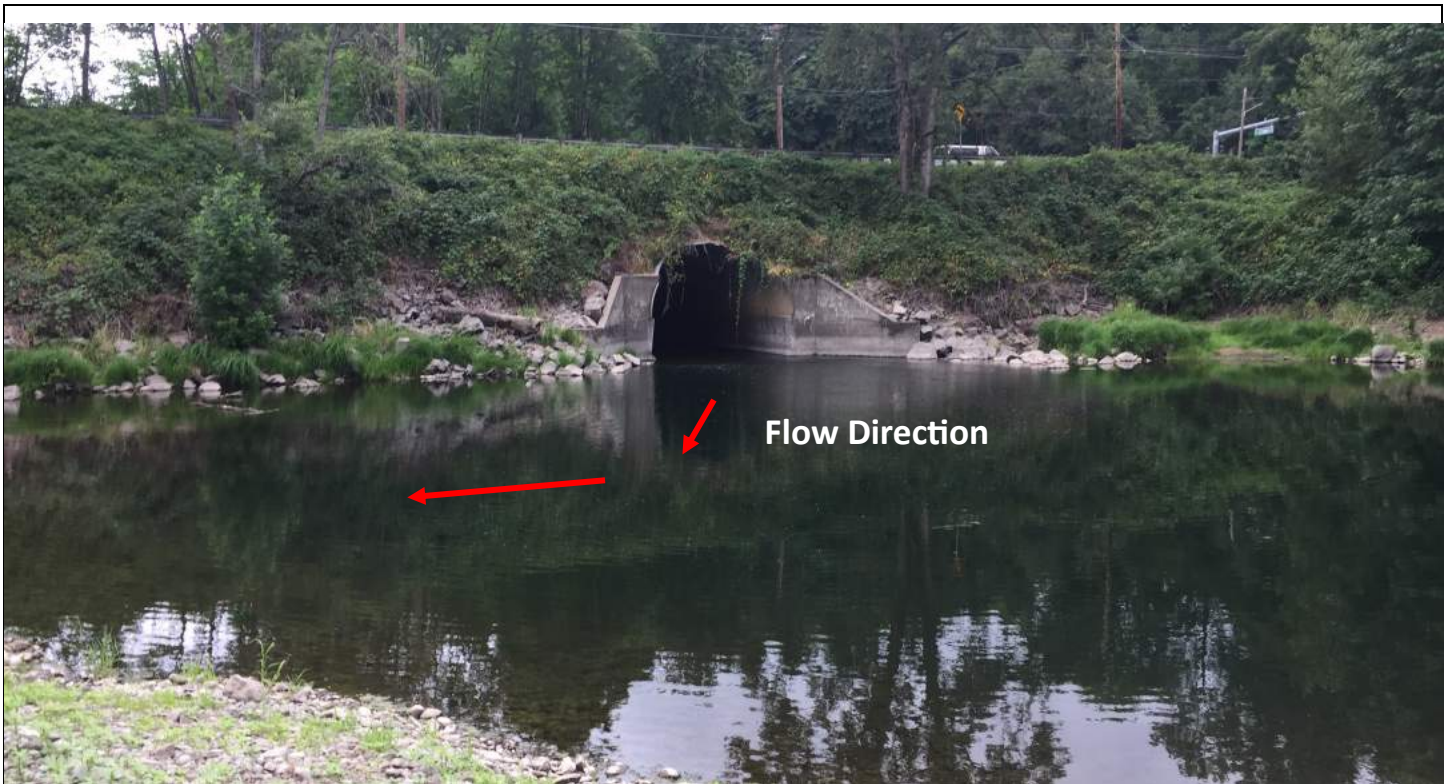
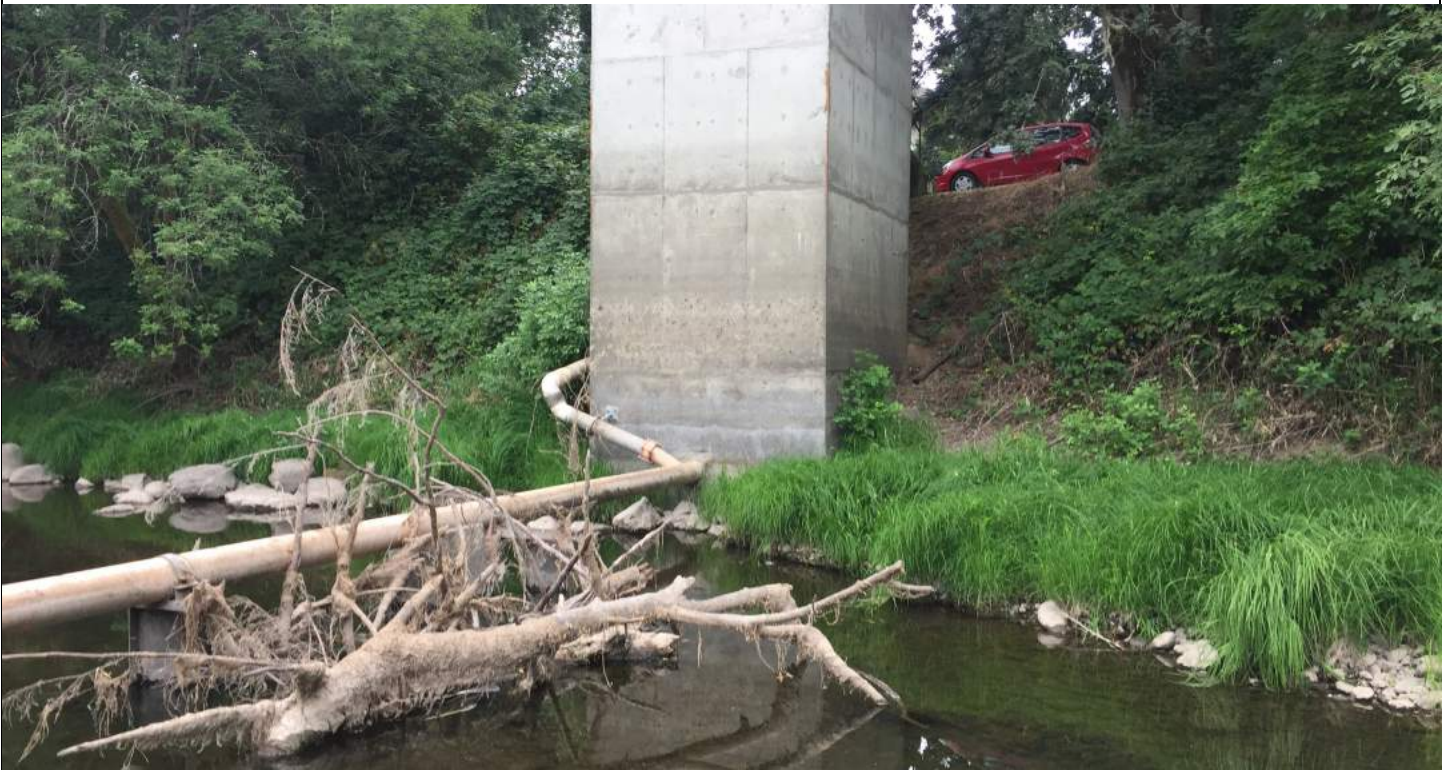
Photoplate 2
Site Photos
Lacamas Creek Sewer Pump Station
City of Camas
Camas, Clark County, Washington

Above: View north of culvert outlet for Lacamas Creek. July 19, 2018.

Below: View west of pump station portion below OHWM. July 19, 2018.
