CRITICAL AREAS DETERMINATION

August 2018

Lacamas Creek Sewer Pump Station
Camas, Washington

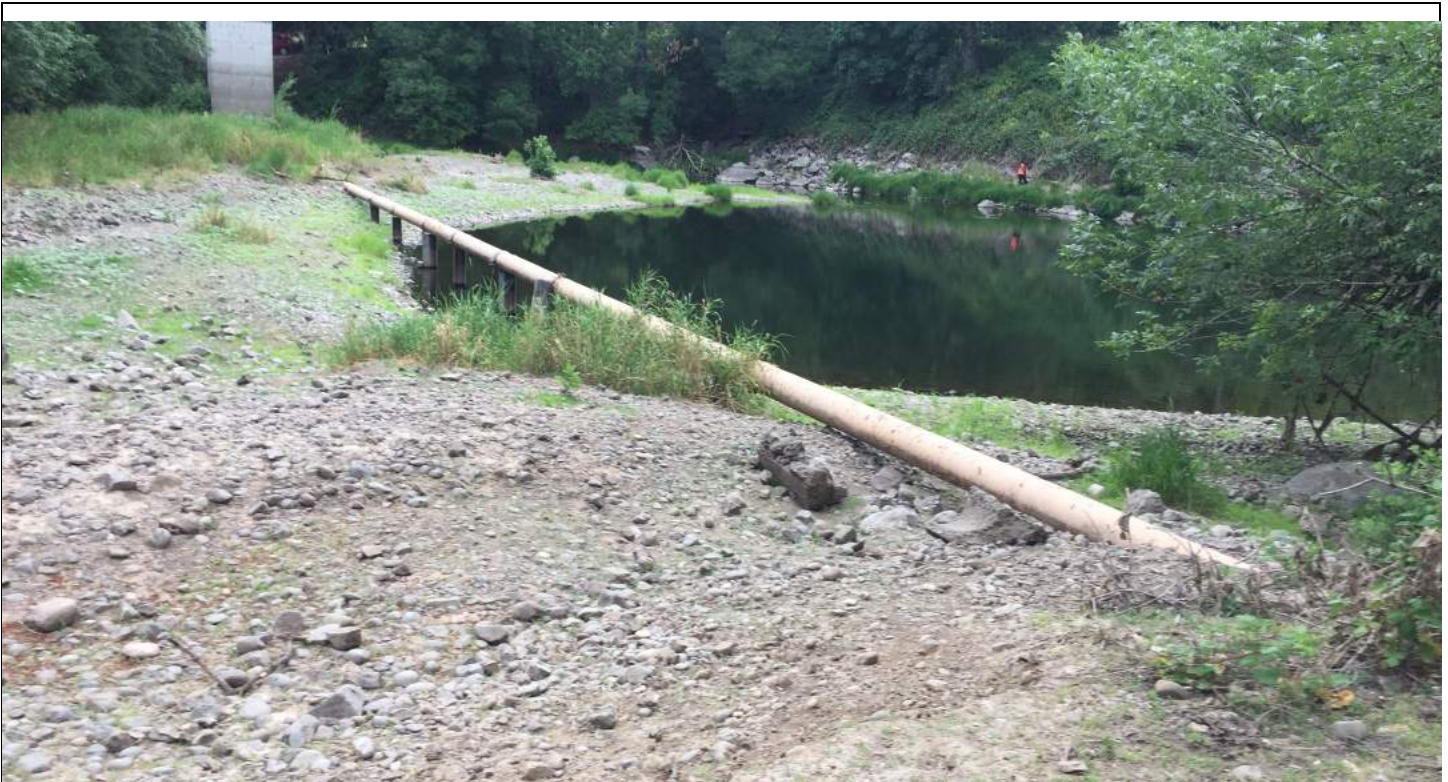
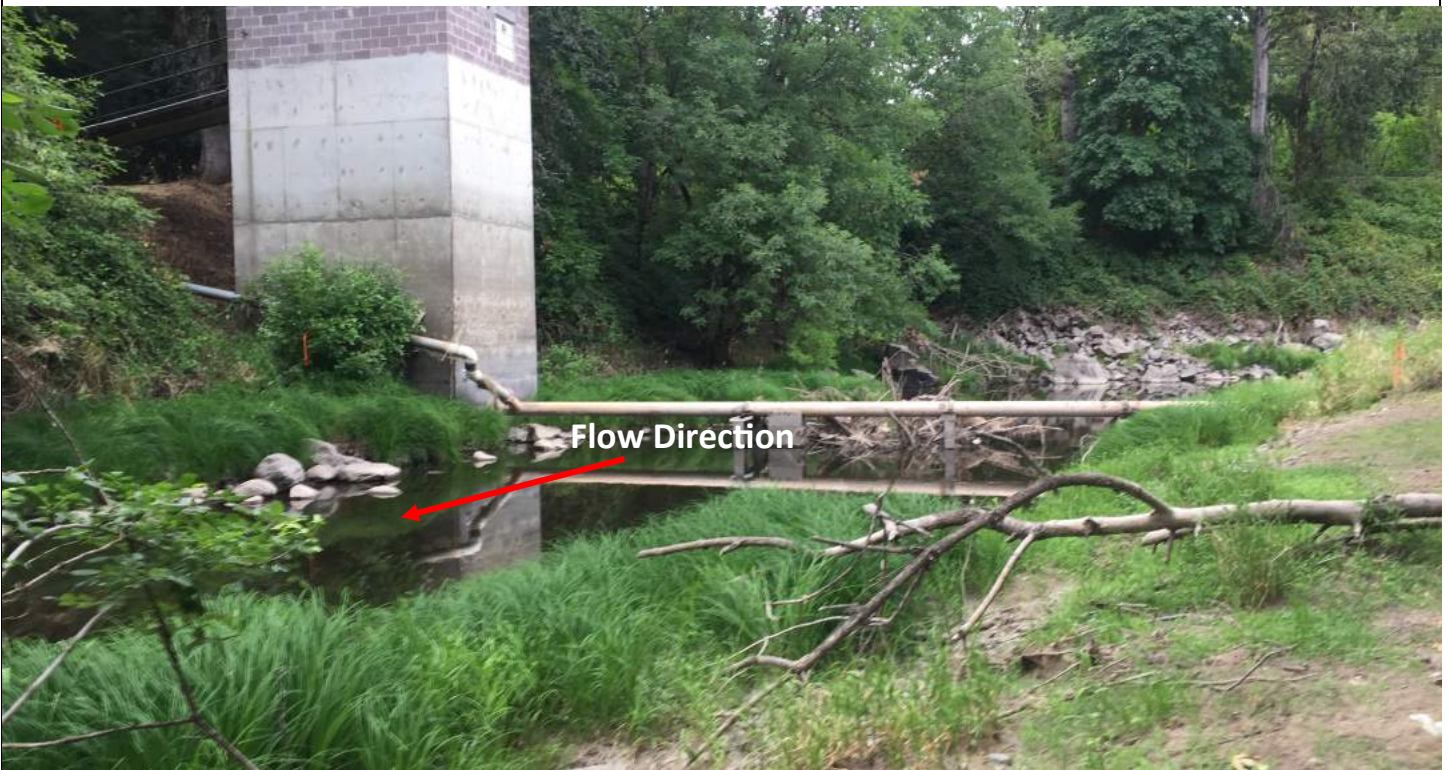
Above: View west of suspended pipe and steel piling to be removed below OHWM. July 19, 2018.

Below: View north of pump station, suspended pipe, and steel piling to be removed. July 19, 2018.
