# Technical Memorandum

To: Steve Wall, City of Camas  
From: Dawn Chapel and Dan Matlock, Pacific Groundwater Group  
Re: Updated Environmental Review for Select Facilities at the Port of Camas-Washougal Industrial Park  
Date: August 6, 2015

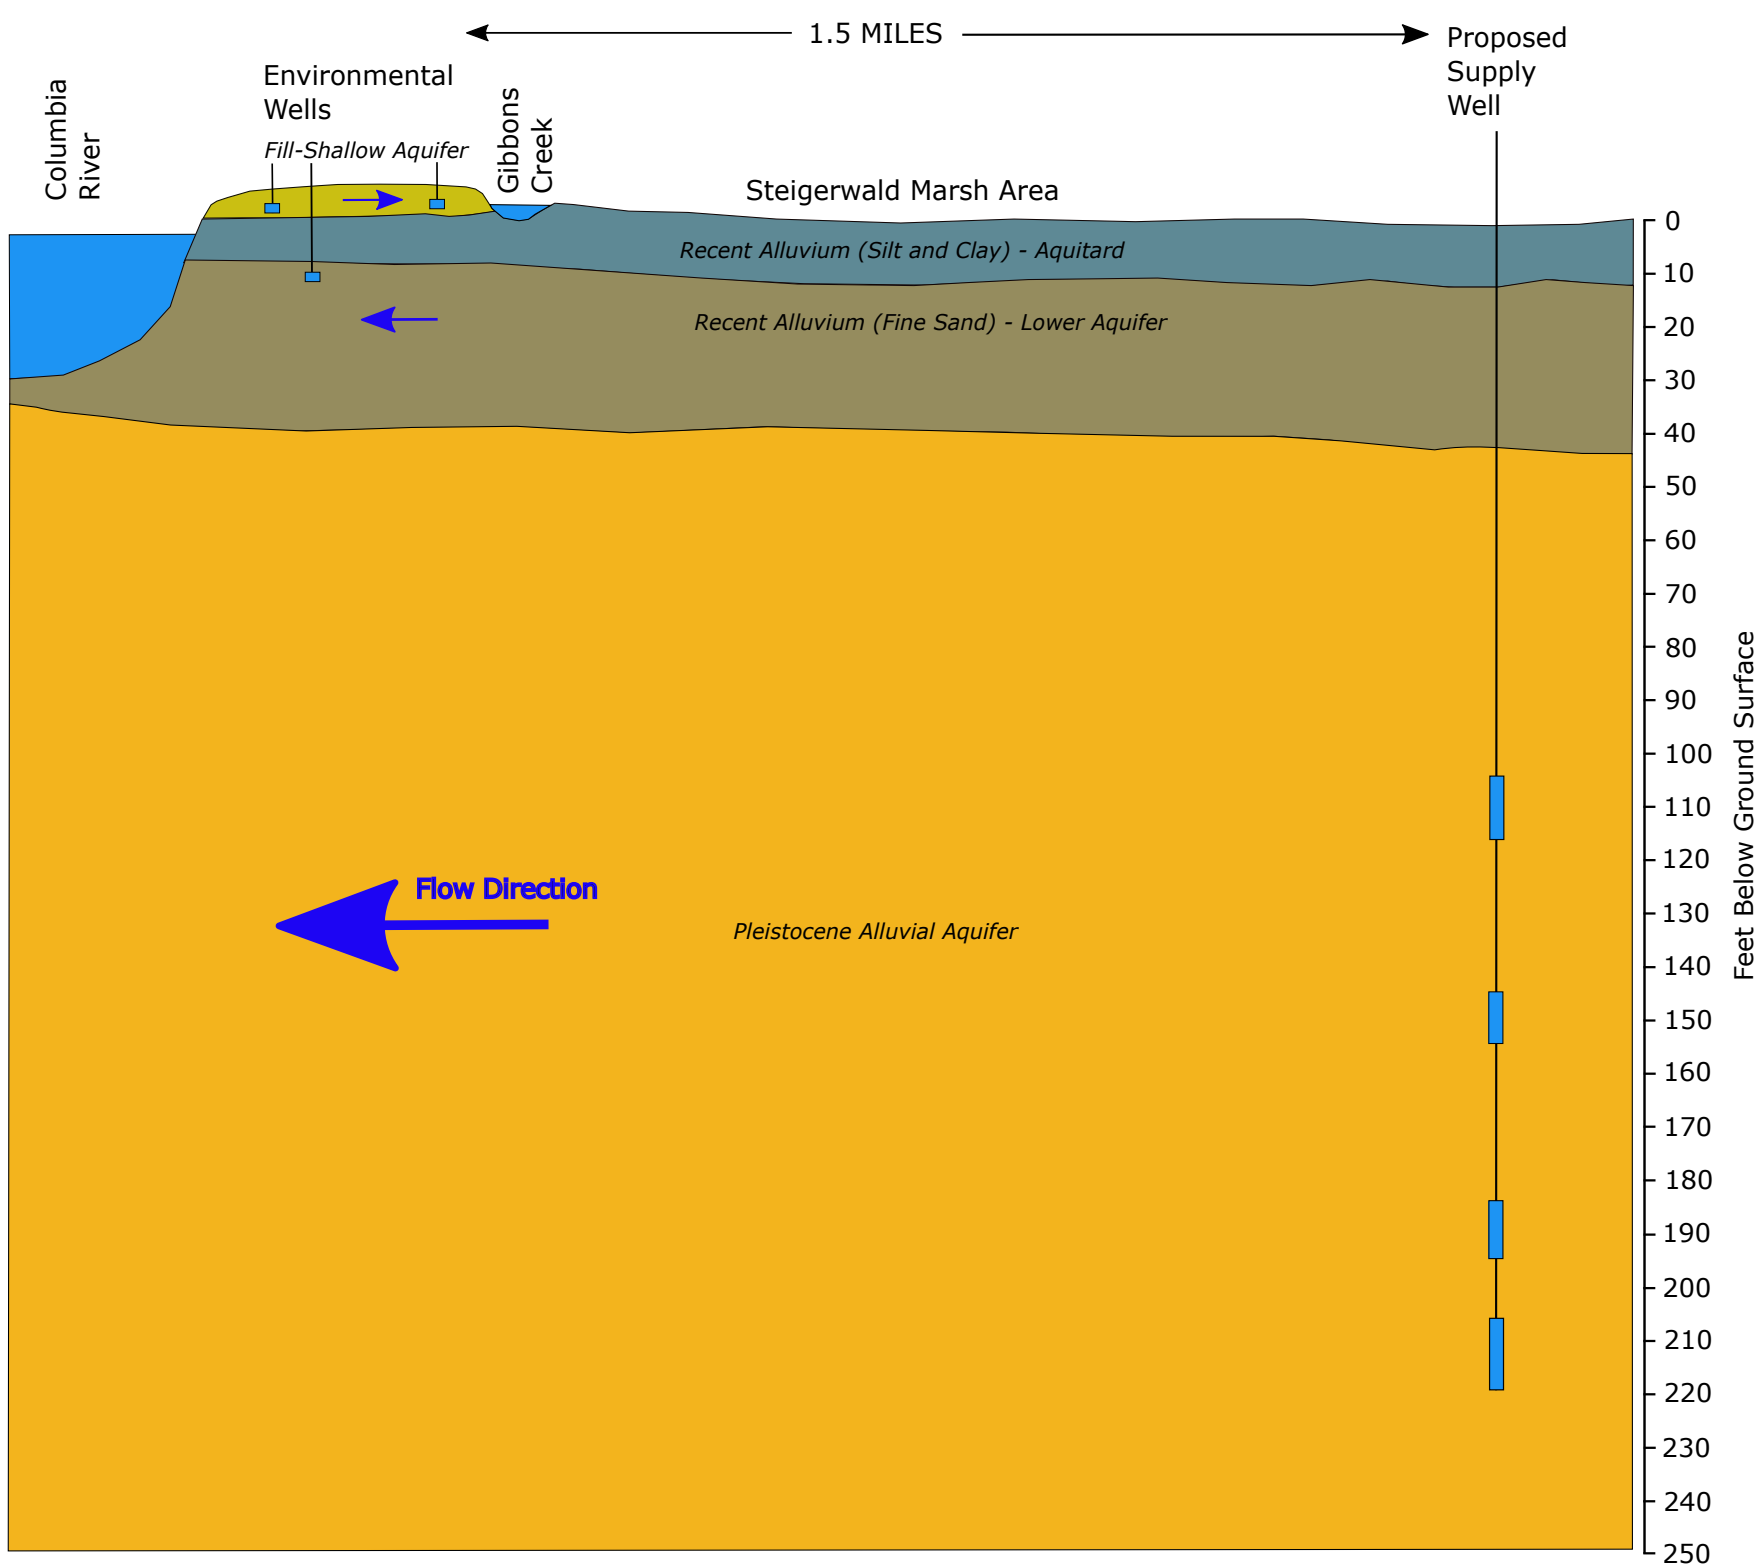
Figure 2. Conceptualized Hydrogeologic Cross Section through Steigerwald Marsh Area

A conceptualized hydrogeologic cross-section of the area is presented in Figure 2. The Industrial Park and proposed future groundwater supply are located on the floodplain of the Columbia River. This area is underlain by recent alluvial floodplain deposits up to 40 feet thick or more. The recent alluvial sediments are broken into two subunits, an upper subunit consisting of organic rich silt and clay followed by a lower subunit consisting of predominantly fine sand. The Pleistocene Alluvial Aquifer (PAA) occurs beneath the recent alluvium and it forms the most productive aquifer in the area, consisting of coarse-grained sand, gravel and cobbles. Sediments dredged from the Columbia River were used to elevate the floodplain for construction of the Industrial Park. These fill sediments occur above the silt subunit of the recent alluvium in the Industrial Park area. Figure 2 shows the general flow directions in each unit.

The proposed wellfield lies approximately 1.5 miles southeast of the environmental sites. The wellfield will withdraw water from the deeper Pleistocene Alluvial Aquifer (PAA) with completion depths well over 100 feet below the fine-grained silt, clay, and silty sand of the recent alluvial deposits (see Figure 2). Operation of the Steigerwald wellfield is not expected to change contaminant mobility and migration on these sites. All three sites are listed as confirmed contaminated sites with the Department of Ecology, measures to correct sources of contamination are ongoing, and with time the sites will be remediated.

Investigative work at the facility has focused on depths less than 46-feet within the recent alluvium and overlying dredge sand fill. Two aquifers (shallow and lower) and one aquitard (confining layer) have been characterized (Figure 2).
