September 8, 2017

Regarding: Geotechnical Engineering Report – Addendum No. 1
Dawson Ridge Development, Northern Site Reconnaissance and Exploration
NW McIntosh Road
Camas, Washington
PBS Project No. 73197.000 Phase 0003

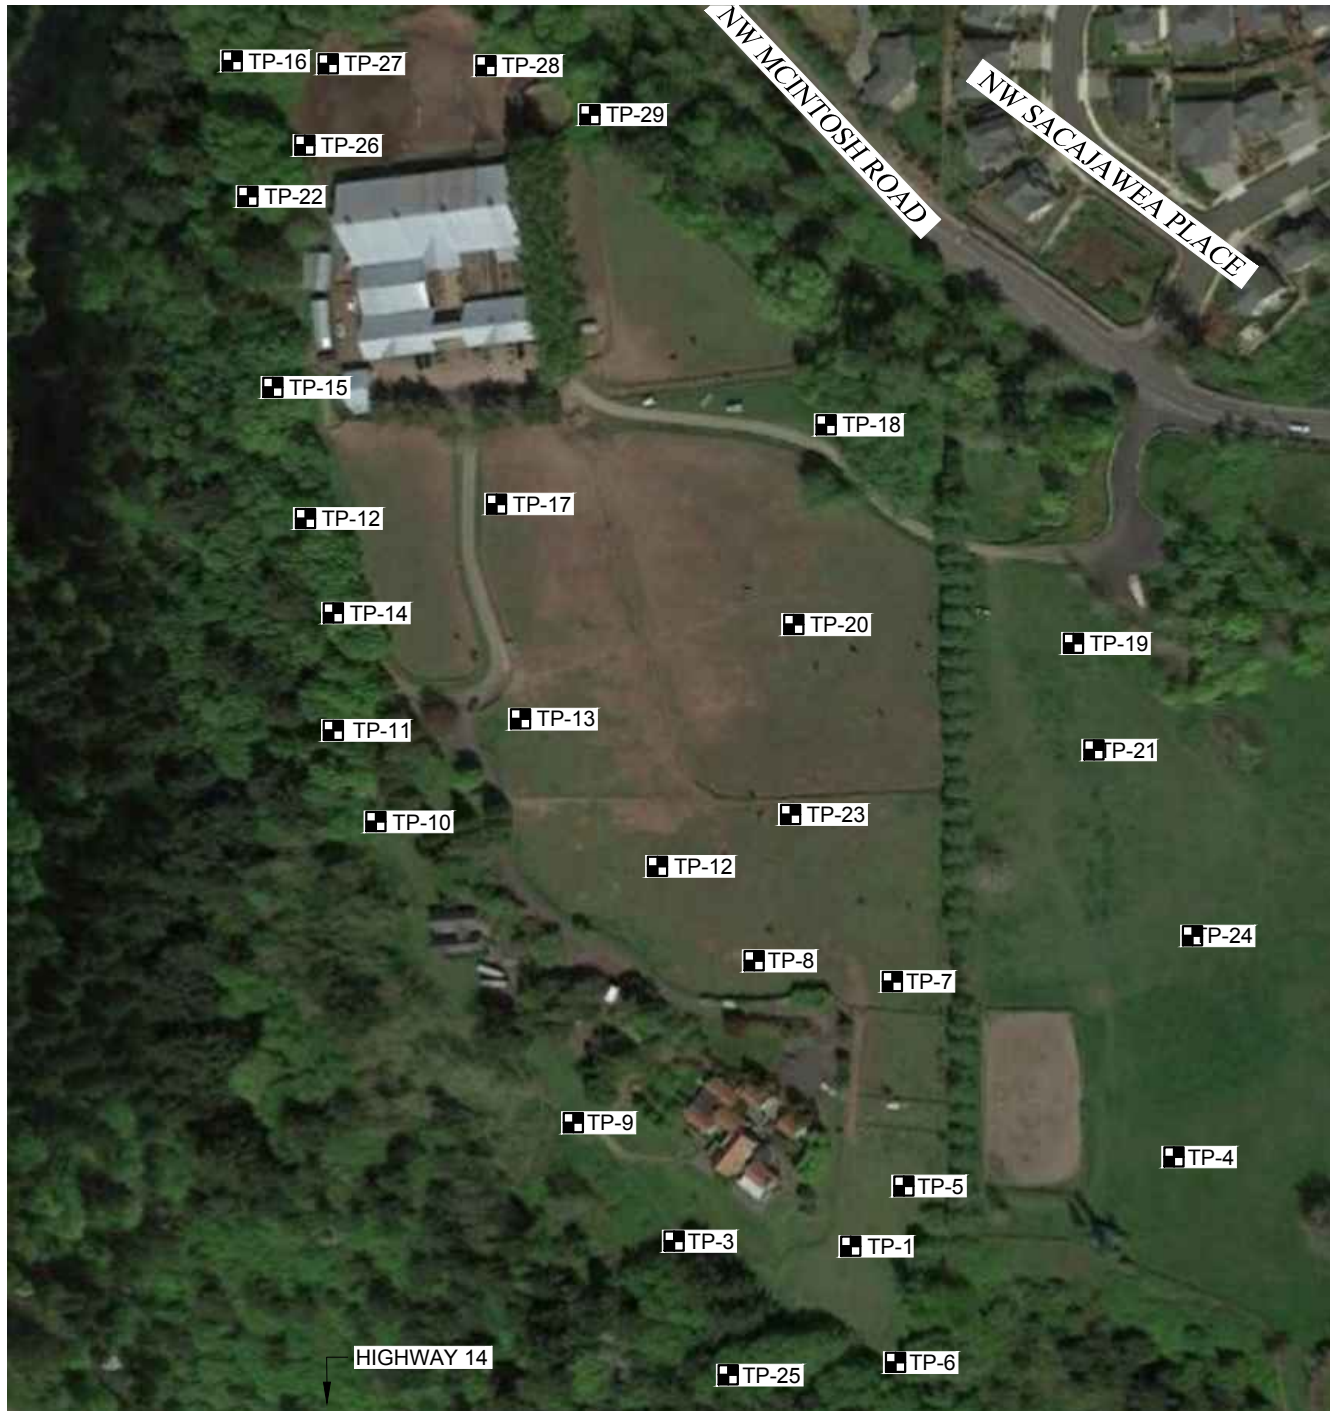
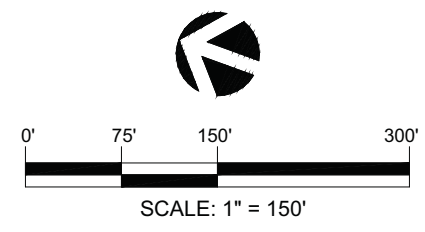
**SITE RECON
MAP**

Based on conversations with staff at the Equestrian Facility, drain tiles are reportedly present beneath the outdoor arena. These have reportedly been disconnected. PBS observed a drain outlet approximately 8 feet below the upper slope break on the northwest end of the area observed for this study. The pipe was daylighting onto the slope and has eroded a 1- to 1.5-foot-deep channel down the face of the slope

The area in the vicinity of the outdoor arena and adjacent ring have been graded to create relatively flat areas by pushing fill north over the slope. This is consistent with the subsurface conditions encountered in our recent test pit explorations. PBS observed some relatively small, localized failures along the slope break in the relatively soft/loose fill.

Utility Trench Location and Excavation – Due to the presence of mapped areas of previous instability, we recommend the outfall pipe from the stormwater facility extend downslope generally north and west between the mapped areas of instability (see Figure 3). The actual location of the pipe should be confirmed in the field by the geotechnical engineer prior to beginning construction. In addition, removal of vegetation should be limited to that required to install the pipe, with vegetation established over the disturbed area once the installation of the pipe has been completed. The geotechnical engineer should be contacted immediately if subsurface or groundwater conditions vary from those described in this addendum.

Emergency Shutoff – Due to the mapped areas of instability along site slopes, we recommend including an emergency shutoff valve at the stormwater facility structure in case the outfall pipe is ever damaged due to slope movement. This would allow for stormwater to be temporarily contained and reduce the risk of erosion or an increased risk of slope instability from leaking stormwater. The system should include provisions for temporarily redirecting the water if the emergency shutoff valve is used. This could be a hose or above-ground pipe directed to a suitable outfall approved by the civil engineer.

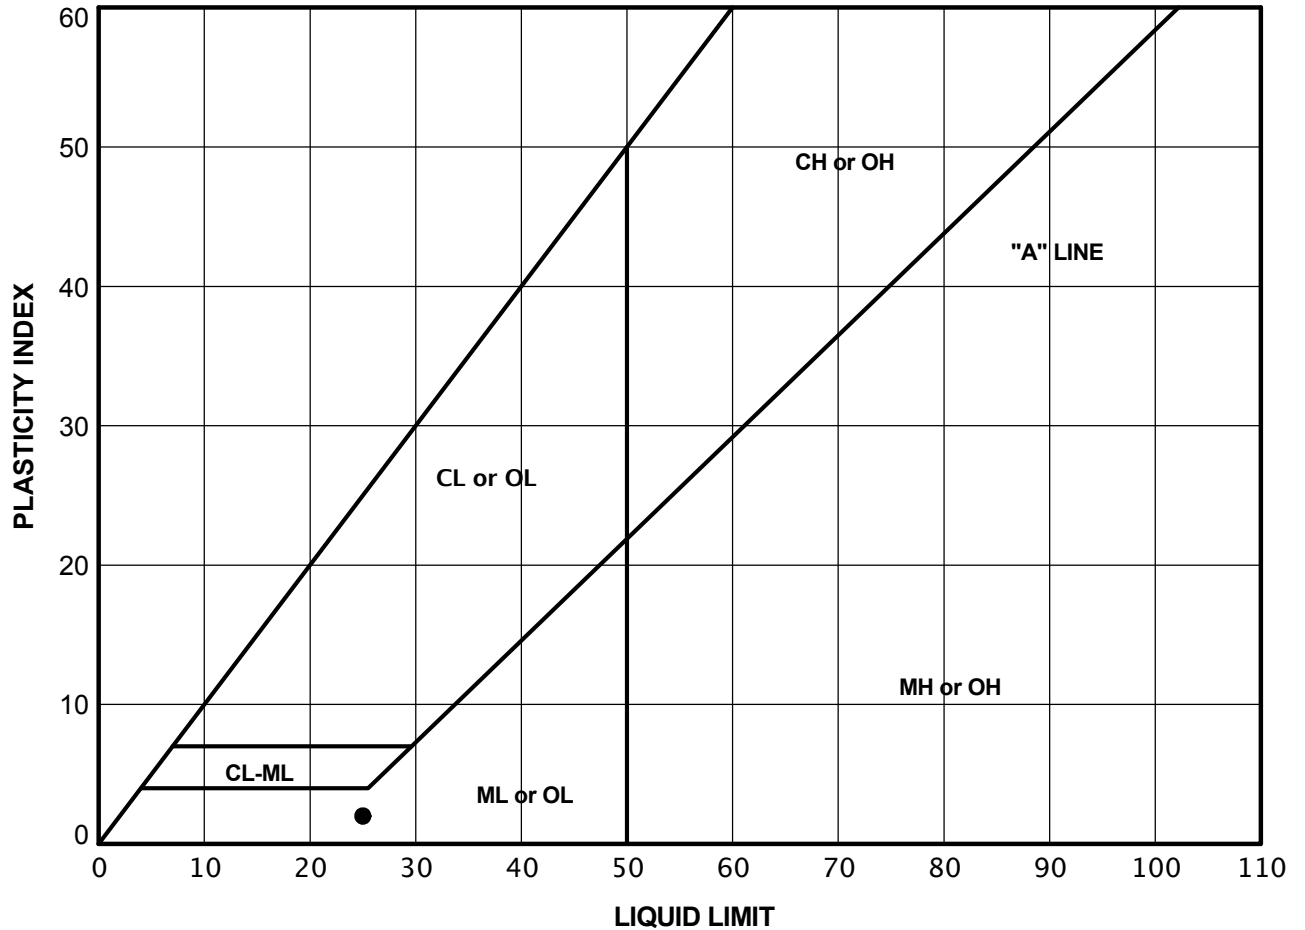
FIGURE B1
Page 1 of 1

KEY	EXPLORATION NUMBER	SAMPLE NUMBER	SAMPLE DEPTH (FEET)	NATURAL MOISTURE CONTENT (PERCENT)	PERCENT PASSING NO. 40 SIEVE (PERCENT)	LIQUID LIMIT	PLASTIC LIMIT	PLASTICITY INDEX
●	TP-29	S-3	8.5	24.6	NA	25	23	2
