MEMORANDUM

FROM: Todd Prager, RCA #597, ISA Board Certified Master Arborist

RE: Tree Removal and Protection Recommendations for Grass Valley Development

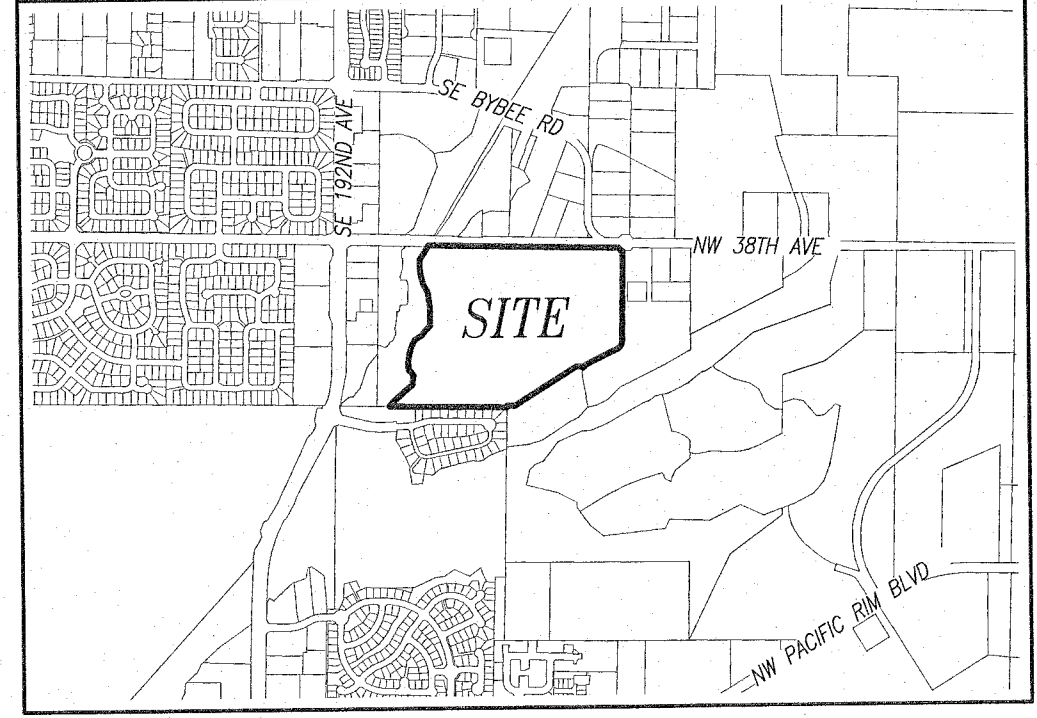
Attachment 2 shows the proposed impacts for site improvements in relation to the trees. Forty-three (43) of the 108 trees at the site are proposed for removal for the following reasons:

- **Trees 7 through 27 and 44 through 50:** Construction impacts from site grading and improvements.
- **Trees 37.1, 41.5, and 41.6:** Potential grading impacts.
- **Trees 41.1 through 41.4:** Very poor health and structural condition, risk to improvements, potential grading impacts.
- **Trees 57 through 60 and 85 through 87:** Site access from NW 38th Avenue.

The following recommendations apply to the 70 trees to be retained:

- **Protect Crowns of Trees:** The crowns of the trees may extend beyond the tree protection fencing. Care will need to be taken to not contact or otherwise damage the crowns of the trees during construction activities.
