E PLAN AND ASSESSMENT BY
WHYNN J. DEAN, ISA CERTIFIED
IST #PN-6396A AND TRAQ #1571

LACAMAS CREEK PARK TREE PLAN

LACAMAS CREEK
SANITARY SEWER
PUMP STATION
IMPROVEMENTS

CITY PROJECT NO. S1000

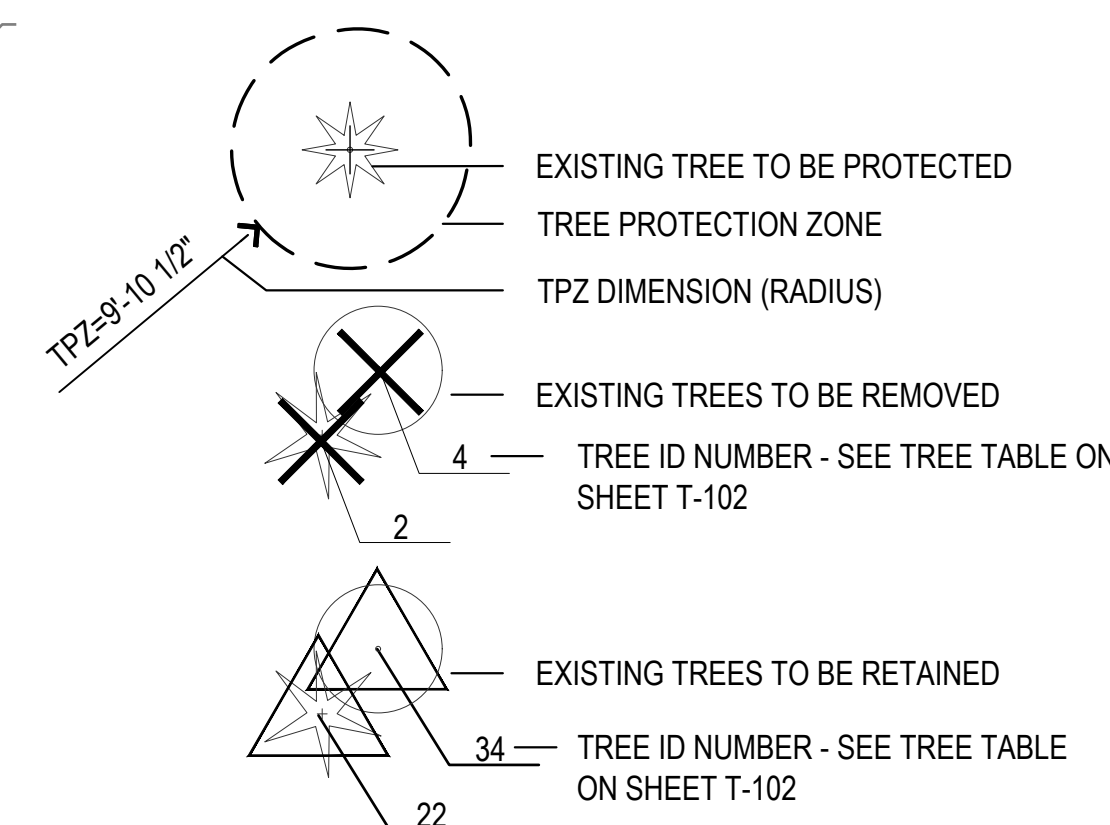
DRAWING NO:
T-101

TABLE OF TREES									<div>GREENWORKS</div> <div>GreenWorks, P.C. Landscape Architecture Environmental Design</div> <div>24 NW 2nd Avenue, Suite 100 Portland, Oregon 97209 Ph:503.222.5612 / F:503.222.2283 Email: info@greenworkspc.com</div> <div>GREENWORKS PROJECT NO: 118060.2</div>
TREE NUMBER	CONIFER OR DECID.	COMMON NAME	BOTANICAL NAME	SIZE (DBH)	CONDITION (STRUCTURAL STABILITY)	COMMENTS	HAZARD (RATING)	RECOMMENDATION	
1	-	ID NUMBER NOT USED							
2	D	BIGLEAF MAPLE	ACER MACROPHYLLUM	17	FAIR	#2 AND #3 ARE CODOMINANT STEMS OF SAME TREE. ABNORMAL BARK PATTERNS MAY INDICATE DECAY IN STEMS. NO CONKS EVIDENT BUT HEAVY IVY COVER MAY BE CONCEALING ANY ON GROUND. SOUNDING REVEALED NO OBVIOUS DECAY COLUMN. THIS TREE SHOULD BE RE-EVALUATED ONCE CANOPY LEAFS OUT. MORE IN-DEPTH TESTING (DRILLING, SONIC TOMOGRAPHY) MAY BE HELPFUL IF DESIRE IS TO RETAIN TREE.		RETAIN AND MONITOR	
3	D	BIGLEAF MAPLE	ACER MACROPHYLLUM	17	FAIR

4	D	NOT SIGNIFICANT TREE		8					
5	D	OREGON WHITE OAK	QUERCUS GARRYANA	22	GOOD.	WELL-HEALED WOUNDS AT 3' HT AND BELOW.		RETAIN. PROVIDE TREE PROTECTION ZONE AS SHOWN ON PLANS PRIOR TO START OF CONSTRUCTION.	
6	D	OREGON WHITE OAK	QUERCUS GARRYANA	12	FAIR	TREE LOCATED AT TOP OF SLOPE OVERLOOKING CREEK. NUMEROUS SMALL CONKS ON TRUNK MAY INDICATE COLUMN OF INTERNAL DECAY NOT REVEALED BY SOUNDING. HEAVY IVY COVER OBSCURES INSPECTION OF ROOT FLARE OR SURROUNDING GROUND. SEASONAL LACK OF FOLIAGE MEANS CANOPY HEALTH CANNOT BE REVIEWED FOR OTHER SIGNS OF INTERNAL DECAY. THIS TREE SHOULD BE RE-EVALUATED ONCE FOLIAGE IS PRESENT. DUE TO TREE'S LOCATION AND LEAN, IF IT WERE TO FAIL IT WOULD MOST LIKELY FALL EAST INTO THE CREEK (LOW TARGET RATING).		RETAIN AND MONITOR	
7	D	NOT SIGNIFICANT TREE		8					
8	C	DOUGLAS FIR	PSEUDOTSUGA MENZIESII	48	GOOD	SUPPRESSED BY #9		RETAIN	
9	C	DOUGLAS FIR	PSEUDOTSUGA MENZIESII	35	GOOD	SUPPRESSED BY #8.		RETAIN

10	D	NOT SIGNIFICANT TREE		8					
11	C	DOUGLAS FIR	PSEUDOTSUGA MENZIESII	44	GOOD			RETAIN	
12	C	DOUGLAS FIR	PSEUDOTSUGA MENZIESII	17	FAIR	SUPPRESSED BY #13. SELF-CORRECTED LEAN.		RETAIN	
13	C	WESTERN RED CEDAR	THUJA PLICATA	19	FAIR	DECAYED STUB ON SE SIDE WITH CENTRAL COLUMN OF DECAY. TOP GONE. SUPPRESSED BY #11 AND #15.	YES (9)	REMOVE FOR CONDITION. ALTHOUGH THUJA PLICATA CAN REMAIN STANDING WITH CENTRAL COLUMN OF DECAY, THIS TREE'S ADJACENCY TO THE TRAIL MEANS THE TARGET RATING IS VERY HIGH. A CODOMINANT STEM IS ALREADY GONE LEAVING A DECAY CAVITY. IF DESIRE IS TO RETAIN THIS TREE, MORE INVASIVE TESTING (DRILLING/SONIC TOMOGRAPHY) SHOULD BE USED TO GIVE MORE INFO ON EXTENT OF INTERNAL DECAY AND THICKNESS OF STEM WALL.	
14	C	DOUGLAS FIR	PSEUDOTSUGA MENZIESII	28	GOOD	SELF-CORRECTED LEAN. ROOTED UNDER #15		RETAIN	
15	C	WESTERN RED CEDAR	THUJA PLICATA	25	GOOD			RETAIN	
16	C	DOUGLAS FIR	PSEUDOTSUGA MENZIESII	40	GOOD	TREE AT CREST OF SLOPE. SWELLING ON UPHILL SIDE AT BASE OF TRUNK APPEARS TO CONTAIN OLD PHAEOLUS SCHWEINTZII CONK. NO OTHER CONKS OR RESINOSUS OBSERVED.		RETAIN AND MONITOR

17	C	DOUGLAS FIR	PSEUDOTSUGA MENZIESII	20	GOOD	LOW CROWN RATIO. AT CREST OF SLOPE. SLIGHT SELF-CORRECTED LEAN.		RETAIN.	
18	C	DOUGLAS FIR	PSEUDOTSUGA MENZIESII	28	GOOD	SUPPRESSED ON NORTH SIDE BY TREES UPHILL (OFF-SITE)		RETAIN	
19	D	OREGON OAK	QUERCUS GARRYANA	18	POOR	TOP GONE. DECAYED STUB AT 15' HT. LOTS OF PRUNING CUTS NOT WELL-HEALED. LARGE NUMBERS OF SMALL YOUNG FUNGUS ON STEM. TREE LOCATED ON SLOPE ABOVE LAWN AREA.	YES (7)	REMOVE FOR CONDITION.	
20A	D	BIGLEAF MAPLE	ACER MACROPHYLLUM	18 + 20	FAIR	SURVEY GROUPED 3 STEMS AS ONE TREE; ACTUALLY TWO TREES: ONE MAPLE WITH TWO STEMS AND ONE SMALLER OAK GROWING IN CLOSE PROXIMITY. THE MAPLE HAS TWO CODOMINANT STEMS WITH INCLUDED BARK, SPLIT ALONG INCLUSION LINE AND CAVITY WITH CALLUSED EDGES. NO OBVIOUS DECAY COLUMN REVEALED BY SOUNDING WITH MALLET; GROUND INSPECTION LIMITED BY HEAVY IVY GROWTH.	YES (8)	EITHER REMOVE OR DO CROWN REDUCTION TO REDUCE PROBABILITY OF FAILURE IF DESIRE IS TO RETAIN TREE. TREE IS ON SLOPE ABOVE LAWN (HIGH TARGET RATING/ FREQUENTLY OCCUPIED) AND ANOTHER TREE HAS RECENTLY FAILED TO THE SOUTH OF THIS ONE.

20B	D	GARRY OAK	QUERCUS GARRYANA	10	FAIR	THE OAK OF THIS GROUP HAS NO OBVIOUS HEALTH PROBLEMS, BUT IS LEANING SIGNIFICANTLY ON THE SLOPE ABOVE THE LAWN AREA. HEAVY IVY INFESTATION OF GROUND MAKES DETECTION OF ANY FUNGAL FRUITING BODIES ON ROOTS IMPOSSIBLE. RE-EVALUATE WHEN CANOPY LEAFS OUT FOR ANY SIGNS OF ROOT ROT.		RETAIN AND RE-EVALUATE. CROWN REDUCTION TO REDUCE WEIGHT.	
21	D	BIGLEAF MAPLE	ACER MACROPHYLLUM	12	GOOD	SELF-CORRECTED LEAN DUE TO SLOPE. HEAVY IVY INFESTATION.		RETAIN	
22	D	BIGLEAF MAPLE	ACER MACROPHYLLUM	12	FAIR	TOP IS GONE, HEAVY IVY INFESTATION. CAVITY AT ROOT FLARE ON DOWNHILL SIDE. TREE ON SLOPE ABOVE LAWN AREA.		REMOVE	
23	D	BIGLEAF MAPLE	ACER MACROPHYLLUM	12 + 16	GOOD	CODOMINANT AT 2' HT. NO CRACK OR SPLIT AT INCLUSION LINE. HEAVY IVY INFESTATION.		RETAIN	
24	C	DOUGLAS FIR	PSEUDOTSUGA MENZIESII	30	GOOD	HEAVY IVY INFESTATION.		RETAIN	
25	D	BIGLEAF MAPLE	ACER MACROPHYLLUM	16	FAIR	HEAVY IVY INFESTATION OBSCURING BASE. LEANS 15° TOWARDS LAWN ON STEEP SLOPE. RECOMMEND RE-EVALUATION ONCE CANOPY LEAFS OUT.		RETAIN AND MONITOR

26	D	BIGLEAF MAPLE	ACER MACROPHYLLUM	14 + 15	FAIR	CODOMINANT STEMS AT 2' HT; NO CRACKS, CAVITIES OR CONKS OBSERVED. HEAVY IVY INFESTATION OBSCURING BASE. RECOMMEND RE-EVALUATION ONCE CANOPY LEAFS OUT TO DETERMINE AMOUNT OF DEADWOOD IN CROWN AND REVIEW FOLIAGE HEALTH. PRIOR FAILURE OF LARGE TREE TO SOUTH.		RETAIN AND MONITOR. MAY NEED CROWN CLEANING TO REDUCE WEIGHT ON BRANCHES LEANING OUT TO LAWN (TARGET AREA).	
27	D	RED ALDER	ALNUS RUBRA	16	POOR	DEAD/DYING. MULTIPLE SAPROPHYTIC CONKS ON STEM.	YES (10)	REMOVE FOR CONDITION	
28	D	RED ALDER	ALNUS RUBRA	17	POOR	DEAD/DYING. LARGE AREA OF DECAY AT BASE OF STEM ON EAST WHERE CODOMINANT STEM TORE OUT. CONKS. LEANING IN TO LAWN AREA.	YES (10)	REMOVEFOR CONDITION	
29	C	LEYLAND CYPRESS	X CUPRESSOCYPARIS LEYLANDII	17	GOOD			REMOVE FOR CONSTRUCTION	
30	C	LEYLAND CYPRESS	X CUPRESSOCYPARIS LEYLANDII	16	GOOD			REMOVE FOR CONSTRUCTION	
31	C	LEYLAND CYPRESS	X CUPRESSOCYPARIS LEYLANDII	19	GOOD			REMOVE FOR CONSTRUCTION

32	C	LEYLAND CYPRESS	X CUPRESSOCYPARIS LEYLANDII	20	GOOD			REMOVE FOR CONSTRUCTION	
33	C	LEYLAND CYPRESS	X CUPRESSOCYPARIS LEYLANDII	19	GOOD			REMOVE FOR CONSTRUCTION	
34	C	LEYLAND CYPRESS	X CUPRESSOCYPARIS LEYLANDII	22	FAIR	CODOMINANT STEMS WITH INCLUDED BARK UP TO 5'		REMOVE FOR CONSTRUCTION	
35	C	LEYLAND CYPRESS	X CUPRESSOCYPARIS LEYLANDII	25 @ 2'	FAIR	FOUR STEMS; INCLUDED BARK AT ATTACHMENTS		REMOVE FOR CONSTRUCTION	
36	C	LEYLAND CYPRESS	X CUPRESSOCYPARIS LEYLANDII	28 @ 3'	GOOD			REMOVE FOR CONSTRUCTION	
37	D	EMPRESS TREE	PAULOWNIA TOMENTOSA	34	GOOD	ONESIDED CROWN TO SOUTH.		REMOVE FOR CONSTRUCTION	
38	D	RED ALDER	ALNUS RUBRA	31 @ 3'	POOR	CONKS, VISIBLE WHITE ROT WHERE STEM TO NORTH BROKE OUT IN PAST AND NO WOUND CLOSURE HAS OCCURRED.	YES (9)	REMOVE FOR CONDITION	
39	C	DOUGLAS FIR	PSEUDOTSUGA MENZIESII	62	GOOD	CODOMINANT STEMS WITH INCLUDED BARK UP TO 8'. WEST STEM TOP GONE		RETAIN AND MONITOR - PROVIDE TREE PROTECTION FENCING AS SHOWN ON PLANS. THE PLANNED FULL BUILD-OUT WILL IMPACT APPROXIMATELY 66% OF THIS TREE'S TPZ. RECOMMENDATION IS TO MINIMIZE IMPACTS WHERE POSSIBLE BY MOVING PLANNED IMPROVEMENTS FURTHER FROM TREE, CONSTRUCTING HARD SURFACES ON GRADE WHERE POSSIBLE AND REDUCING AREA OF FILL BY USE OF RETAINING WALLS. WALLS SHALL BE MIN. 16' FROM TRUNK TO MAINTAIN ORIGINAL GRADE WITHIN CRITICAL ZONE CLOSE TO TRUNK. MINIMIZE ROOT DAMAGE BY LIMITING WORK TO ONLY HAND TOOLS WHERE TRENCHING MUST RUN THROUGH TPZ; NO ROOTS OVER 3" TO BE SEVERED; ANY ROOTS THAT ARE PRUNED SHOULD LEAVE FLAT SURFACE WITH CLEAN EDGES; ROOTS SHALL NOT BE LEFT UNCOVERED AND ALLOWED TO DRY OUT. ARBORIST SHOULD MONITOR EXCAVATION IN CASE ROOTS OVER 3" Ø ARE ENCOUNTERED. DOUG FIRS ARE RELATIVELY TOLERANT OF FILL AS LONG AS IT DOES NOT EXCEED 25% OF THE TPZ. THIS TREE WILL NEED TO BE MONITORED ANNUALLY AFTER CONSTRUCTION TO CHECK FOR SIGNS OF DECLINE.

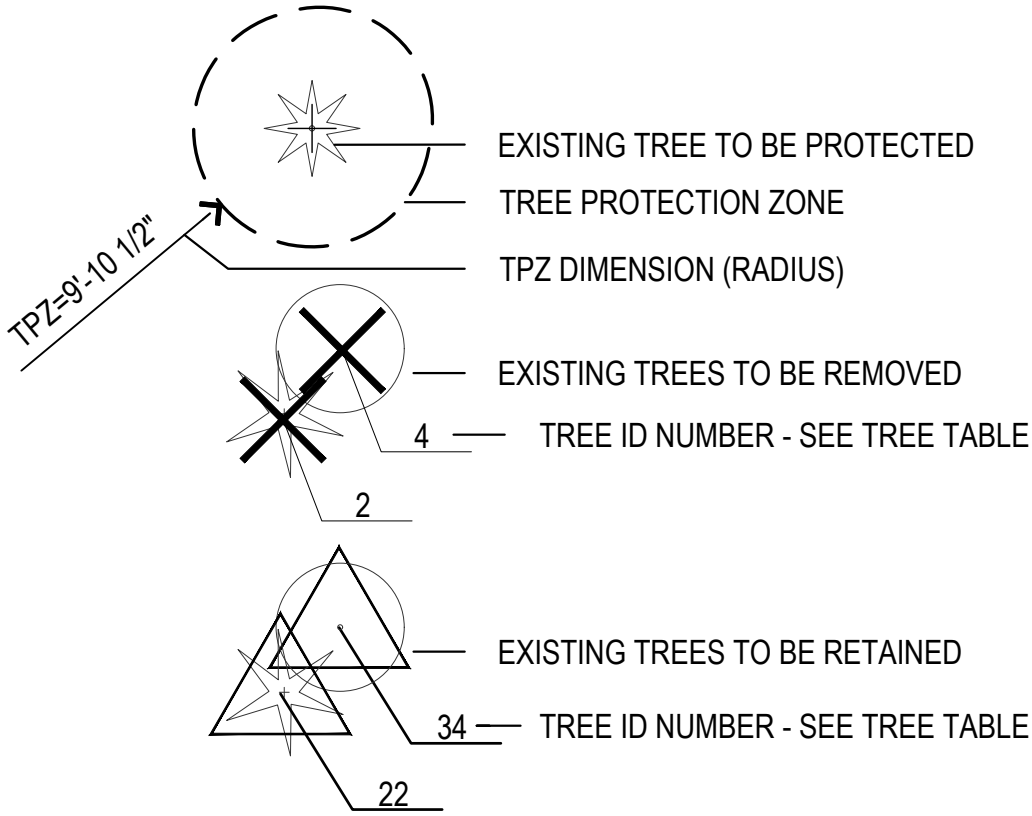
DRAWING NO:
T-103

TABLE OF TREES									
TREE NUMBER	CONIFER OR DECID.	COMMON NAME	BOTANICAL NAME	SIZE (DBH)	CONDITION (STRUCTURAL STABILITY)	COMMENTS	HAZARD (RATING)	RECOMMENDATION	
1	C	ARBORVITAE	THUJA OCCIDENTALIS	3 STEM: 4.5", 6" AT 2.5' AND 9" AT GRND	GOOD			RETAIN	
2	D	BLACK COTTONWOOD	POPULUS TRICHOCARPA	23"	POOR	HEAVY IVY INFESTATION UP ENTIRE STEM. TOP MISSING AT 30'. BARK SEPARATING FROM SAPWOOD ON WEST SIDE OF STEM FROM GROUND LEVEL UP TO 6', EXPOSING PARTIALLY HEALED AREA OF DECAY THAT ENCOMPASSES ALMOST ONE-HALF OF STEM'S CIRCUMFERENCE.SOME CALLUS WOOD FORMED AT EDGES OF DECAY. DEAD BRANCHES WITH MISSING BARK IN CROWN. TREE IS LEANING 9-10° TO NORTHEAST BUT IS SHORT ENOUGH THAT IT WOULD NOT IMPACT THE NEARBY RESIDENCE IN THE EVENT OF TOTAL FAILURE. LEAN OF THIS TREE (AND #3 AND #4) APPEAR TO BE PHOTOTROPIC; THESE WERE PROBABLY ALL EDGE TREES BEFORE THE ADJACENT BAZ PARK WAS CREATED.	YES (11)	REMOVE

3	D	BLACK COTTONWOOD	POPULUS TRICHOCARPA	40"	POOR/FAIR	DYING 12" STEM ON NORTH WITH MISSING BARK FROM GROUND LEVEL UP TO 2/3 OF TOTAL HEIGHT, CONKS, MISSING LEADER, AND BIRD NESTING CAVITIES. LEANING TO NE; COMPLETE FAILURE COULD IMPACT DECK OF ADJACENT RESIDENCE DEPENDING ON DIRECTION OF FAILURE. SOUTH STEM (36") HAS HAD MULTIPLE BRANCHES FAIL PREVIOUSLY, HAS BARK LIFTING FROM SAPWOOD AT BASE UP TO ABOUT 7' HT., AND CONSTRUCTION DEBRIS (CONCRETE CHUNKS) PILED AROUND BASE. HEAVY IVY AND BLACKBERRY COVER MAKES INSPECTION OF ROOTS IMPOSSIBLE; IT APPEARS FILL HAS BEEN PLACED OVER ORIGINAL GRADE. THERE IS ONE VISIBLE LARGE ROOT ON EAST SIDE OF TREE THAT HAS BEEN REPEATEDLY DAMAGED.	YES (11 - NORTH STEM, 10 - SOUTH STEM)	REMOVE	
4	D	BLACK COTTONWOOD	POPULUS TRICHOCARPA	24"	FAIR	MISSING ORIGINAL LEADER, ONE-SIDED CROWN DUE TO #3, SELF-CORRECTED LEAN TO SOUTHEAST. VERY HEAVY IVY AND BLACKBERRY COVER SO ROOTS CANNOT BE VISUALLY EXAMINED. LARGE DEAD BRANCH ON NORTH SIDE AT ABOUT 30'.		RETAIN; CROWN CLEAN, REMOVE LARGE DEAD LIMB.

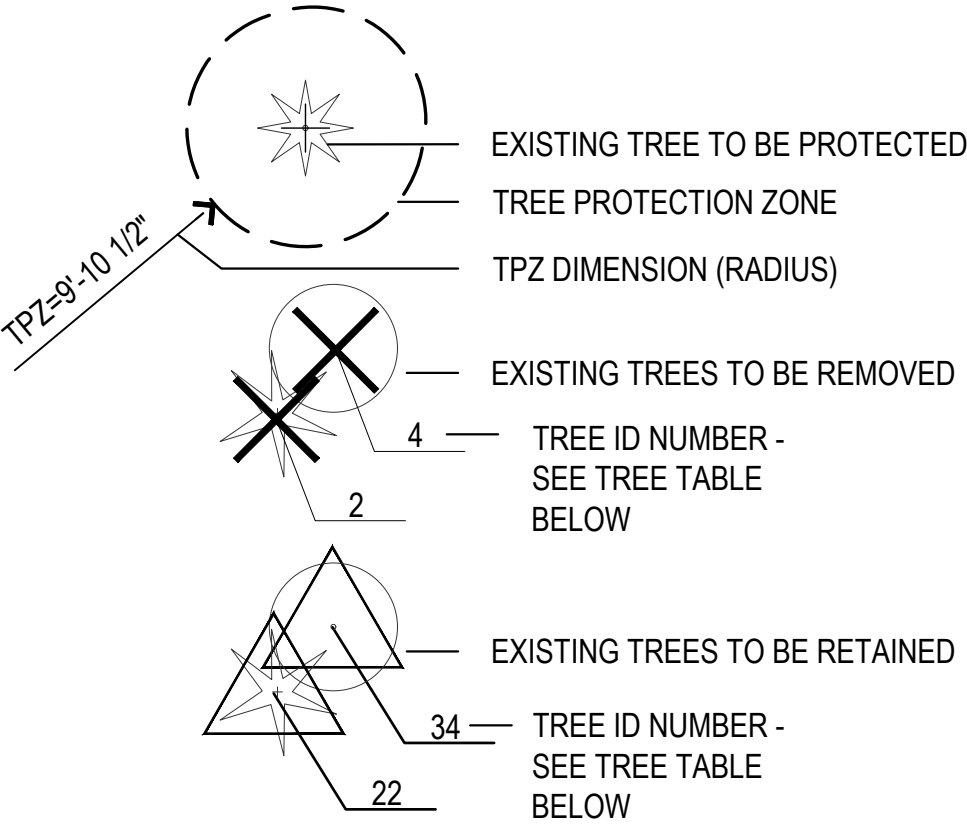
TABLE OF TREES								
TREE NUMBER	CONIFER OR DECID.	COMMON NAME	BOTANICAL NAME	SIZE (DBH CAL-INCHES)	CONDITION (STRUCTURAL STABILITY)	COMMENTS	HAZARD (RATING)	RECOMMENDATION
1	C	GIANT SEQUOIA	SEQUOIAENDRON GIGANTEUM	95	GOOD			RETAIN. DO NOT SEVER ROOTS OVER 3'Ø; ANY ROOTS THAT ARE PRUNED SHOULD LEAVE FLAT SURFACE WITH CLEAN EDGES; DO NOT TEAR ROOTS. EXPOSED ROOTS SHALL NOT BE LEFT UNCOVERED AND ALLOWED TO DRY OUT.
2	C	SHORE PINE	PINUS CONTORTA	17	FAIR	LOW LIVE CROWN RATIO. SOME RESINOSUS AT BASE		RETAIN
3	C	DOUG FIR	PSEUDOTSUGA MENZIESII	14	FAIR	SHADED OUT BY #6; THINNING FOLIAGE WITH APPARENT NEEDLE RUST INFECTION.		RETAIN
4	C	LOW'S FIR	ABIES CONCOLOR V. LOWIANA	17	FAIR	FINE DEAD TWIGS IN CROWN. UNHEALED WOUND AT BASE.		RETAIN
5	D	OREGON OAK	QUERCUS GARRYANA	91 AT 1' HT.	GOOD	MASSIVE TREE WITH 7 STEMS DIVIDING AT 1' ABOVE GRADE. AT TOP OF SLOPE. CAVITY WITH CALLUS EDGES AT BASE OF NORTH STEM. UNHEALED BARK WOUND AT BASE ON SOUTHWEST SIDE. NEW SEWER LINE PROPOSED WITHIN LESS THAN 10' OF FACE OF TRUNK. TRENCHING WILL CUT UPHILL ROOTS.		RETAIN. RECOMMEND RELOCATING NEW SEWER LINE OUTSIDE THE TREE PROTECTION ZONE. WHERE SEWER LINE PASSES WITHIN A 40' RADIUS OF THE TRUNK FACE, RECOMMEND INSTALLATION OF NEW LINE BY BORING OR TUNNELING AT A MIN. DEPTH OF 3'. WITHIN THE TPZ, TRENCHING SHALL OCCUR UNDER THE SUPERVISION OF AN ARBORIST TO ENSURE TREE STABILITY IS NOT COMPROMISED. WHERE CONSTRUCTION ACTIVITY SHALL OCCUR WITHIN THE TPZ, PROVIDE 6"-16" DEPTH WOOD CHIPS OVER GEOTEXTILE TO MINIMIZE SOIL COMPACTION; LEAVE IN PLACE UNTIL COMPLETION OF CONSTRUCTION. DO NOT SEVER ROOTS OVER 3'Ø; ROOTS SHALL NOT BE TORN OR CRUSHED; PRUNED ROOTS SHALL BE LEFT WITH FLAT SURFACE WITH ADJACENT BARK FIRMLY ATTACHED. EXPOSED ROOTS SHALL NOT BE LEFT UNCOVERED AND ALLOWED TO DRY OUT. TRENCH BACKFILL SHALL BE NATIVE SOIL WHEN POSSIBLE. IF ROCK BACKFILL IS USED, EXPOSED ROOTS SHALL BE WRAPPED IN GEOTEXTILE PRIOR TO BACKFILLING. RECOMMEND PROTECTING TRUNK OF TREE FROM MECHANICAL INJURY DURING CONSTRUCTION TO A MIN. HT. OF 8'. TREE TO BE MONITORED ANNUALLY FOR SIGNS OF DECLINE.

6	D	BIGLEAF MAPLE	ACER MACROPHYLLUM	38	DEAD/DYING	COMPLETELY GIRDLED BY BEAVER. TOP GONE.	YES (8)	REMOVE
7	D	CHERRY	PRUNUS SPP.	13	FAIR	TREE AT TOP OF SLOPE IN GROUP OF 3 WITH #8 AND #9. SELF-CORRECTED LEAN TO SW. PROPOSED TRENCH WILL CUT UPHILL ROOTS.		REMOVE. SINCE THIS TREE IS IN CLOSE PROXIMITY TO #8 AND #9 AND IS NOT A VALUABLE OR UNUSUAL TREE, RECOMMEND REMOVAL. EXPECT THAT ROOTS OF ALL THREE TREES ARE INTERTWINED, SO REMOVING #8 AND #9 MAY COMPROMISE ROOT STABILITY OF THIS TREE AND INCREASE CHANCE OF WINDTHROW FAILURE.
8	D	COTTONWOOD	POPULUS TRICHOCARPA	14	POOR	GIRDLED BY BEAVER, ONLY 1/3 OF STEM REMAINING. PROPOSED TRENCH WILL CUT UPHILL ROOTS.	YES (9)	REMOVE. DO NOT EXCAVATE ROOT WAD IF #7 TO BE RETAINED.
9	D	CHERRY	PRUNUS SPP.	16	POOR	15° LEAN OVER GRAVEL DRIVE. LARGE STEM BULGE. PROPOSED TRENCH WILL CUT UPHILL ROOTS.	YES (7)	REMOVE. DO NOT EXCAVATE ROOT WAD IF #7 TO BE RETAINED.
10	D	COTTONWOOD	POPULUS TRICHOCARPA	27	POOR	BEAVER-GIRDLED FOR THREE-QUARTERS OF CIRCUMFERENCE. CONKS ON EXPOSED SAPWOOD. PROPOSED TRENCH WILL MOST LIKELY CUT ANCHORING UPHILL ROOTS.	YES (9)	REMOVE
