Revised December 3, 2014  
Project No. 13-3186

**SUBJECT: PRELIMINARY GEOTECHNICAL ENGINEERING REPORT**  
**GREEN MOUNTAIN - PHASE 1**  
**NE INGLE ROAD & NE 28<sup>TH</sup> STREET**  
**CAMAS, WASHINGTON**

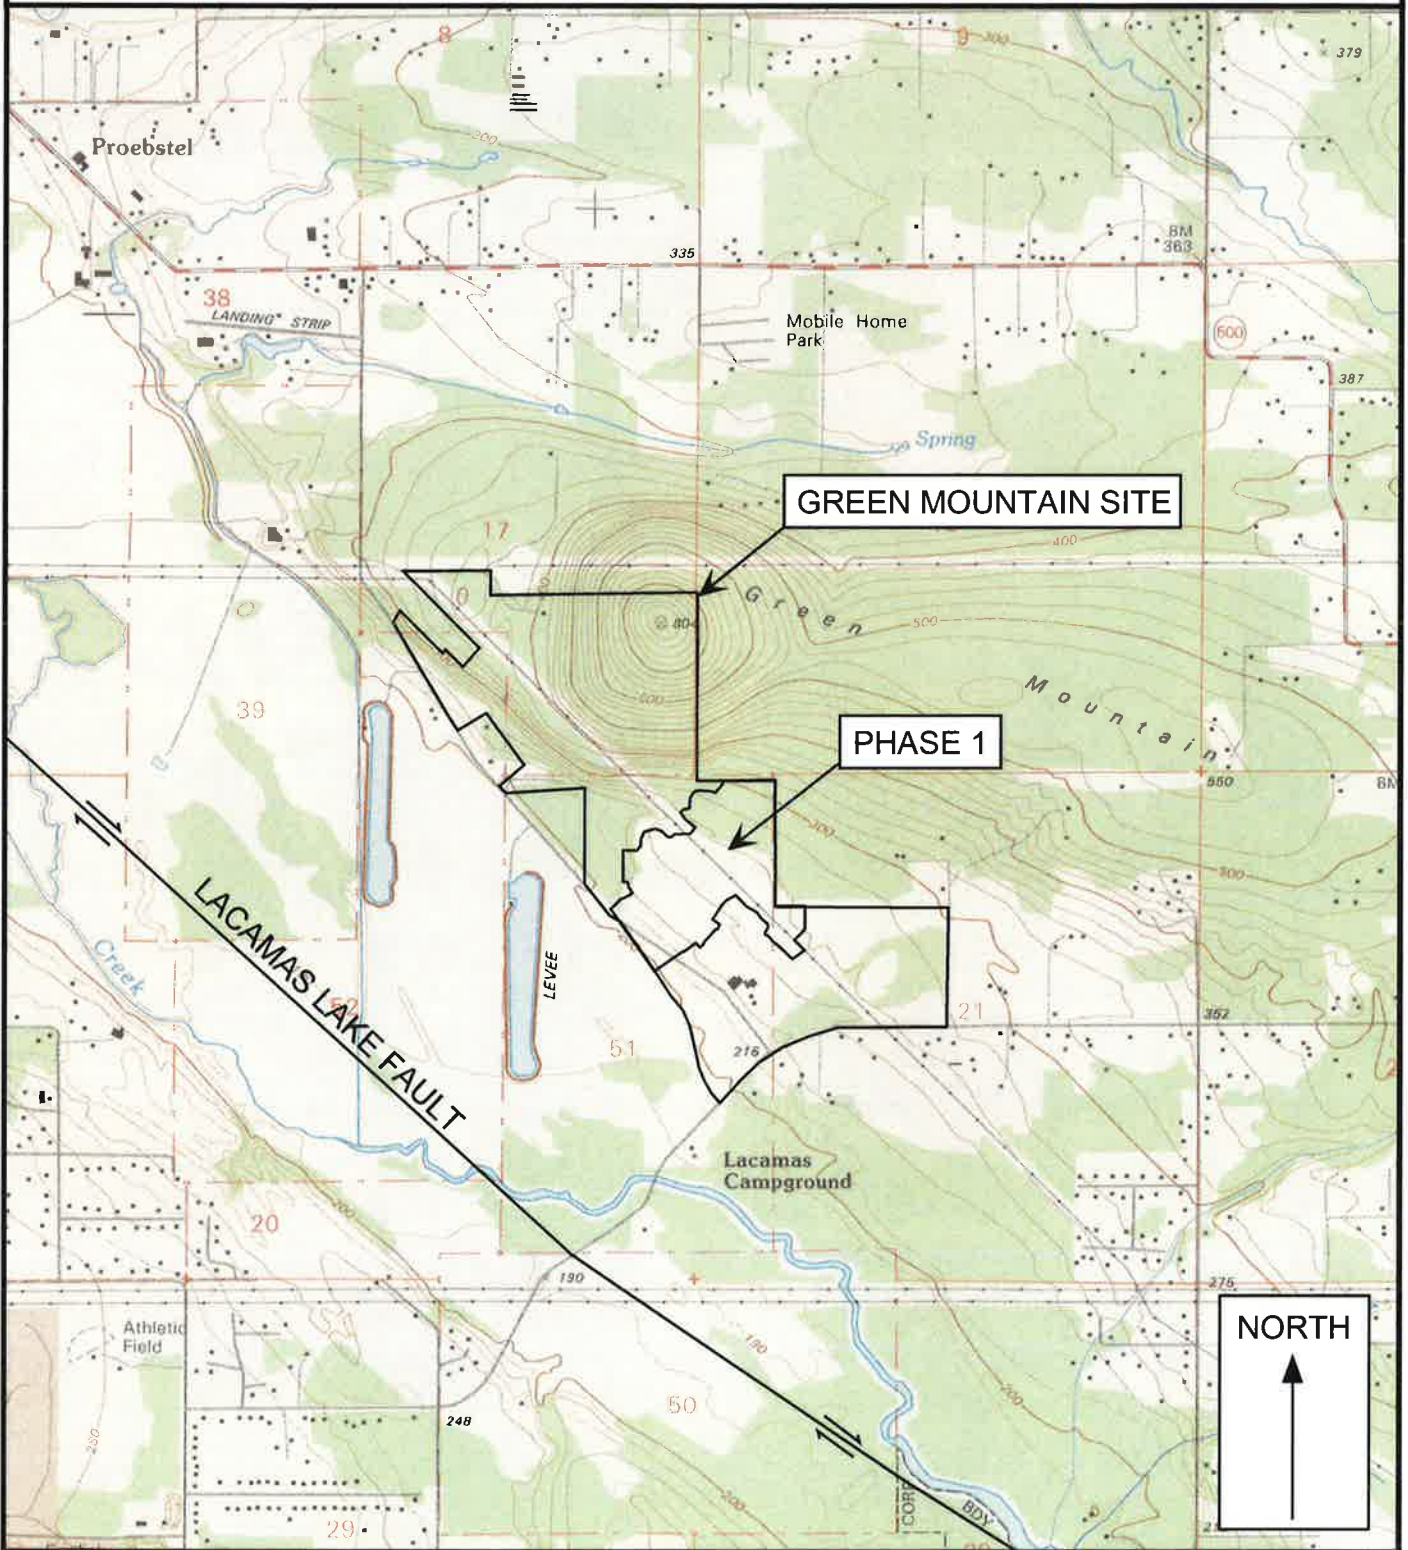
FIGURE 1

### VICINITY MAP

the Lacamas Creek-Sandy River Fault Zone is potentially active with a possible rupture length of greater than 25 miles. The Lacamas Creek Fault is mapped as being ½ mile southwest of the subject site (Figure 1).

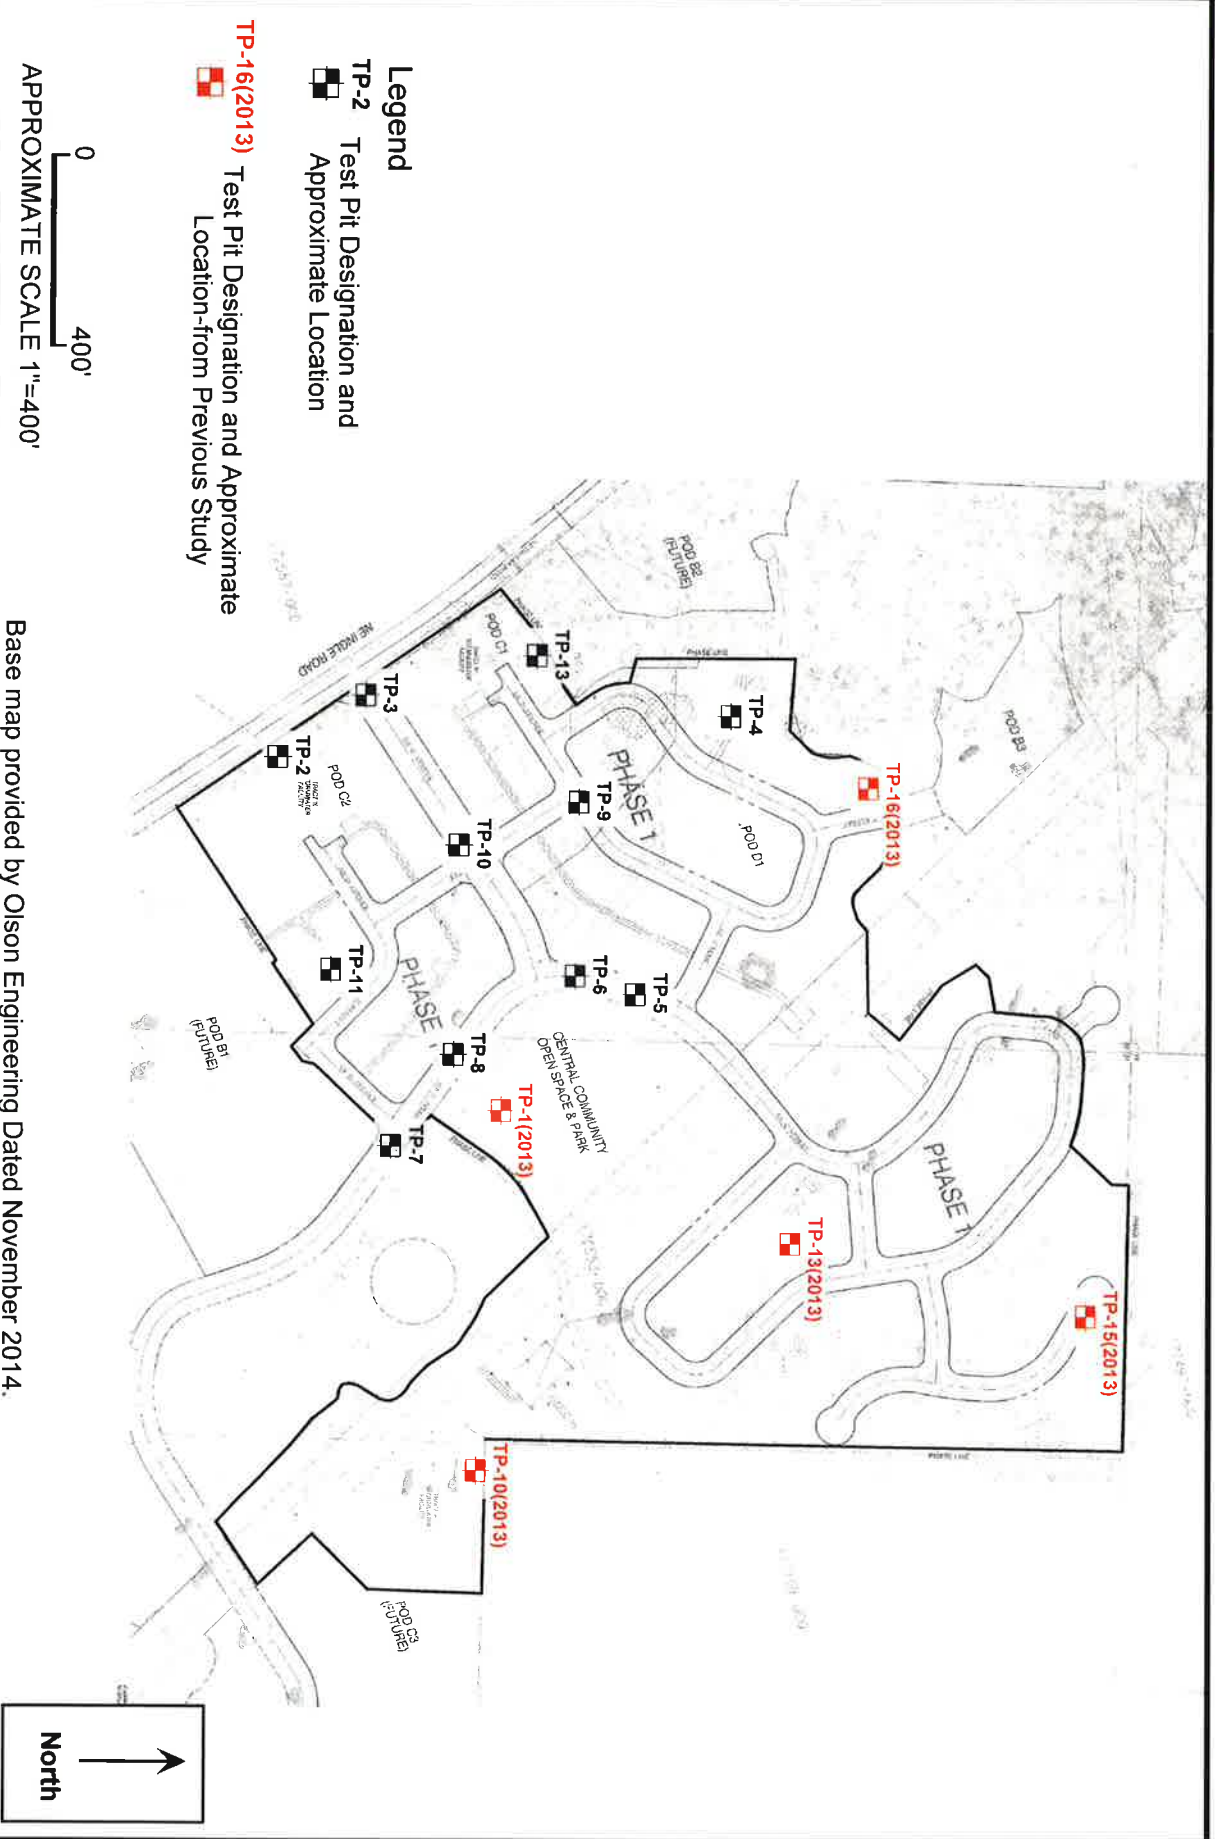
Project: Green Mountain Phase 1 Camas, Washington	Project No. 13-3186	Date: 10/2/2014 Drawn by: EKR
FIGURE 2

## SITE PLAN AND EXPLORATION LOCATIONS

Our site-specific exploration for Phase 1 was conducted on May 23<sup>rd</sup>, 2014. A total of 13 exploratory test pits were excavated with a medium sized trackhoe to depths ranging between 5 and 9 feet at the approximate locations shown on Figure 2. Test pits TP-1 and TP-12 are outside of the Phase 1 boundary due to a reconfiguration of the layout and are not presented. The previous investigation for the entire Green Mountain site consisted of 25 exploratory test pits excavated November 5<sup>th</sup> through 7<sup>th</sup>, 2013. Five test pits from the previous investigation are located within Phase 1 – test pits TP-1, TP-10, TP-13, TP-15, and TP-16. Test pits from the 2013 investigation for the entire Green Mountain site will be referred to as TP-1 (2013), TP-10 (2013), TP-13 (2013), TP-15 (2013), and TP-16 (2013). It should be noted that exploration locations were located in the field by pacing or taping distances from apparent property corners and other site features shown on the plans provided. As such, the locations of the explorations should be considered approximate.
