Geotechnical Site Investigation

Parklands at Camas Meadows

Camas, Washington

June 23, 2015

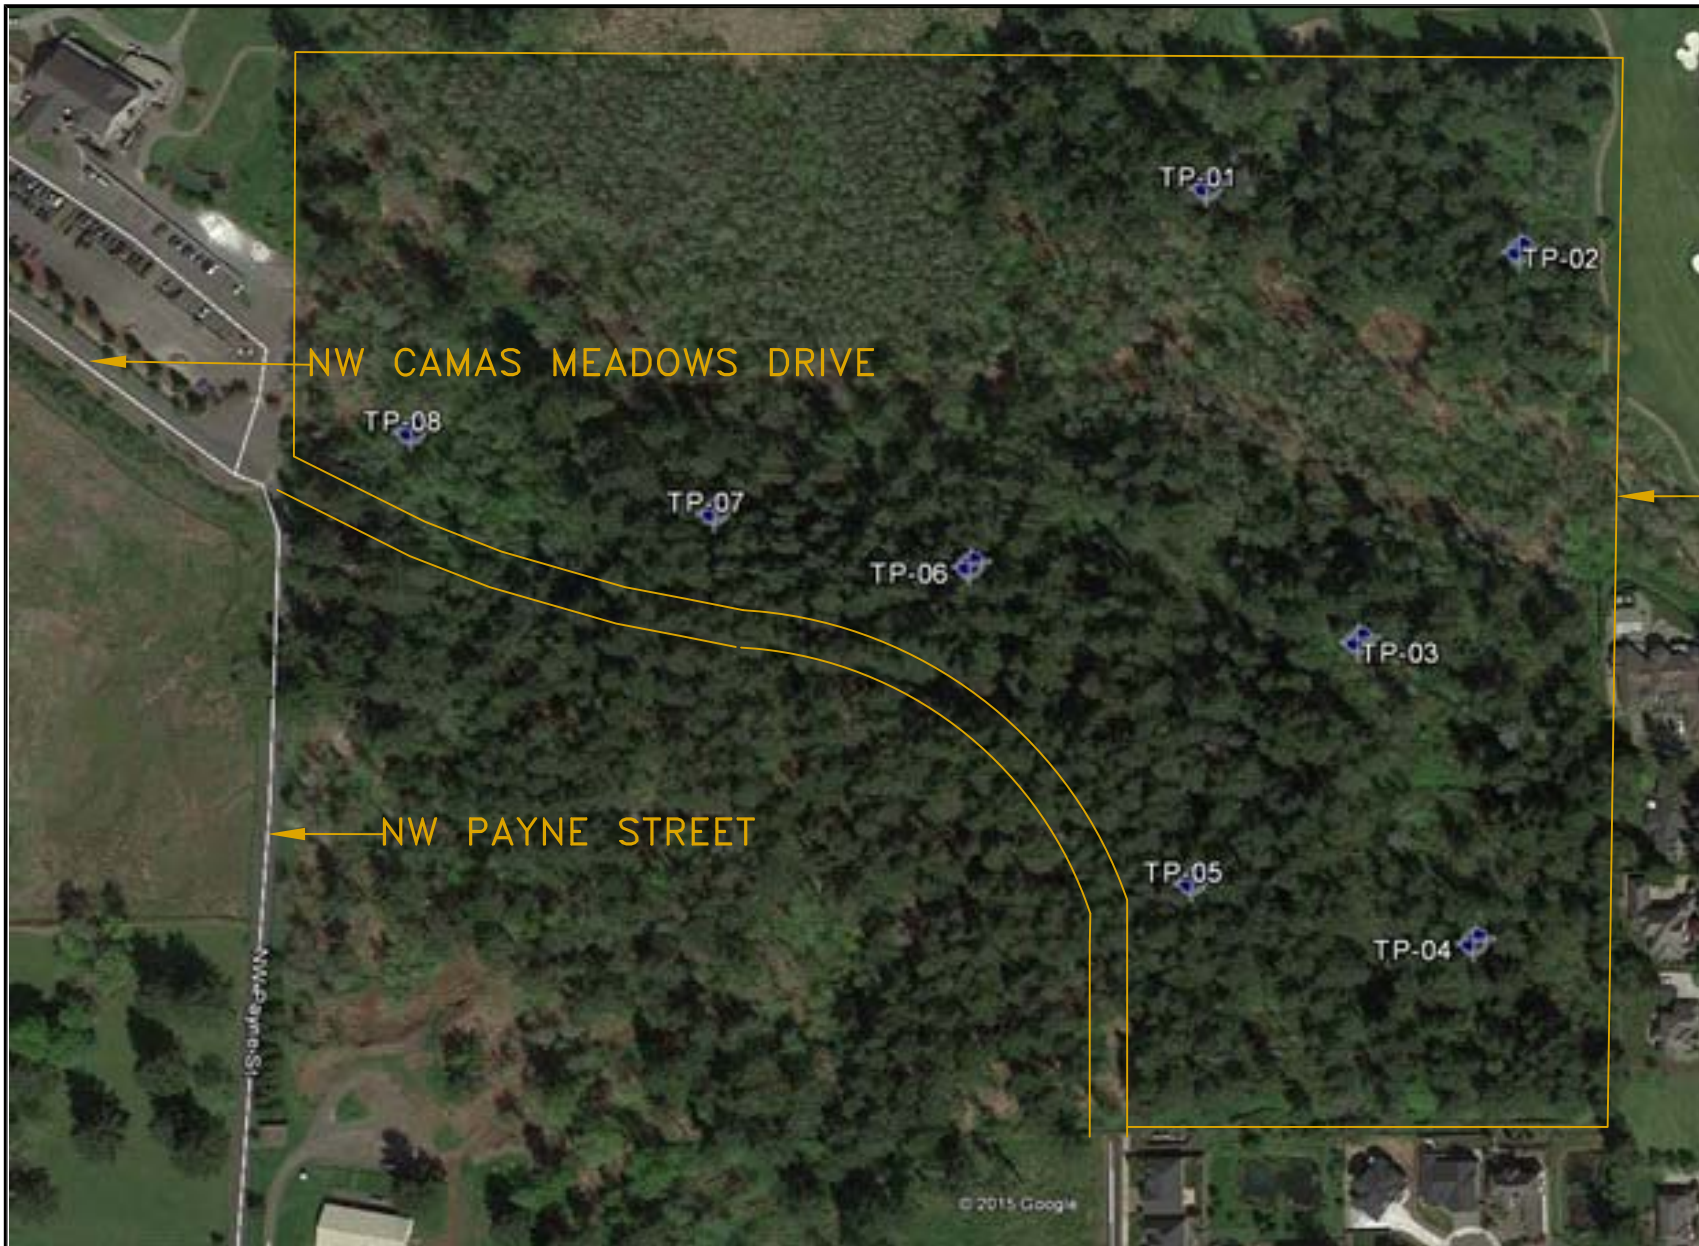
APPROXIMATE
SUBJECT
SITE
BOUNDARY

As indicated on Figures 1 and 2, the subject site is located northeast of the intersection of NW Payne Street and NW Camas Meadows Drive in Camas, Washington. The site is comprised of two tax parcels numbered 986031650 and 175948000 totaling approximately 36.4 acres. The regulatory jurisdictional agency is the City of Camas, Washington. The approximate latitude and longitude are N 45° 37' 40" and W 122° 26' 54", and the legal description is a portion of the SW and SE ¼ of Section 28, T2N, R3E, Willamette Meridian.

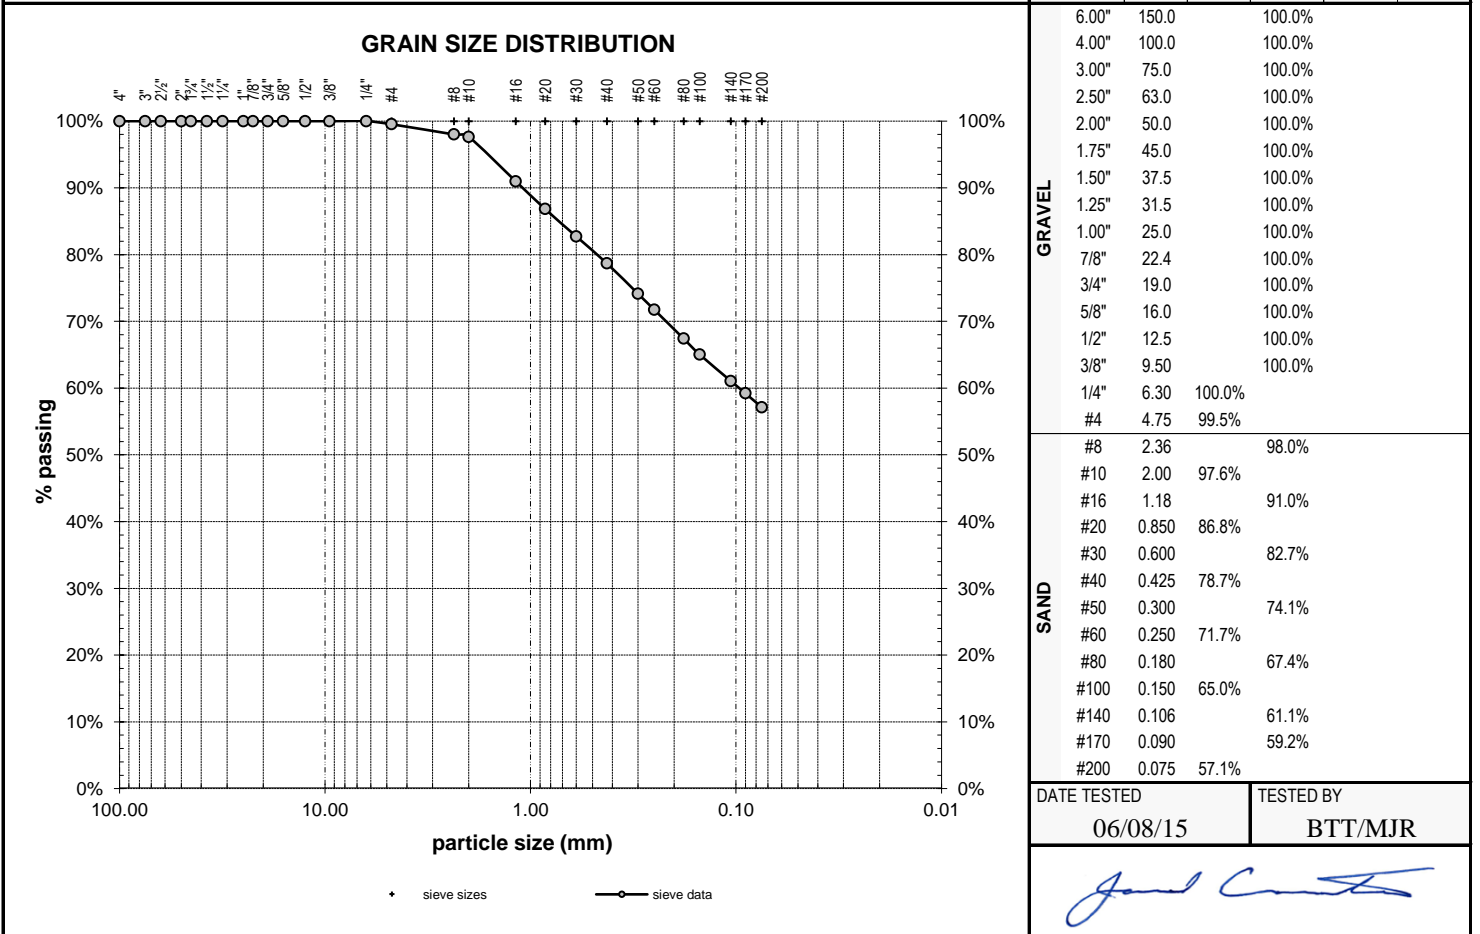
LABORATORY TEST DATA	
LABORATORY EQUIPMENT Rainhart "Mary Ann" Sifter 637	TEST PROCEDURE ASTM D6913, D422

ADDITIONAL DATA initial dry mass (g) = 158.3 as-received moisture content = 36.4% liquid limit = 44 plastic limit = 28 plasticity index = 16 fineness modulus = n/a coefficient of curvature, C_c = n/a coefficient of uniformity, C_u = n/a effective size, $D_{(10)}$ = n/a $D_{(30)}$ = n/a $D_{(60)}$ = 0.097 mm	SIEVE DATA % gravel = 0.5% % sand = 42.4% % silt and clay = 57.1%
--	---

Analytical laboratory testing conducted upon representative soil samples obtained from test pits TP-3 (sandy SILT) and TP-6 (sandy FAT CLAY) indicate approximately 57 to 63 percent by weight passing the No. 200 sieve and in situ moisture content ranging from 32

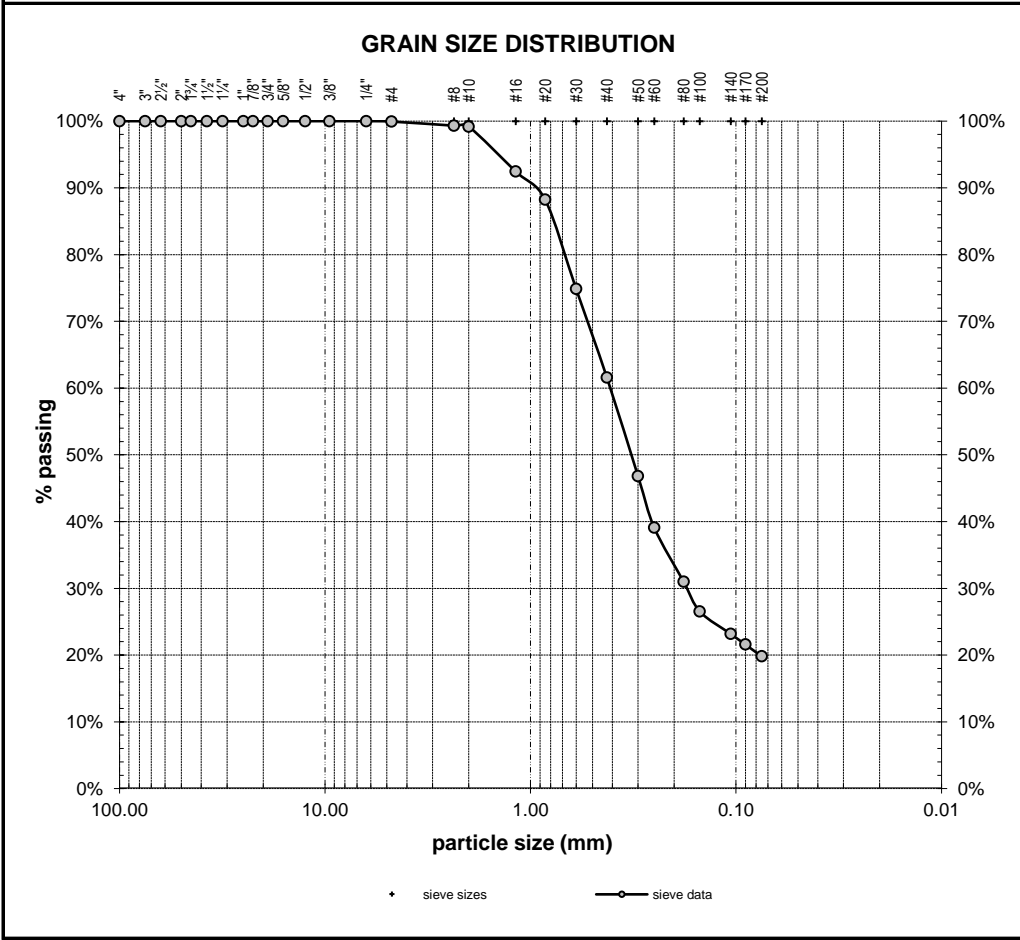
LABORATORY TEST DATA					
LABORATORY EQUIPMENT Rainhart "Mary Ann" Sifter 637				TEST PROCEDURE ASTM D6913, D422

ADDITIONAL DATA						SIEVE DATA					
initial dry mass (g) = 151.9 as-received moisture content = 42.6% liquid limit = 43 plastic limit = 25 plasticity index = 18 fineness modulus = n/a			coefficient of curvature, C_c = n/a coefficient of uniformity, C_u = n/a effective size, $D_{(10)}$ = n/a $D_{(30)}$ = 0.173 mm $D_{(60)}$ = 0.410 mm			% gravel = 0.1% % sand = 80.1% % silt and clay = 19.8%					
		PERCENT PASSING				SIEVE		SPECS			
		SIEVE SIZE				act.		interp.		max min	
		US mm

GRAVEL	6.00"	150.0		100.0%		
	4.00"	100.0		100.0%		
	3.00"	75.0		100.0%		
	2.50"	63.0		100.0%		
	2.00"	50.0		100.0%		
	1.75"	45.0		100.0%		
	1.50"	37.5		100.0%		
	1.25"	31.5		100.0%		
	1.00"	25.0		100.0%		
	7/8"	22.4		100.0%		
SAND	3/4"	19.0		100.0%		
	5/8"	16.0		100.0%		
	1/2"	12.5		100.0%		
	3/8"	9.50		100.0%		
	1/4"	6.30	100.0%			
	#4	4.75	99.9%			
	#8	2.36		99.3%		
	#10	2.00	99.2%			
	#16	1.18		92.4%		
	#20	0.850	88.3%			
#30	0.600		74.8%			
#40	0.425	61.6%				
#50	0.300		46.8%			
#60	0.250	39.1%				
#80	0.180		31.0%			
#100	0.150	26.5%				
#140	0.106		23.2%			
#170	0.090		21.6%			
#200	0.075	19.8%

Analytical laboratory testing conducted upon representative soil samples obtained from test pit TP-8 indicate approximately 8 to 20 percent by weight passing the No. 200 sieve and in situ moisture content ranging from 33 to 43 percent. Atterberg test results indicated a liquid limit ranging from 43 to 46 percent and a plasticity index of 18 percent. Soil Type 2 is classified as SC, clayey SAND and GP-GM, poorly-graded GRAVEL with silt and sand according to USCS specifications and A-2-7(0) according to AASHTO specifications.

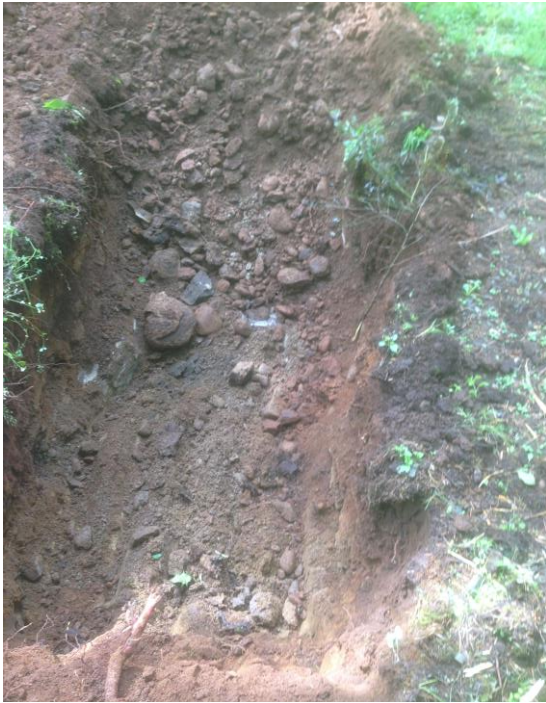
Shallow conglomerate bedrock in Test Pit TP-1

Weathered and competent conglomerate bedrock was encountered in all test pits at various depths. The conglomerate bedrock encountered generally resembled the descriptions of the unnamed Pleistocene to Pliocene, semi-consolidated, pebble to cobble conglomerate (QTc) and the Hyaoclastic sandstone member of the Troutdale formation (Ttff). The bedrock consisted of angular to sub-rounded clasts of various sizes cemented in a matrix of sand, silt, and clay. The bedrock was very dense and excavator refusal was noted at various depths as indicated in Table 1 in Section 5.7, *Excavation*.

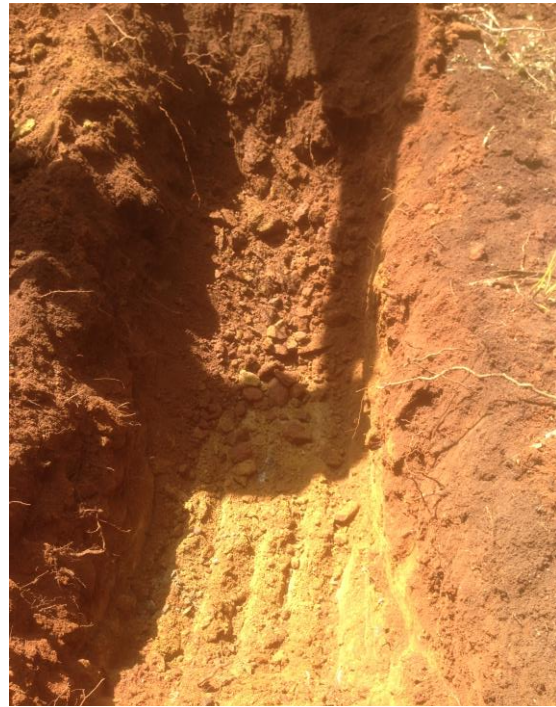
Shallow hyaoclastic sandstone bedrock in Test Pit TP-3

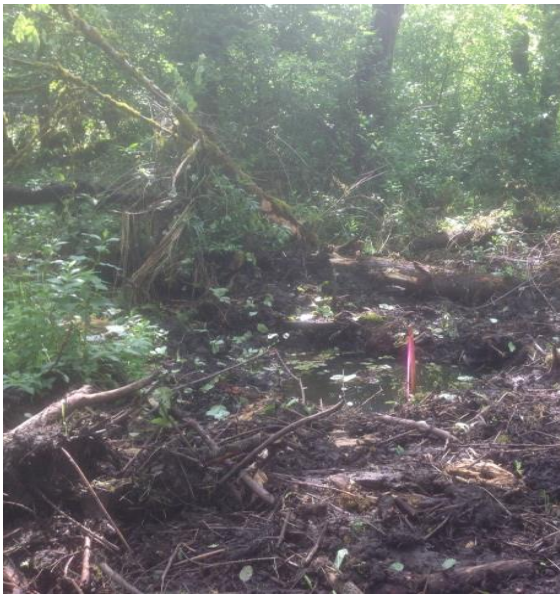
Shallow groundwater near Test Pit TP-1

Groundwater was encountered in test pits TP-1 and TP-8 at depths of 2.5 feet and 15 feet below ground surface, respectively. Standing water was observed at the ground surface elevation in the wetland which occupies the central north portion of the site. According to *Clark County Maps Online*, the static aquifer elevation in the vicinity of the subject site ranges from 190 to 210 feet amsl. These elevations correspond to an approximate depth to groundwater between 0 and 20 feet below ground surface.

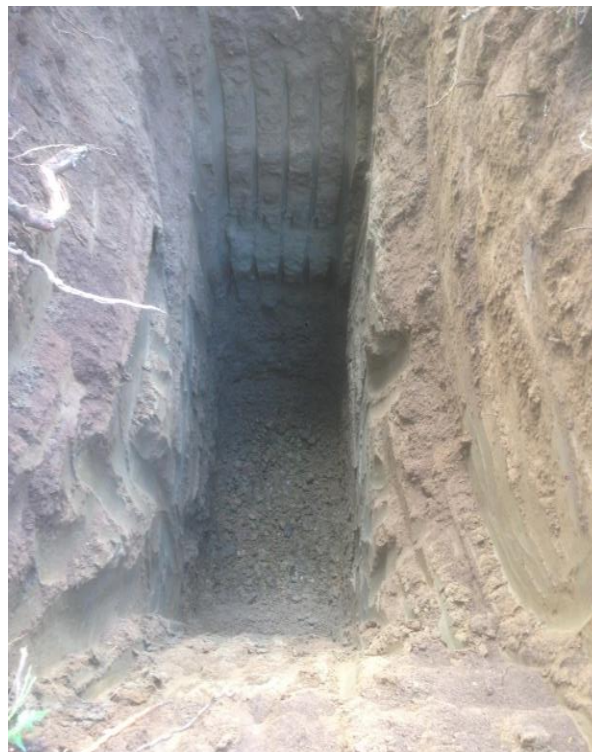
Deeper conglomerate bedrock encountered in Test Pit TP-8
