**Geotechnical Critical Areas Report**

**Green Mountain North**

**Camas, Washington**

**September 28, 2017**

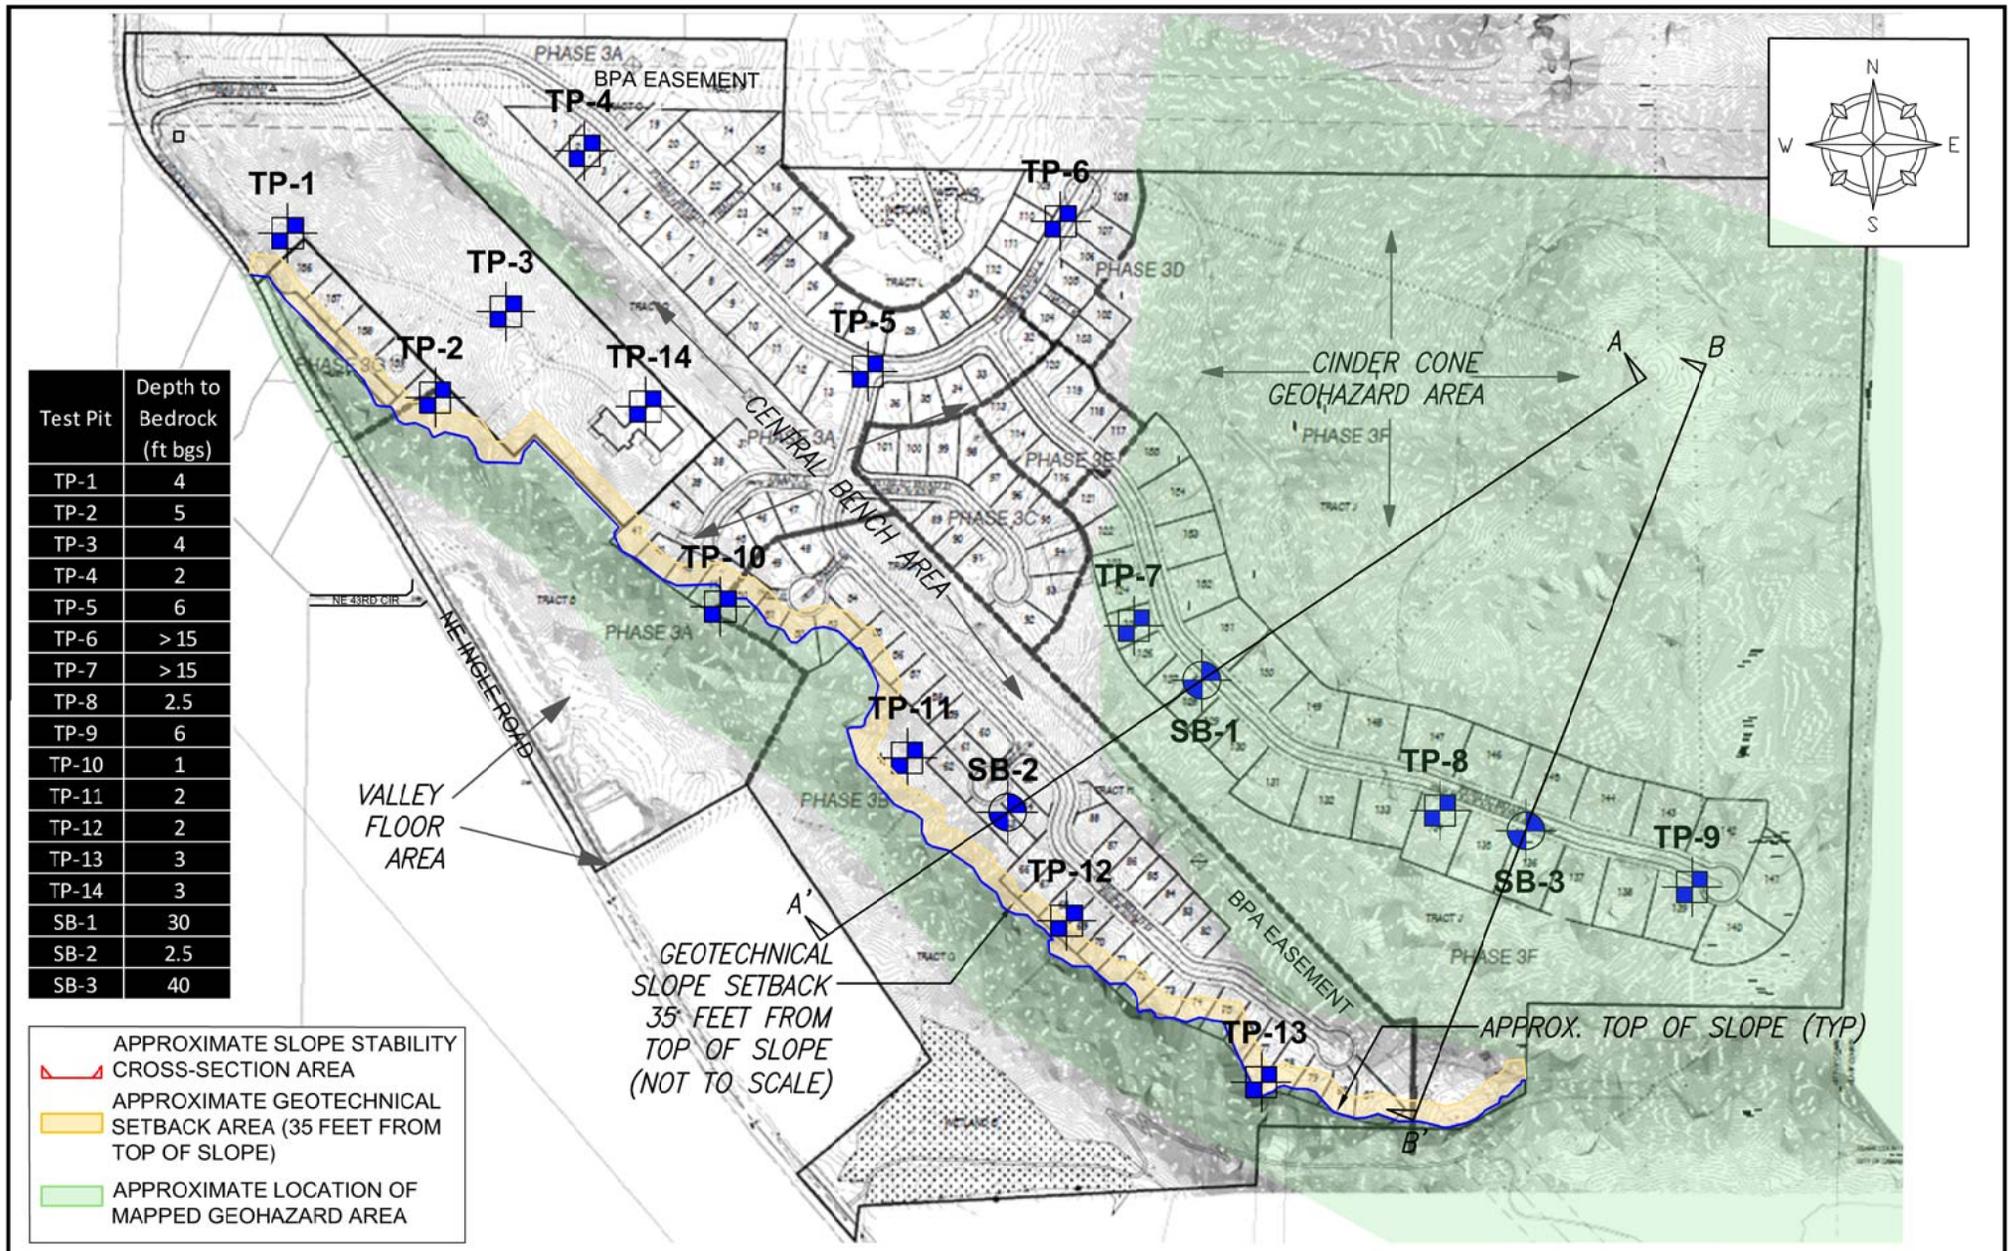
FIGURE 2

EXPLORATION LOCATION MAP
GREEN MOUNTAIN NORTH CAMAS, WASHINGTON

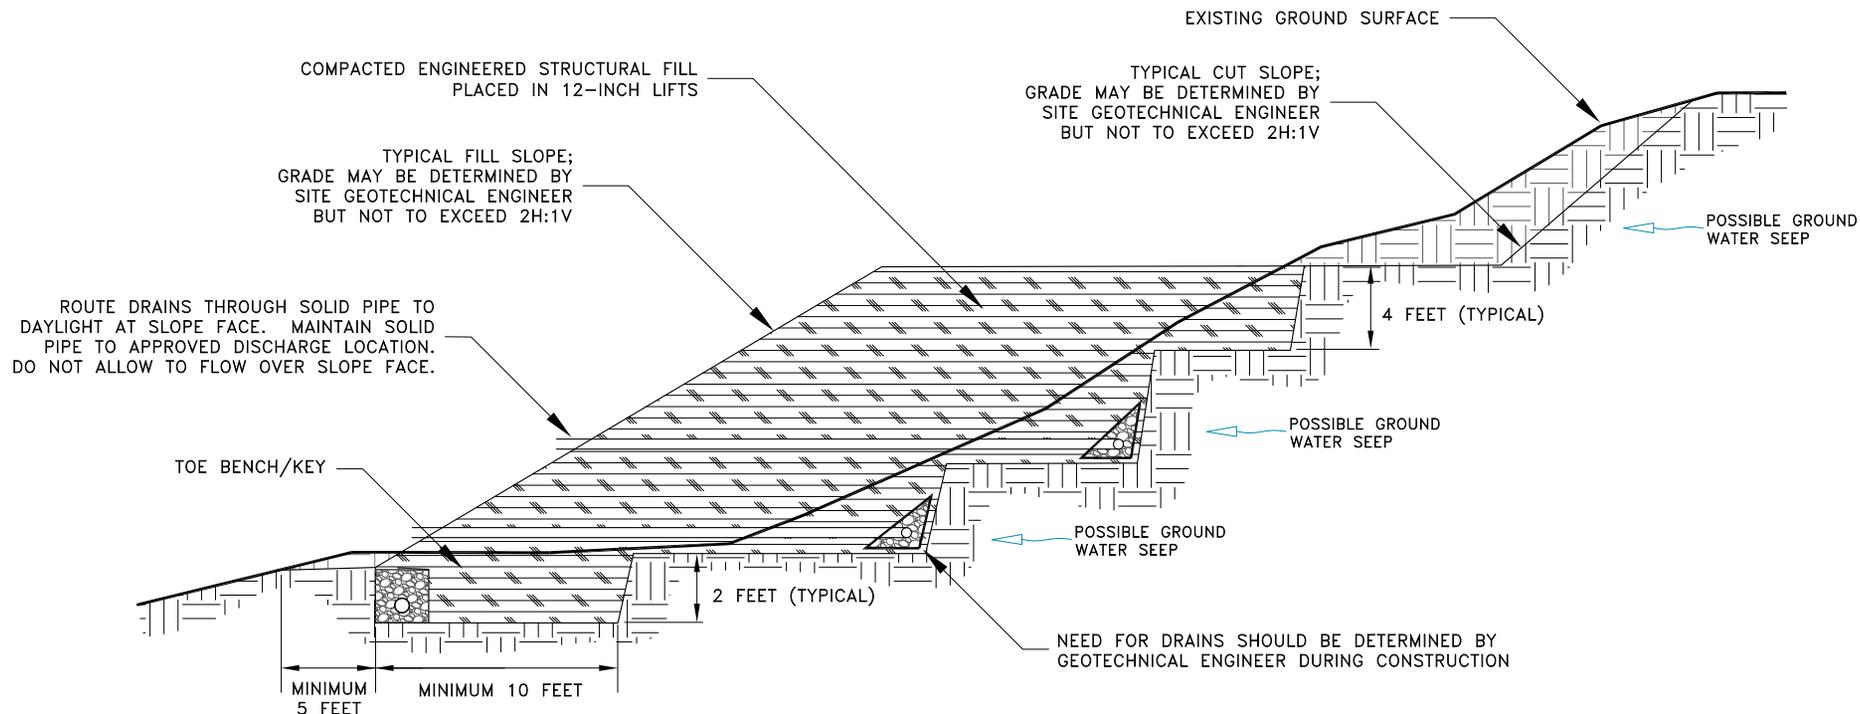
FIGURE  
3

# TYPICAL CUT AND FILL SLOPE CROSS-SECTION

- NOTES:
1. DRAWING IS NOT TO SCALE.
  2. SLOPES AND PROFILES SHOWN ARE APPROXIMATE.
  3. DRAWING REPRESENTS TYPICAL FILL AND CUT SLOPE SECTION, AND MAY NOT BE SITE-SPECIFIC.

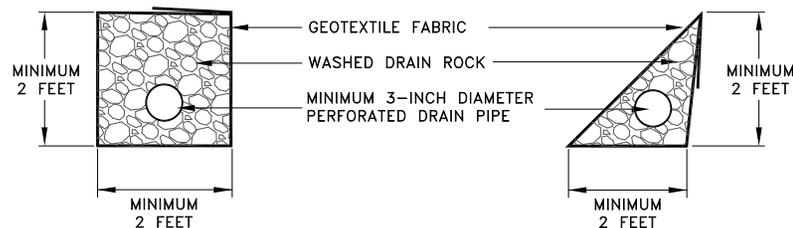
## DRAIN SPECIFICATIONS

GEOTEXTILE FABRIC SHALL CONSIST OF MIRAFI 140N OR APPROVED EQUIVALENT WITH AOS BETWEEN No. 70 AND No. 100 SIEVE.

WASHED DRAIN ROCK SHALL BE OPEN-GRADED ANGULAR DRAIN ROCK WITH LESS THAN 2 PERCENT PASSING THE No. 200 SIEVE AND A MAXIMUM PARTICLE SIZE OF 3 INCHES.

## TYPICAL DRAIN SECTION DETAIL

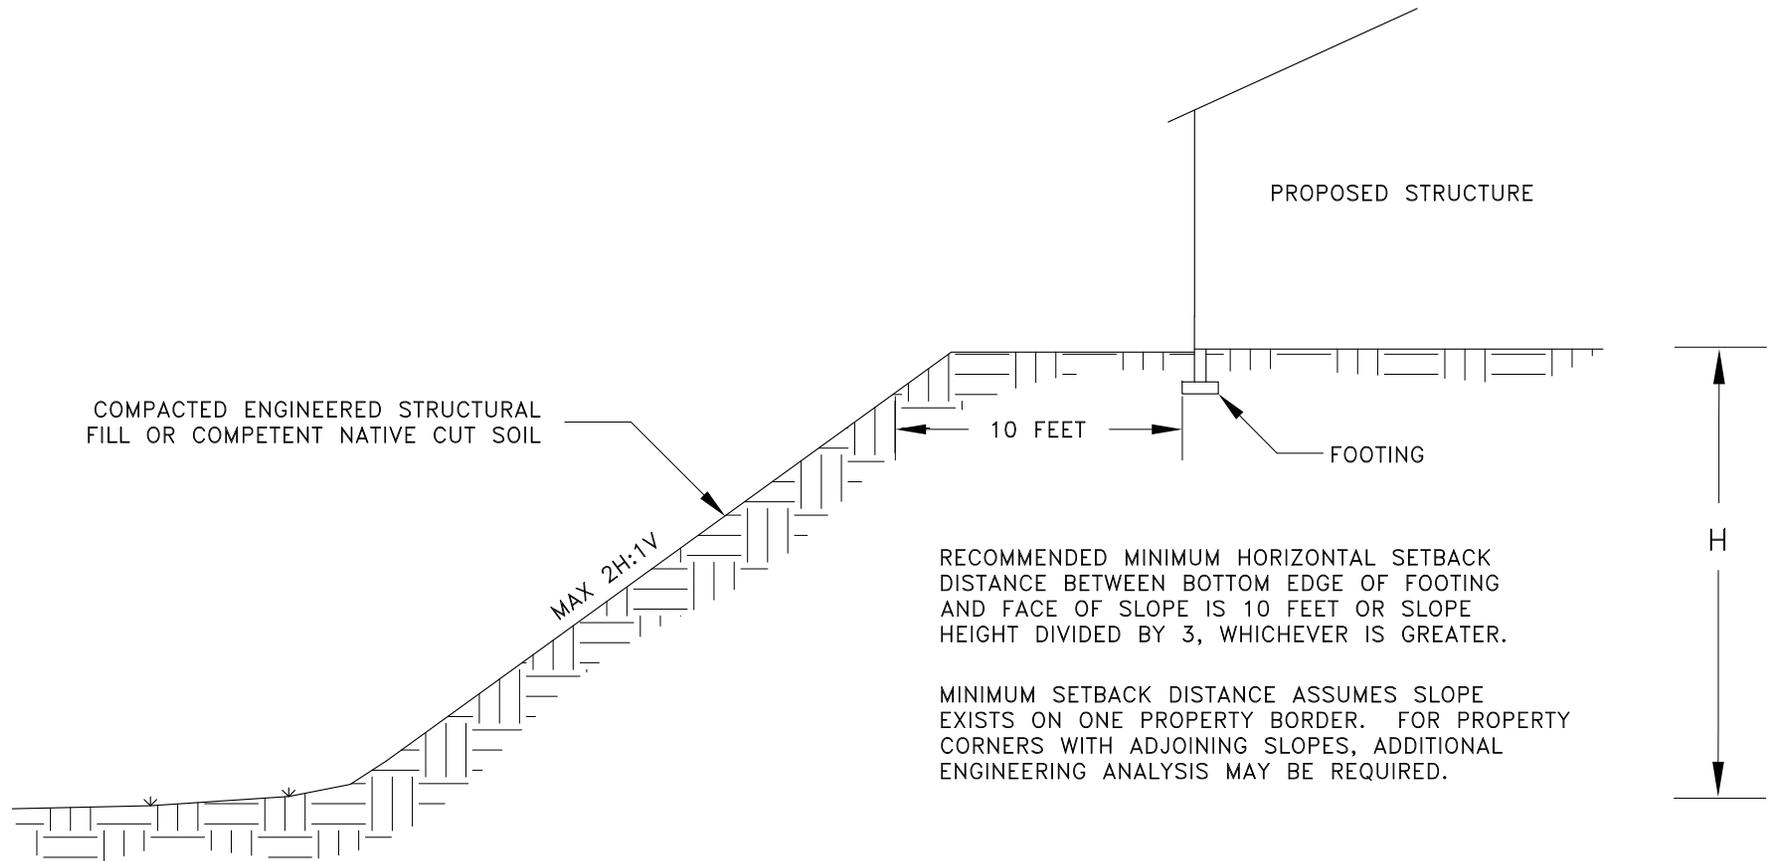
FIGURE  
4

# MINIMUM FOUNDATION SLOPE SETBACK DETAIL

- NOTES:
1. DRAWING IS NOT TO SCALE.
  2. SLOPES AND PROFILES SHOWN ARE APPROXIMATE.
  3. DRAWING REPRESENTS TYPICAL FOUNDATION SETBACK DETAIL, AND MAY NOT BE SITE-SPECIFIC.

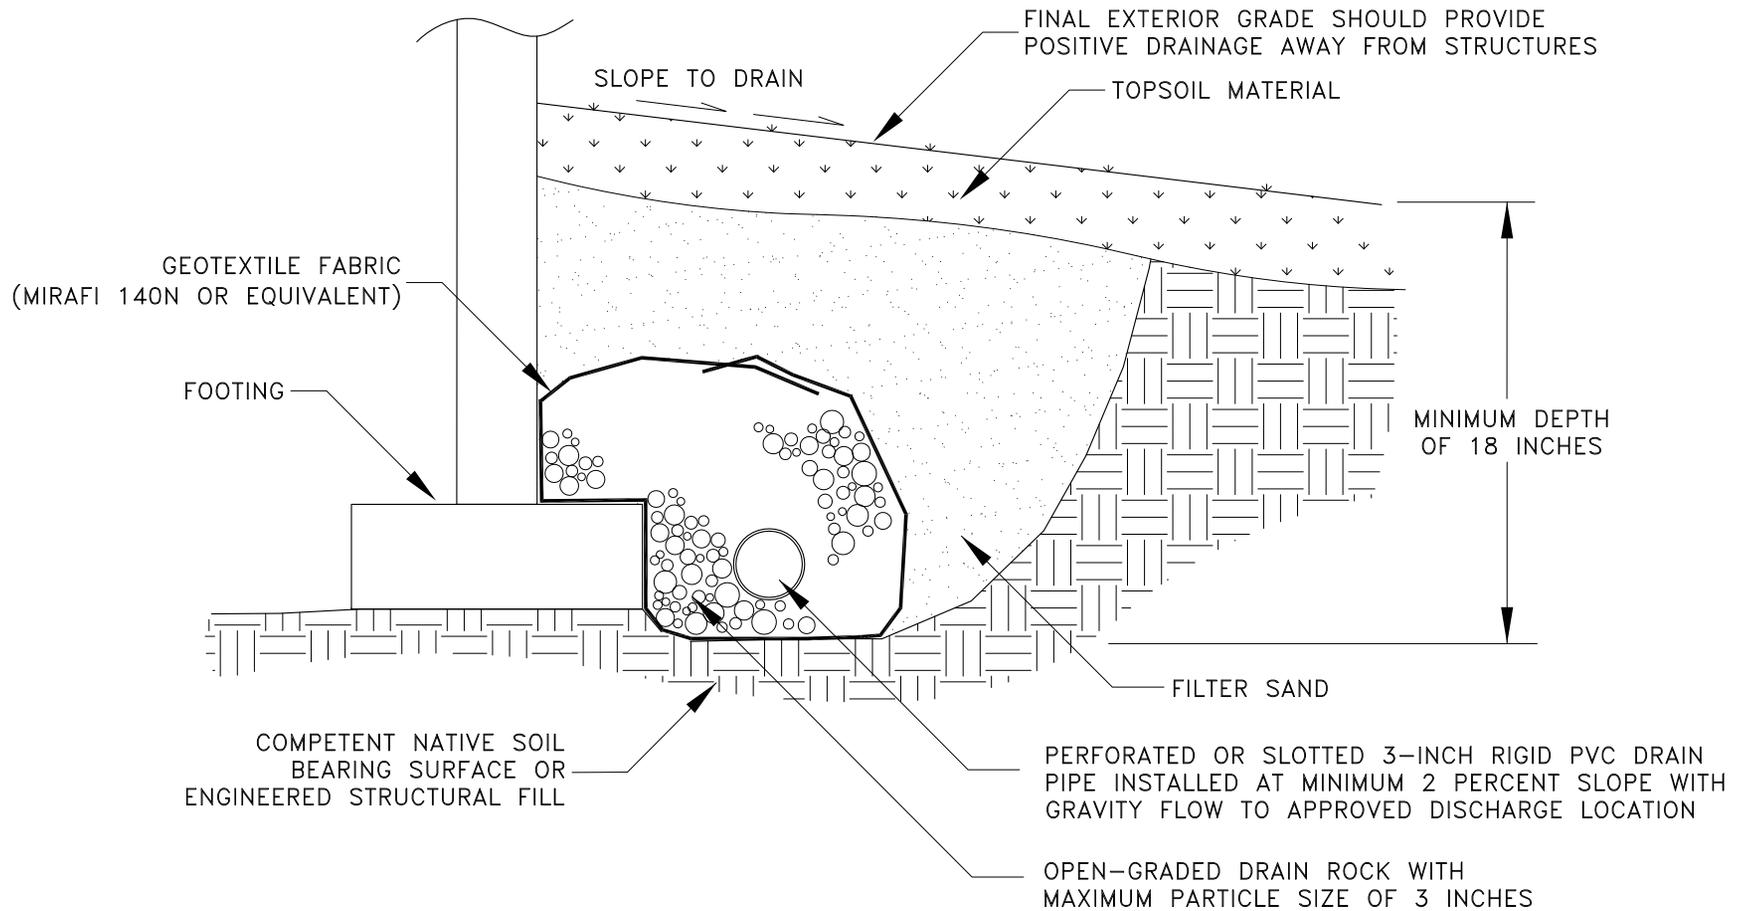
FIGURE  
5

## TYPICAL PERIMETER FOOTING DRAIN DETAIL

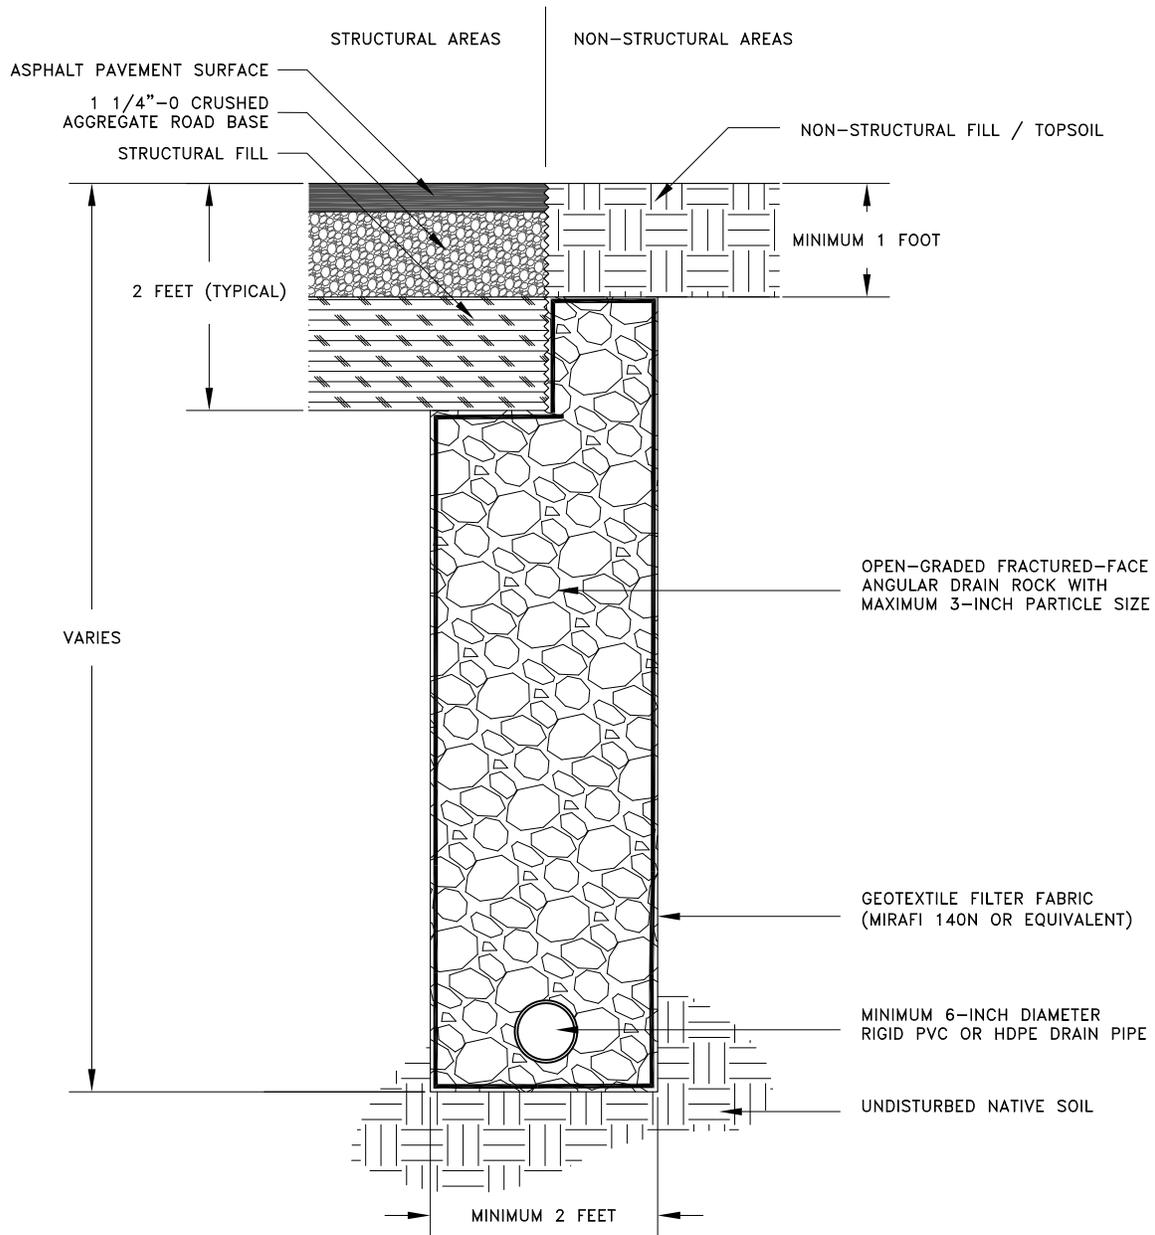
# TYPICAL PERFORATED DRAIN PIPE TRENCH DETAIL

NOTE: LOCATION, INVERT ELEVATION, DEPTH OF TRENCH, AND EXTENT OF PERFORATED PIPE REQUIRED MAY BE MODIFIED BY THE GEOTECHNICAL ENGINEER DURING CONSTRUCTION BASED UPON FIELD OBSERVATION AND SITE-SPECIFIC SOIL CONDITIONS.

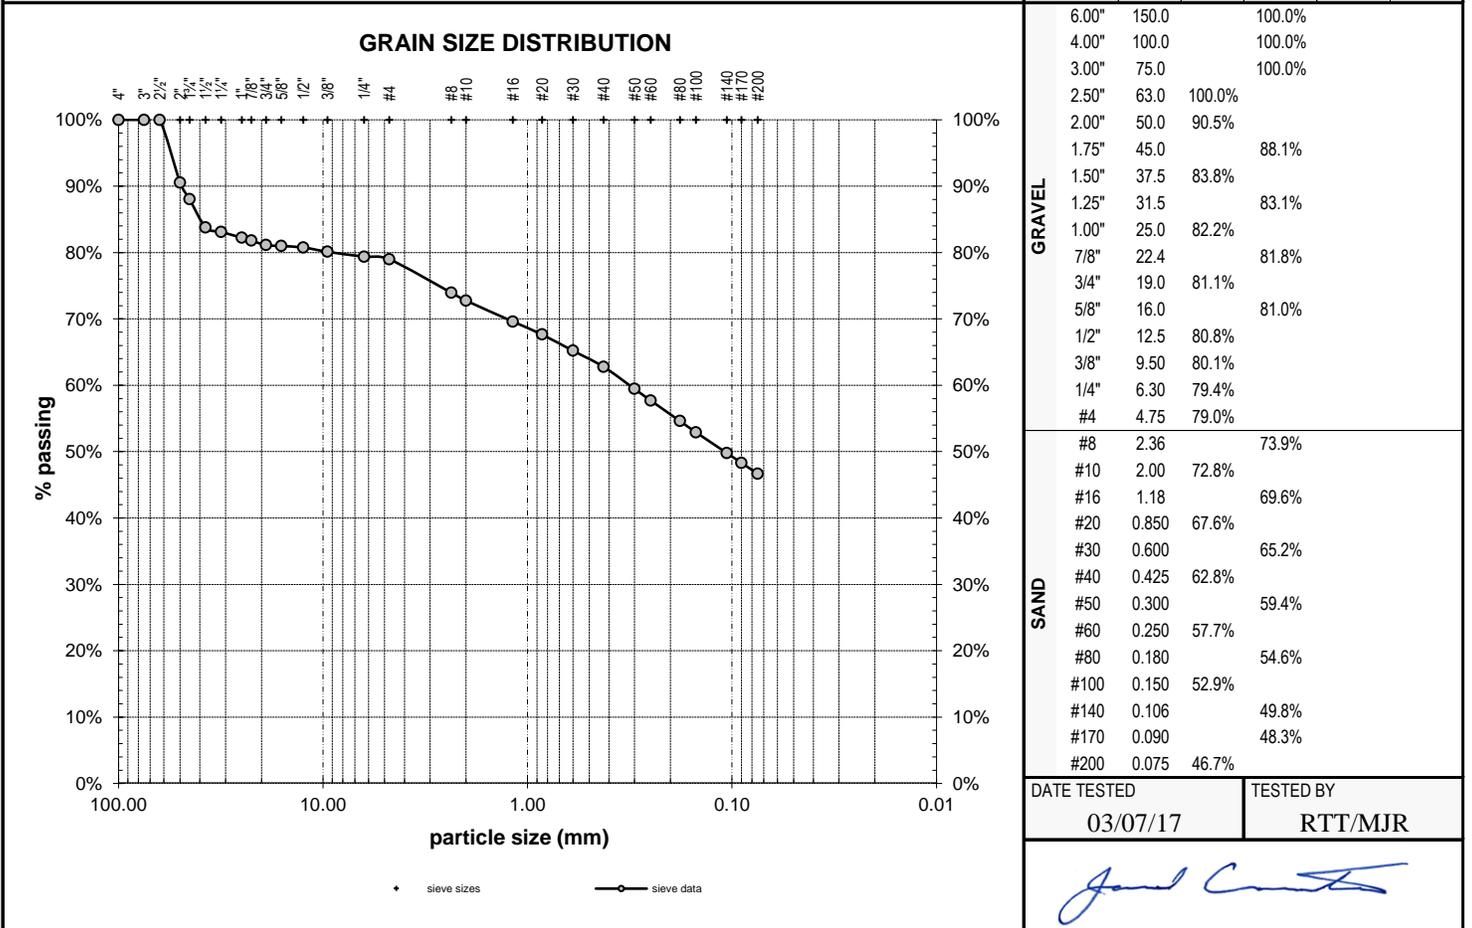
<b>LABORATORY TEST DATA</b>	
LABORATORY EQUIPMENT Rainhart "Mary Ann" Sifter 637	TEST PROCEDURE ASTM D6913, D422

<b>ADDITIONAL DATA</b> initial dry mass (g) = 1510.3 as-received moisture content = 32.6% liquid limit = 37 plastic limit = 26 plasticity index = 11 fineness modulus = n/a coefficient of curvature, $C_c$ = n/a coefficient of uniformity, $C_u$ = n/a effective size, $D_{(10)}$ = n/a $D_{(30)}$ = n/a $D_{(60)}$ = 0.318 mm	<b>SIEVE DATA</b> % gravel = 21.0% % sand = 32.3% % silt and clay = 46.7%
---	--

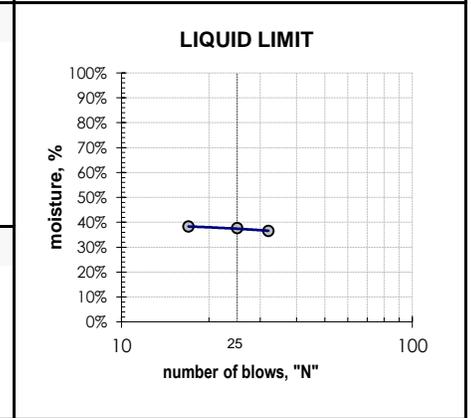
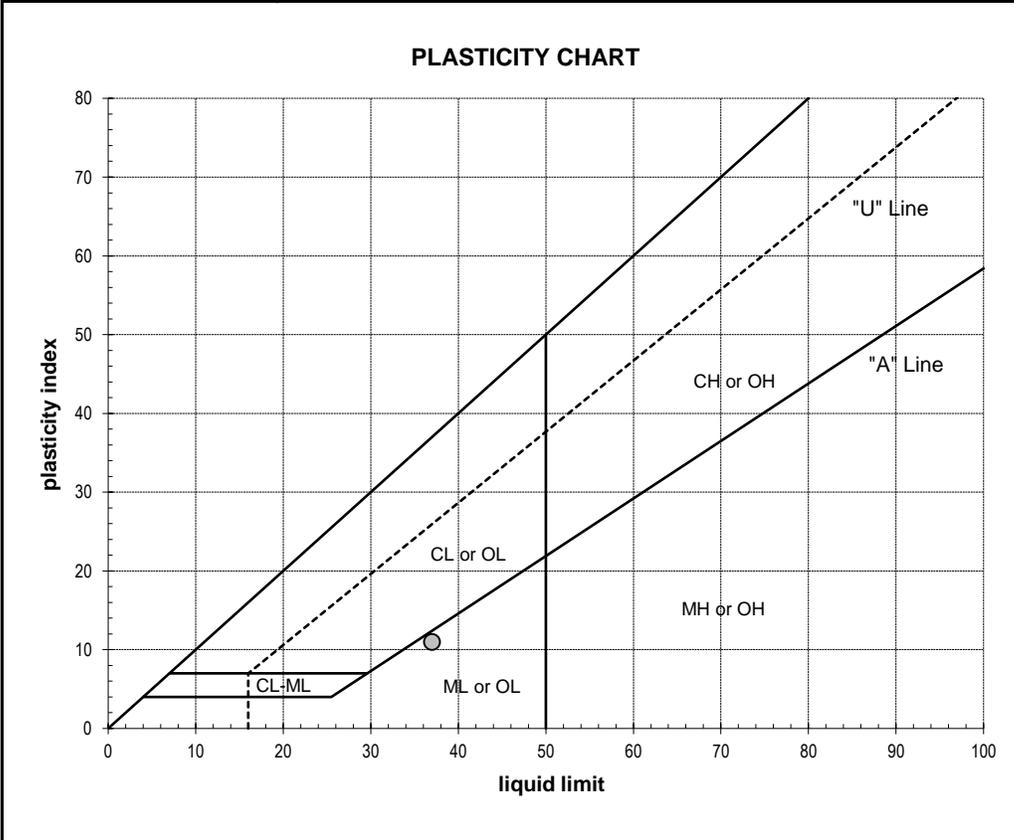
## ATTERBERG LIMITS REPORT

<b>1</b>	<b>2</b>	<b>3</b>	<b>4</b>	wet soil + pan weight, g =	37.84	41.76	39.75		dry soil + pan weight, g =	33.29	36.05	34.53		pan weight, g =	20.81	20.88	20.87		N (blows) =	32	25	17		moisture, % =	36.5 %	37.6 %	38.2 %	
	<b>1</b>	<b>2</b>	<b>3</b>	<b>4</b>																											
wet soil + pan weight, g =	37.84	41.76	39.75																												
dry soil + pan weight, g =	33.29	36.05	34.53																												
pan weight, g =	20.81	20.88	20.87																												
N (blows) =	32	25	17																												
moisture, % =	36.5 %	37.6 %	38.2 %

<b>ADDITIONAL DATA</b>	
% gravel =	21.0%
% sand =	32.3%
% silt and clay =	46.7%
% silt =	n/a
% clay =	n/a
moisture content =	32.6%

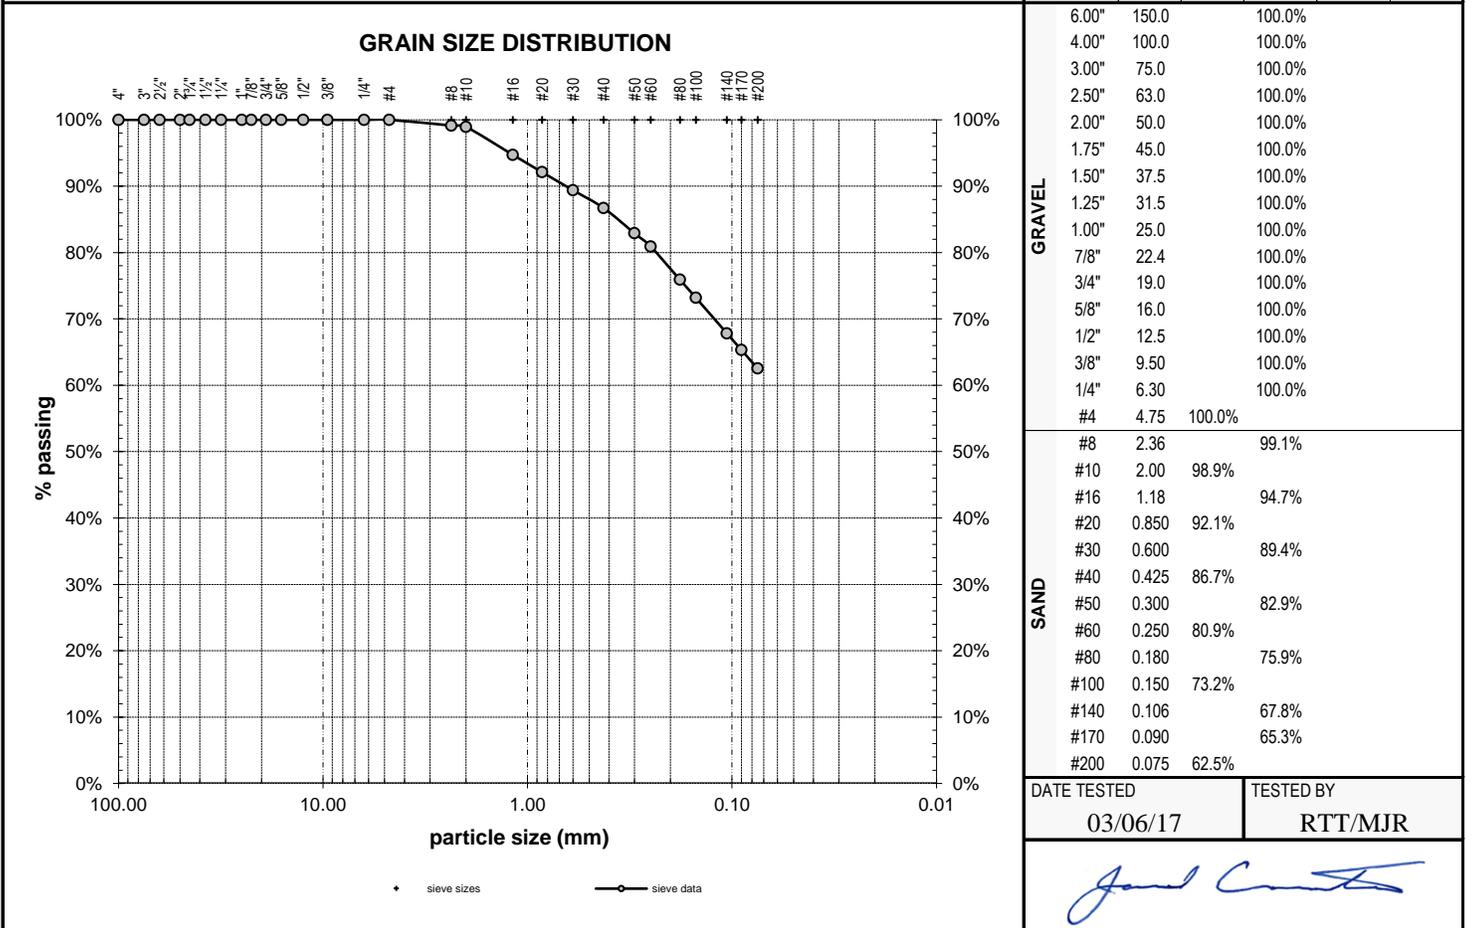
<b>LABORATORY TEST DATA</b>	
LABORATORY EQUIPMENT Rainhart "Mary Ann" Sifter 637	TEST PROCEDURE ASTM D6913, D422

<b>ADDITIONAL DATA</b> initial dry mass (g) = 185.7 as-received moisture content = 29.2% liquid limit = 53 plastic limit = 24 plasticity index = 29 fineness modulus = n/a coefficient of curvature, $C_c$ = n/a coefficient of uniformity, $C_u$ = n/a effective size, $D_{(10)}$ = n/a $D_{(30)}$ = n/a $D_{(60)}$ = n/a	<b>SIEVE DATA</b> % gravel = 0.0% % sand = 37.5% % silt and clay = 62.5%
---	---

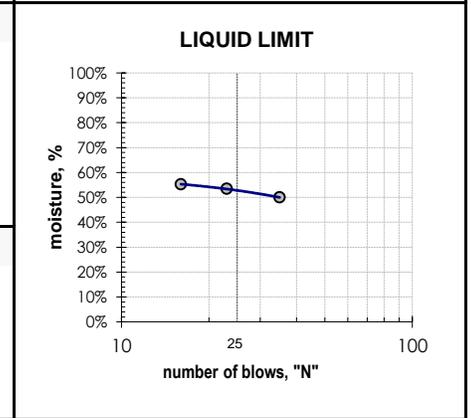
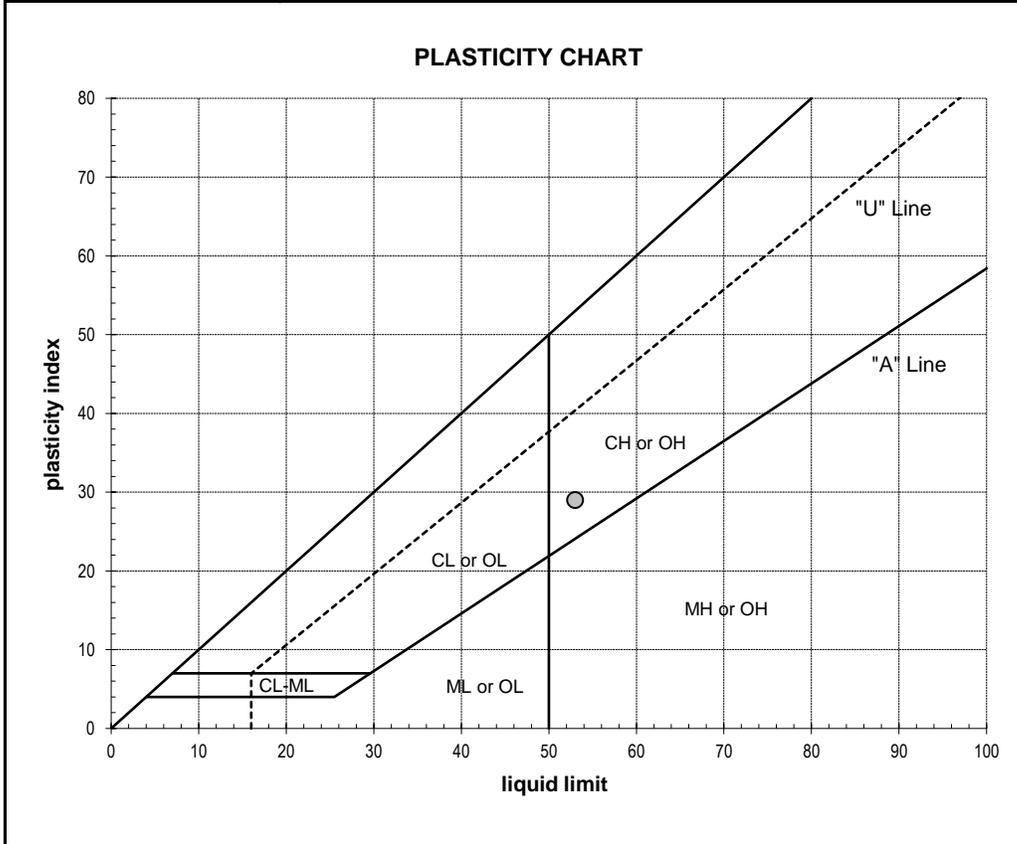
ATTERBERG LIMITS	LIQUID LIMIT DETERMINATION					
liquid limit = 53 plastic limit = 24 plasticity index = 29	<table style="width: 100%; border-collapse: collapse;"> <tr> <th></th> <th style="text-align: center;">①</th> <th style="text-align: center;">②</th> <th style="text-align: center;">③</th> <th style="text-align: center;">④</th> </tr> </table>		①	②	③	④
		①	②	③	④	
	wet soil + pan weight, g =	38.24	36.93	36.53		
	dry soil + pan weight, g =	32.45	31.29	30.89		
	pan weight, g =	20.86	20.73	20.69		
N (blows) =	35	23	16			
moisture, % =	50.0 %	53.4 %	55.3 %

SHRINKAGE	PLASTIC LIMIT DETERMINATION					
shrinkage limit = n/a shrinkage ratio = n/a	<table style="width: 100%; border-collapse: collapse;"> <tr> <th></th> <th style="text-align: center;">①</th> <th style="text-align: center;">②</th> <th style="text-align: center;">③</th> <th style="text-align: center;">④</th> </tr> </table>		①	②	③	④
		①	②	③	④	
	wet soil + pan weight, g =	28.16	28.02			
	dry soil + pan weight, g =	26.73	26.60			
	pan weight, g =	20.73	20.59			
moisture, % =	23.8 %	23.6 %

% gravel =	0.0%
% sand =	37.5%
% silt and clay =	62.5%
% silt =	n/a
% clay =	n/a
moisture content =	29.2%

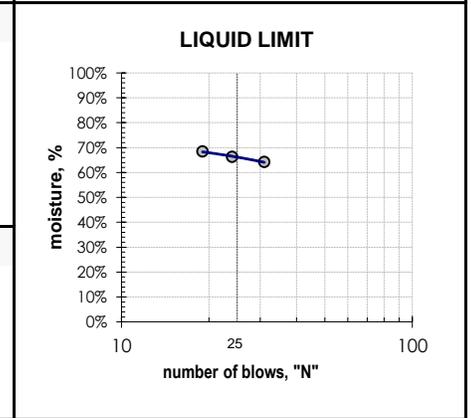
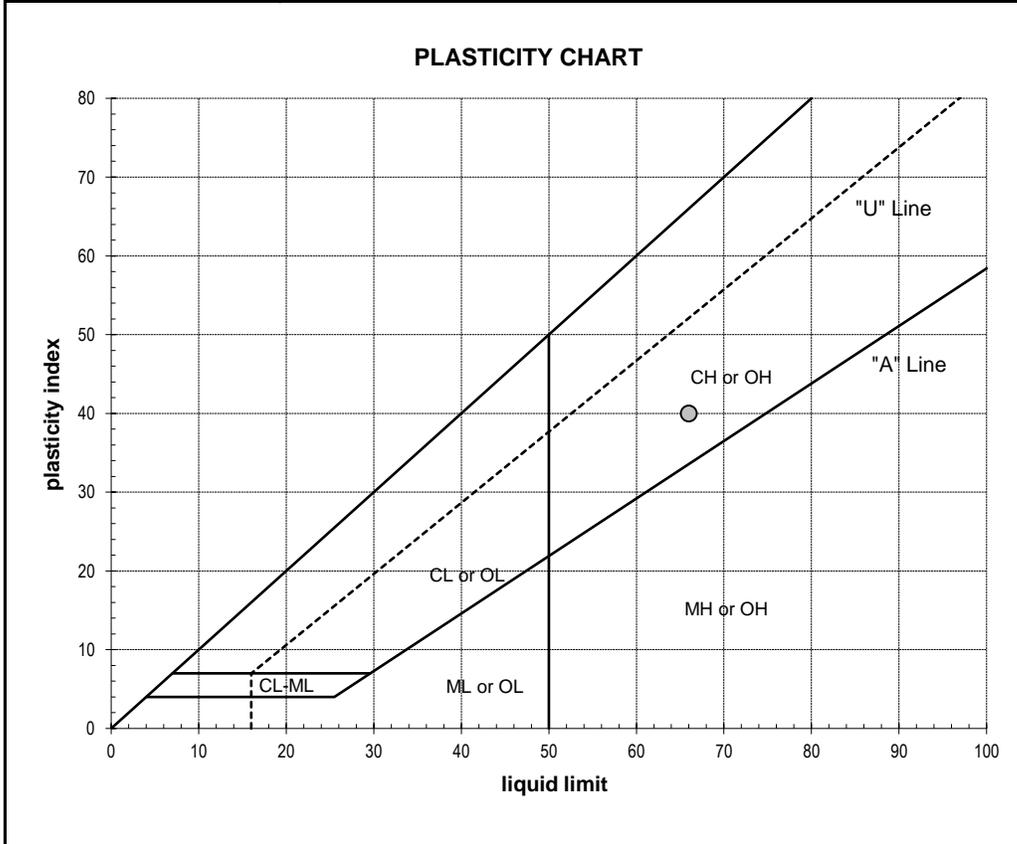
ATTERBERG LIMITS	LIQUID LIMIT DETERMINATION			
	1	2	3	4
liquid limit = 66	wet soil + pan weight, g = 32.70	32.53	34.74	
plastic limit = 26	dry soil + pan weight, g = 28.08	27.81	29.02	
plasticity index = 40	pan weight, g = 20.88	20.69	20.66	
	N (blows) = 31	24	19	
	moisture, % = 64.2 %	66.3 %	68.4 %

SHRINKAGE	PLASTIC LIMIT DETERMINATION			
	1	2	3	4
shrinkage limit = n/a	wet soil + pan weight, g = 28.01	27.91		
shrinkage ratio = n/a	dry soil + pan weight, g = 26.50	26.39		
	pan weight, g = 20.79	20.60		
	moisture, % = 26.4 %	26.3 %

% gravel =	0.0%
% sand =	19.6%
% silt and clay =	80.4%
% silt =	n/a
% clay =	n/a
moisture content =	41.4%

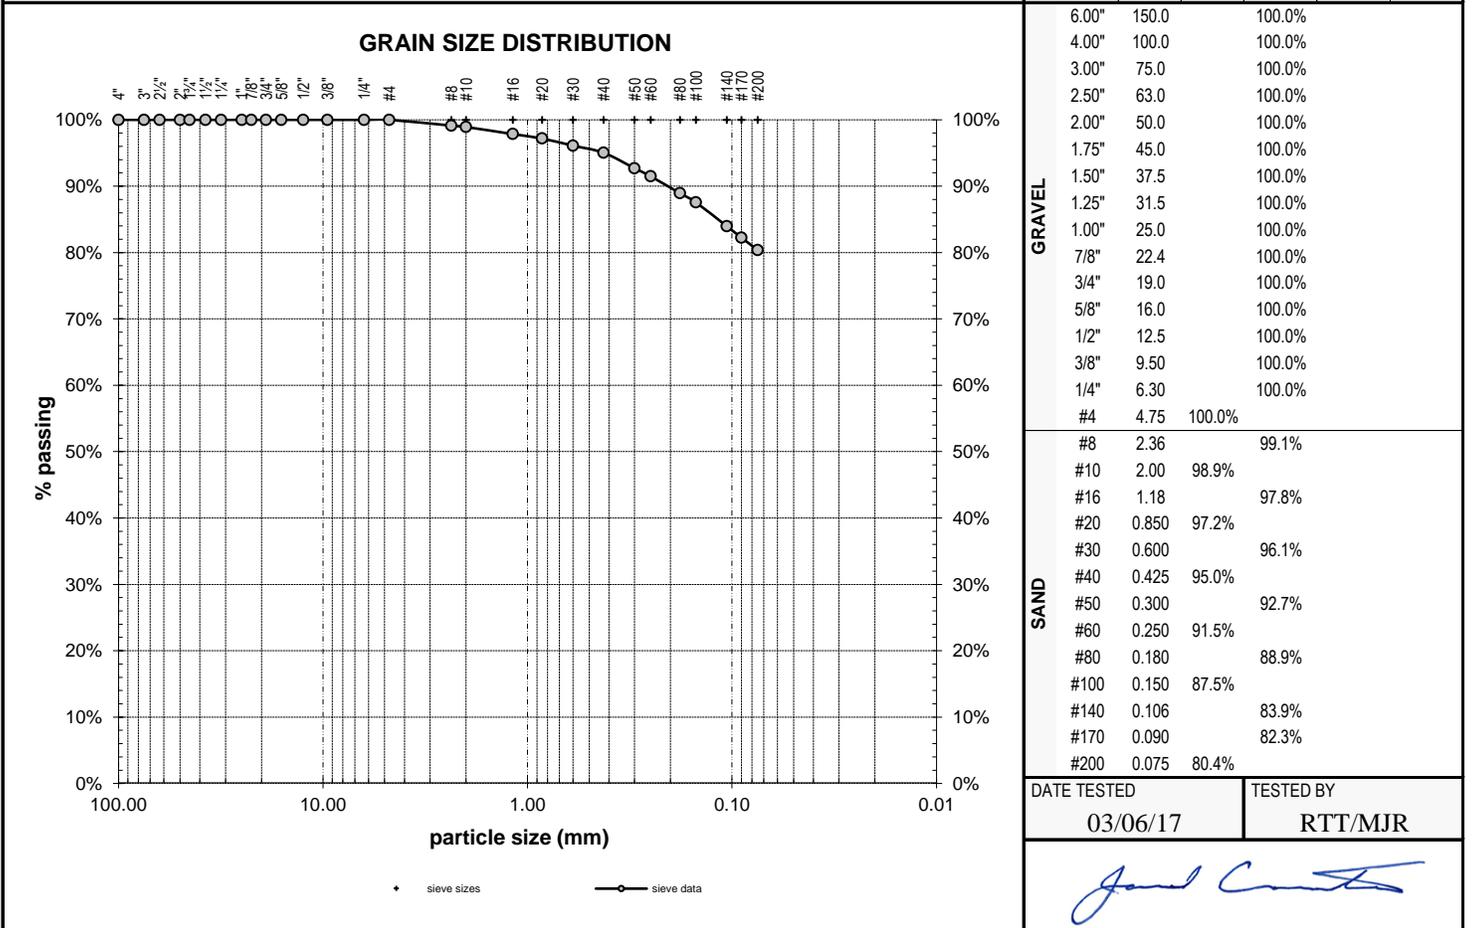
<b>LABORATORY TEST DATA</b>	
LABORATORY EQUIPMENT Rainhart "Mary Ann" Sifter 637	TEST PROCEDURE ASTM D6913, D422

<b>ADDITIONAL DATA</b> initial dry mass (g) = 139.7 as-received moisture content = 41.4% liquid limit = 66 plastic limit = 26 plasticity index = 40 fineness modulus = n/a  coefficient of curvature, $C_c$ = n/a coefficient of uniformity, $C_u$ = n/a effective size, $D_{(10)}$ = n/a $D_{(30)}$ = n/a $D_{(60)}$ = n/a	<b>SIEVE DATA</b> % gravel = 0.0% % sand = 19.6% % silt and clay = 80.4%
---	---

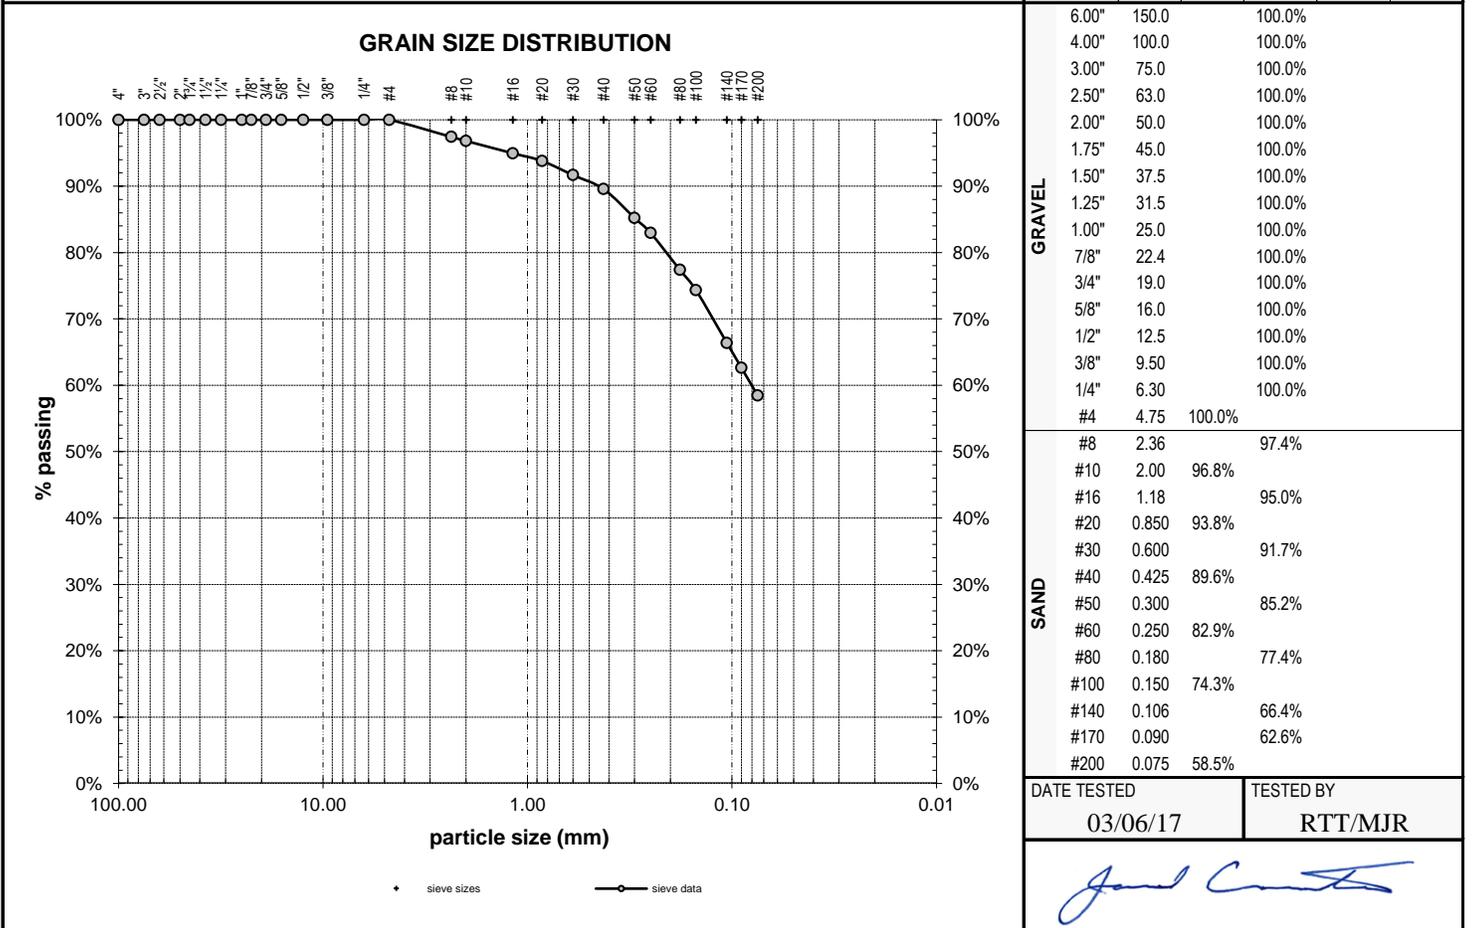
<b>LABORATORY TEST DATA</b>	
LABORATORY EQUIPMENT Rainhart "Mary Ann" Sifter 637	TEST PROCEDURE ASTM D6913, D422

<b>ADDITIONAL DATA</b> initial dry mass (g) = 179.2 as-received moisture content = 29.8% liquid limit = 34 plastic limit = 22 plasticity index = 12 fineness modulus = n/a  coefficient of curvature, $C_c$ = n/a coefficient of uniformity, $C_u$ = n/a effective size, $D_{(10)}$ = n/a $D_{(30)}$ = n/a $D_{(60)}$ = 0.080 mm	<b>SIEVE DATA</b> % gravel = 0.0% % sand = 41.5% % silt and clay = 58.5%
--	---

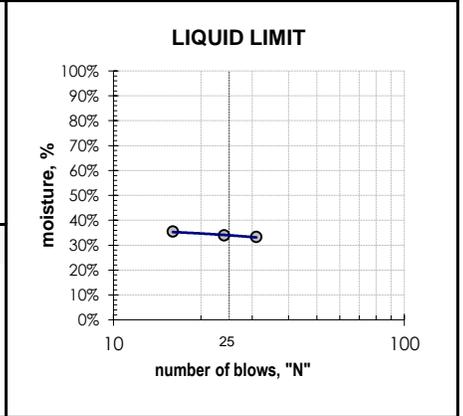
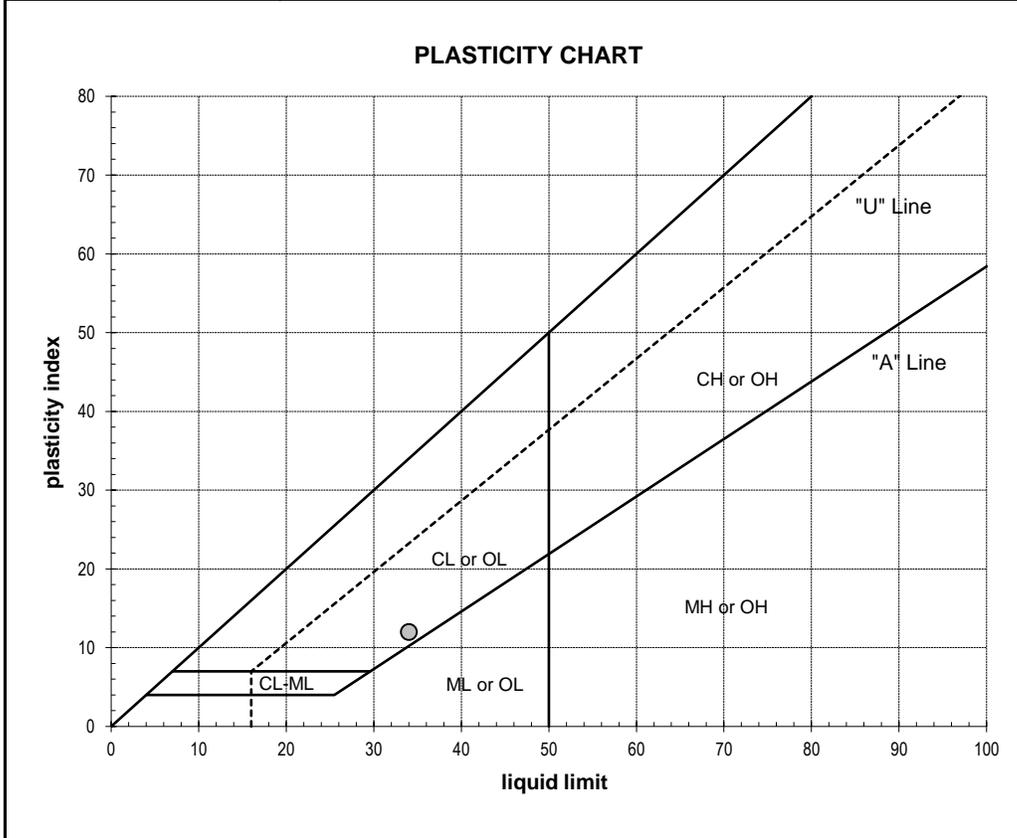
## ATTERBERG LIMITS REPORT

①	②	③	④	wet soil + pan weight, g =	28.28	28.89			dry soil + pan weight, g =	26.89	27.43			pan weight, g =	20.69	20.85			moisture, % =	22.4 %	22.2 %		
	①	②	③	④																						
wet soil + pan weight, g =	28.28	28.89																								
dry soil + pan weight, g =	26.89	27.43																								
pan weight, g =	20.69	20.85																								
moisture, % =	22.4 %	22.2 %

% gravel =	0.0%
% sand =	41.5%
% silt and clay =	58.5%
% silt =	n/a
% clay =	n/a
moisture content =	29.8%

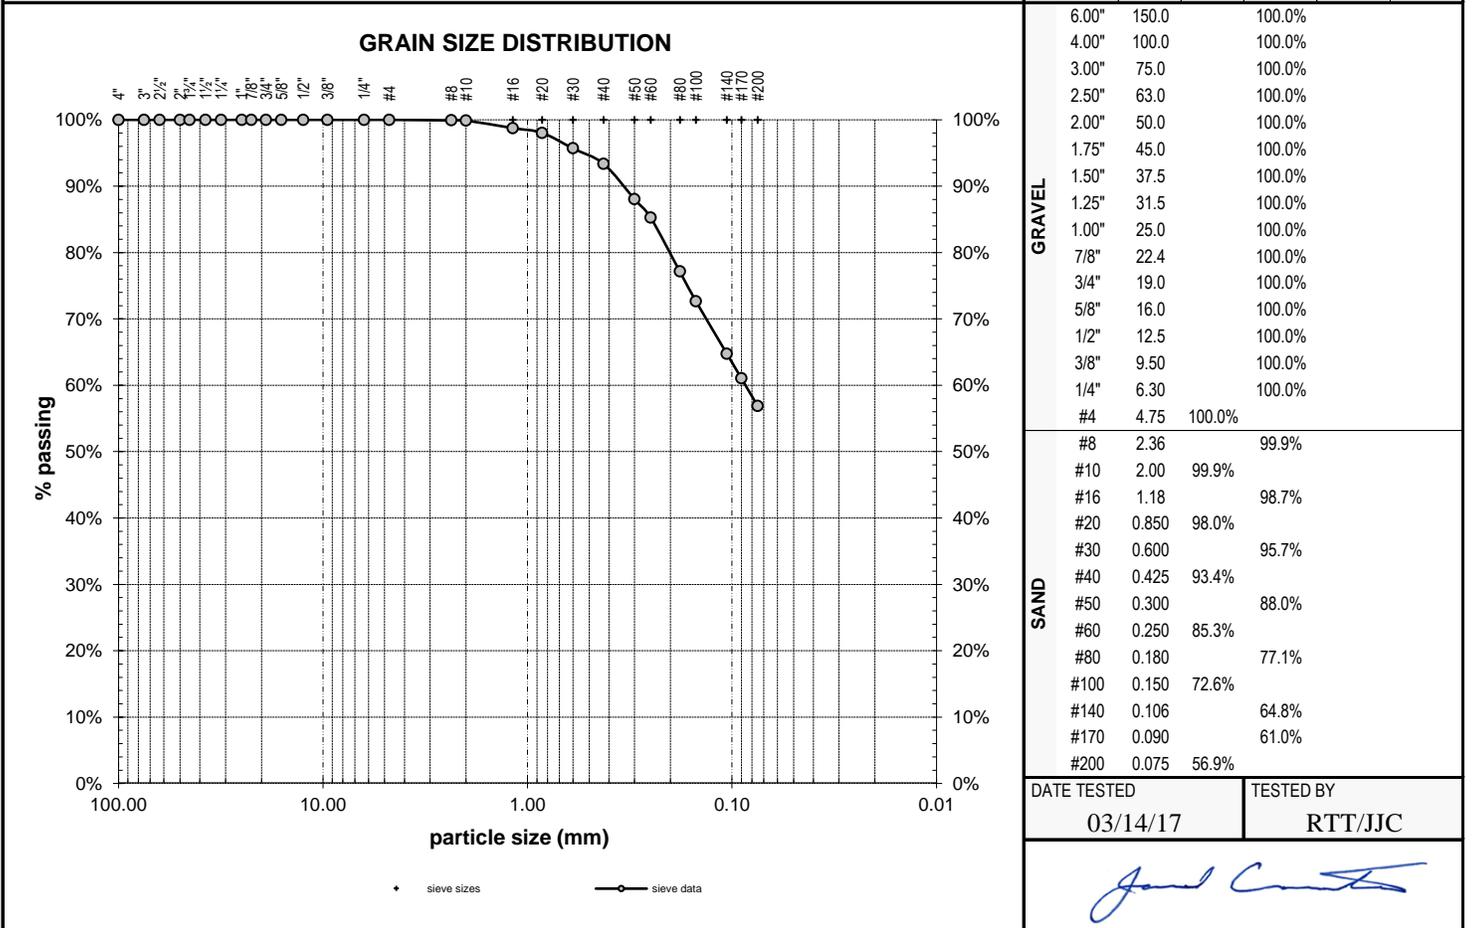
<b>LABORATORY TEST DATA</b>					
<b>LABORATORY EQUIPMENT</b>			<b>TEST PROCEDURE</b>		
Rainhart "Mary Ann" Sifter 637			ASTM D6913, D422

<b>ADDITIONAL DATA</b>	<b>SIEVE DATA</b>
initial dry mass (g) = 121.8 as-received moisture content = 64.8% liquid limit = 56 plastic limit = 35 plasticity index = 21 fineness modulus = n/a	coefficient of curvature, $C_c$ = n/a coefficient of uniformity, $C_u$ = n/a effective size, $D_{(10)}$ = n/a $D_{(30)}$ = n/a $D_{(60)}$ = 0.086 mm
	% gravel = 0.0% % sand = 43.1% % silt and clay = 56.9%

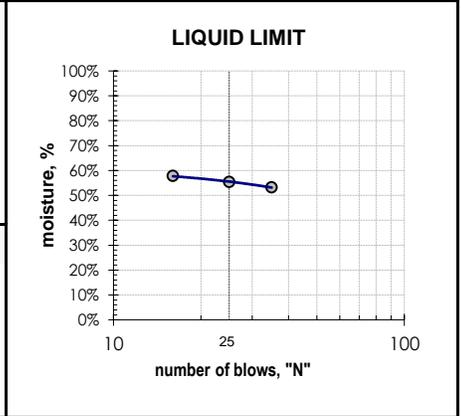
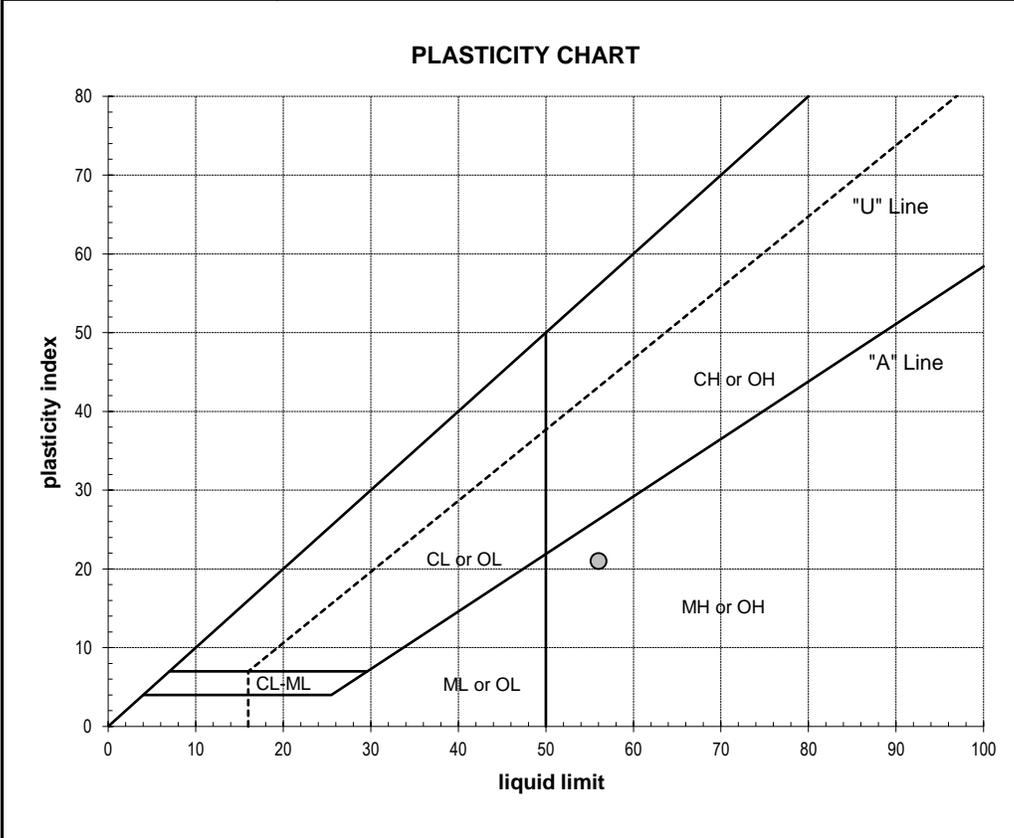
①	②	③	④	wet soil + pan weight, g =	36.73	35.51	35.32		dry soil + pan weight, g =	31.23	30.20	29.99		pan weight, g =	20.89	20.62	20.76		N (blows) =	35	25	16		moisture, % =	53.2 %	55.4 %	57.8 %	
	①	②	③	④																											
wet soil + pan weight, g =	36.73	35.51	35.32																												
dry soil + pan weight, g =	31.23	30.20	29.99																												
pan weight, g =	20.89	20.62	20.76																												
N (blows) =	35	25	16																												
moisture, % =	53.2 %	55.4 %	57.8 %

<b>ADDITIONAL DATA</b>	
% gravel =	0.0%
% sand =	43.1%
% silt and clay =	56.9%
% silt =	n/a
% clay =	n/a
moisture content =	64.8%
