**Geotechnical Critical Areas Report**

**Green Mountain North**

**Camas, Washington**

**September 28, 2017**

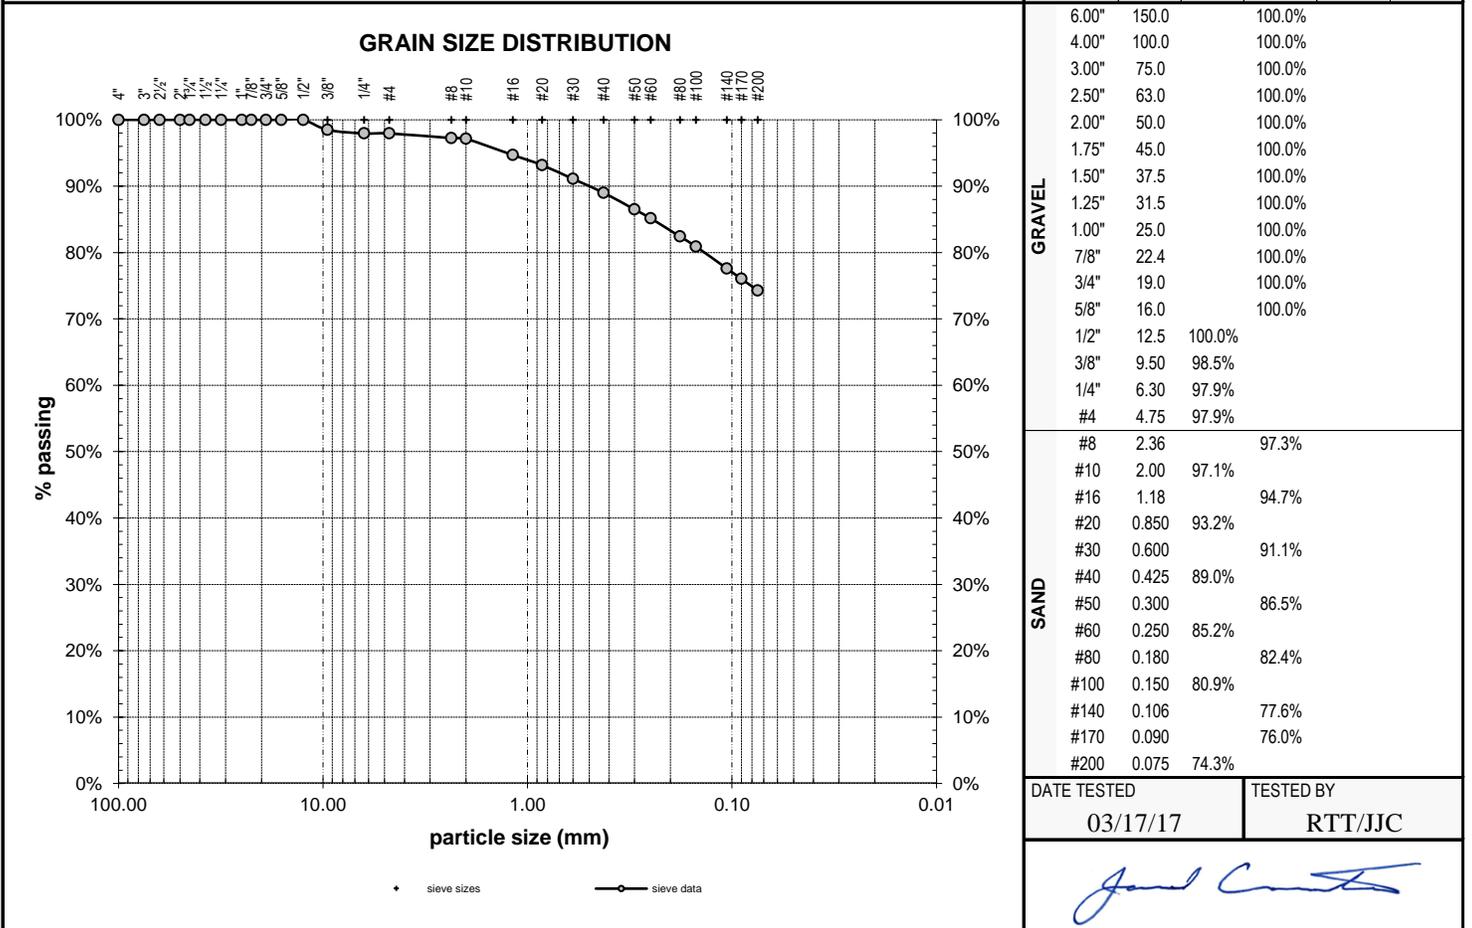
<b>ADDITIONAL DATA</b> initial dry mass (g) = 375.2 as-received moisture content = 58.1% liquid limit = 58 plastic limit = 31 plasticity index = 27 fineness modulus = n/a coefficient of curvature, $C_c$ = n/a coefficient of uniformity, $C_u$ = n/a effective size, $D_{(10)}$ = n/a $D_{(30)}$ = n/a $D_{(60)}$ = n/a	<b>SIEVE DATA</b> % gravel = 2.1% % sand = 23.6% % silt and clay = 74.3%
---	---

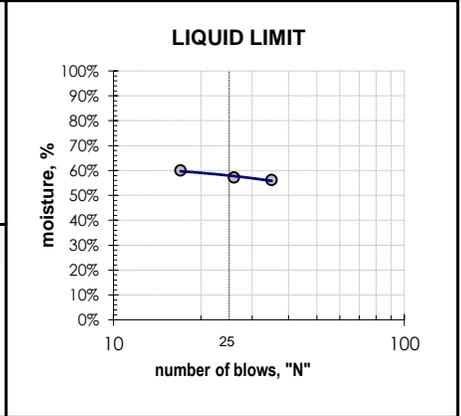
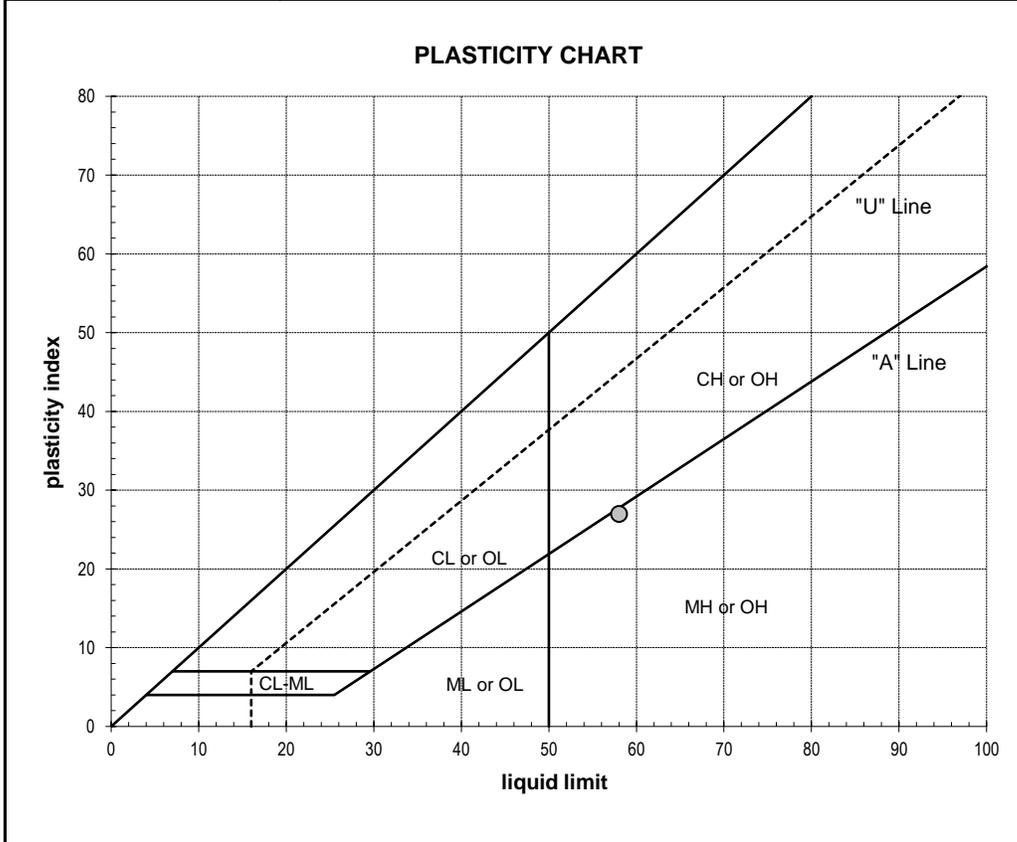
1	2	3	4	wet soil + pan weight, g =	34.48	32.84	36.36		dry soil + pan weight, g =	29.55	28.50	30.44		pan weight, g =	20.76	20.91	20.57		N (blows) =	35	26	17		moisture, % =	56.1 %	57.2 %	60.0 %	
	1	2	3	4																											
wet soil + pan weight, g =	34.48	32.84	36.36																												
dry soil + pan weight, g =	29.55	28.50	30.44																												
pan weight, g =	20.76	20.91	20.57																												
N (blows) =	35	26	17																												
moisture, % =	56.1 %	57.2 %	60.0 %																												
plastic limit = 31																															
plasticity index = 27

1	2	3	4	wet soil + pan weight, g =	27.87	28.11			dry soil + pan weight, g =	26.15	26.38			pan weight, g =	20.70	20.84			moisture, % =	31.6 %	31.2 %		
	1	2	3	4																						
wet soil + pan weight, g =	27.87	28.11																								
dry soil + pan weight, g =	26.15	26.38																								
pan weight, g =	20.70	20.84																								
moisture, % =	31.6 %	31.2 %																								
shrinkage ratio = n/a

ADDITIONAL DATA	
% gravel =	2.1%
% sand =	23.6%
% silt and clay =	74.3%
% silt =	n/a
% clay =	n/a
moisture content =	58.1%

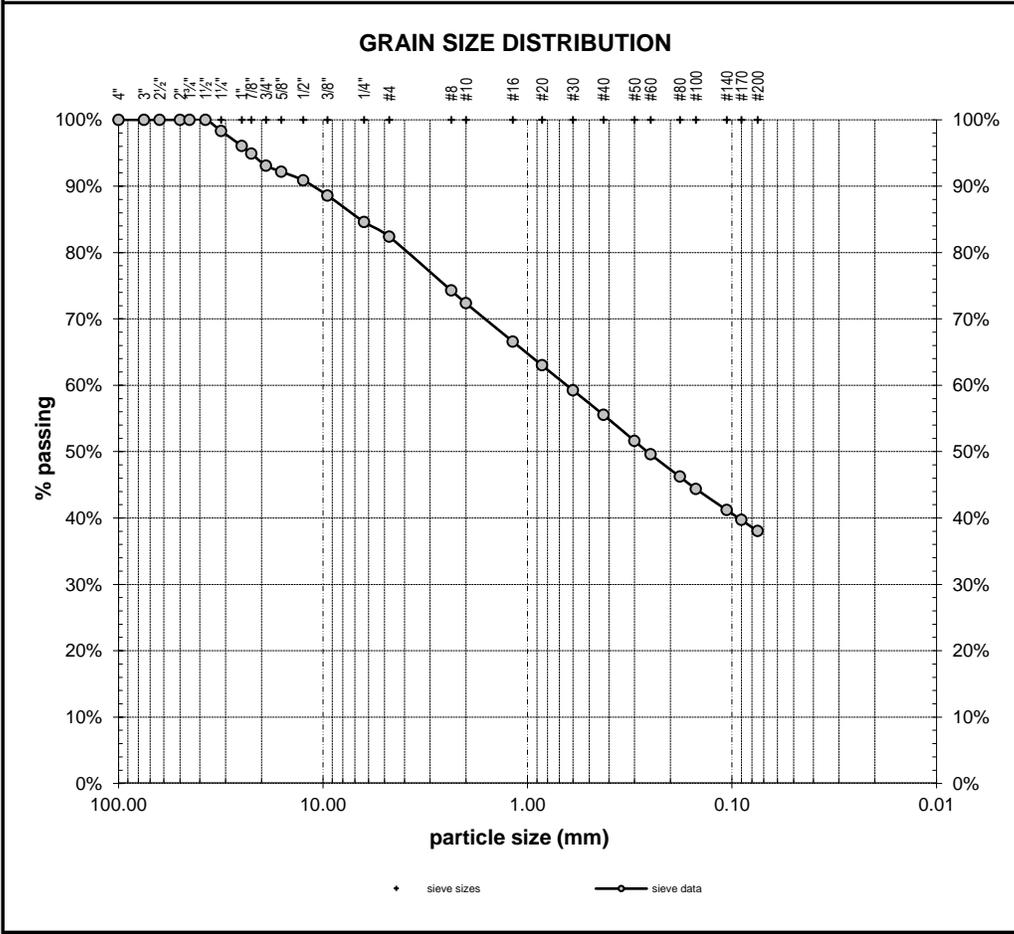
<b>ADDITIONAL DATA</b>						<b>SIEVE DATA</b>							
initial dry mass (g) = 693.7 as-received moisture content = 45.1% liquid limit = 56 plastic limit = 35 plasticity index = 21 fineness modulus = n/a			coefficient of curvature, $C_c$ = n/a coefficient of uniformity, $C_u$ = n/a effective size, $D_{(10)}$ = n/a $D_{(30)}$ = n/a $D_{(60)}$ = 0.644 mm			% gravel = 17.6% % sand = 44.4% % silt and clay = 38.0%							
		<b>PERCENT PASSING</b>				<b>SIEVE</b>		<b>SPECS</b>					
						<b>act.</b>		<b>interp.</b>		<b>max</b>		<b>min</b>

<b>GRAVEL</b>	6.00"	150.0		100.0%		
	4.00"	100.0		100.0%		
	3.00"	75.0		100.0%		
	2.50"	63.0		100.0%		
	2.00"	50.0		100.0%		
	1.75"	45.0		100.0%		
	1.50"	37.5	100.0%			
	1.25"	31.5		98.3%		
	1.00"	25.0		96.1%		
	7/8"	22.4		94.9%		
3/4"	19.0		93.1%			
5/8"	16.0		92.2%			
1/2"	12.5		90.9%			
3/8"	9.50		88.6%			
1/4"	6.30		84.6%			
#4	4.75		82.4%			
<b>SAND</b>	#8	2.36		74.3%		
	#10	2.00	72.3%			
	#16	1.18		66.6%		
	#20	0.850	63.0%			
	#30	0.600		59.2%		
	#40	0.425	55.5%			
	#50	0.300		51.6%		
	#60	0.250	49.6%			
	#80	0.180		46.2%		
	#100	0.150	44.4%			
#140	0.106		41.2%			
#170	0.090		39.7%			
#200	0.075	38.0%				
<b>DATE TESTED</b>				<b>TESTED BY</b>		
03/16/17				MJR

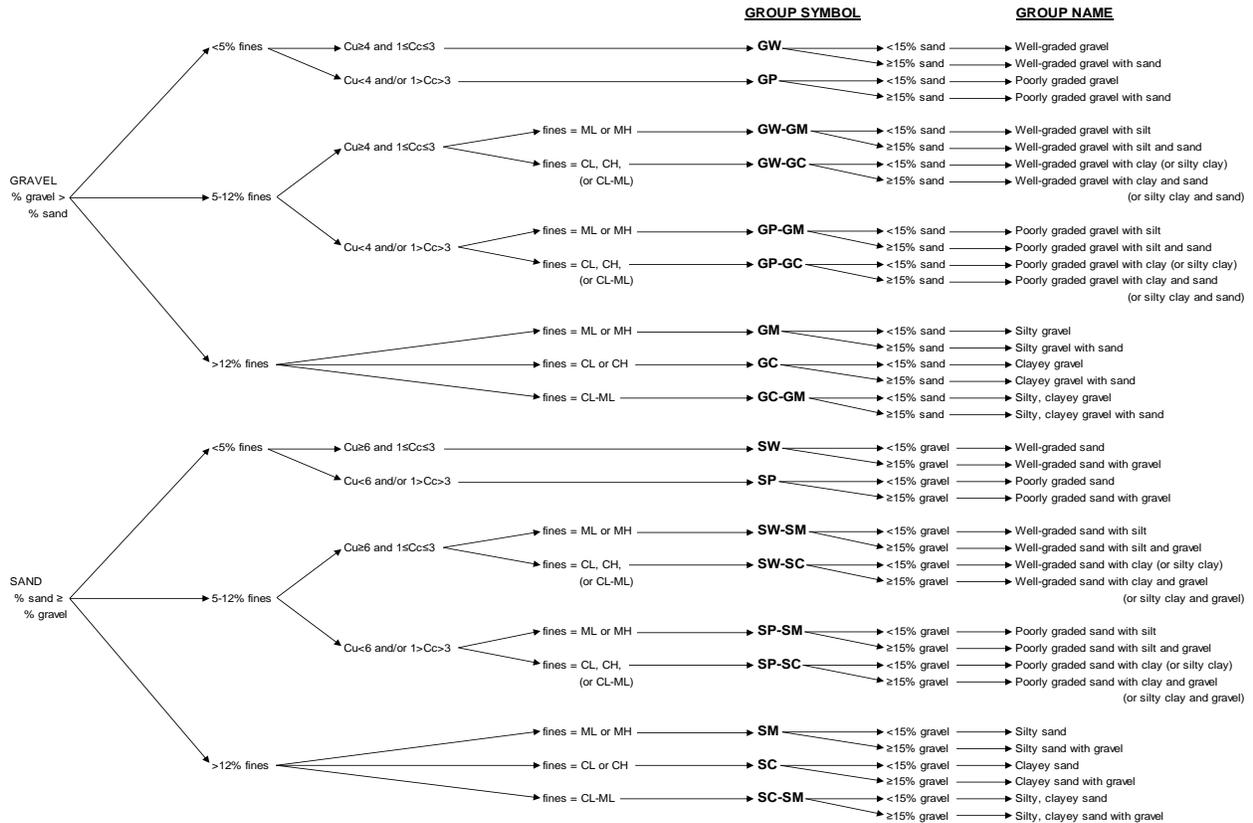
# USCS SOIL CLASSIFICATION SYSTEM

Flow Chart for Classifying Coarse-Grained Soils (More Than 50% Retained on No. 200 Sieve)

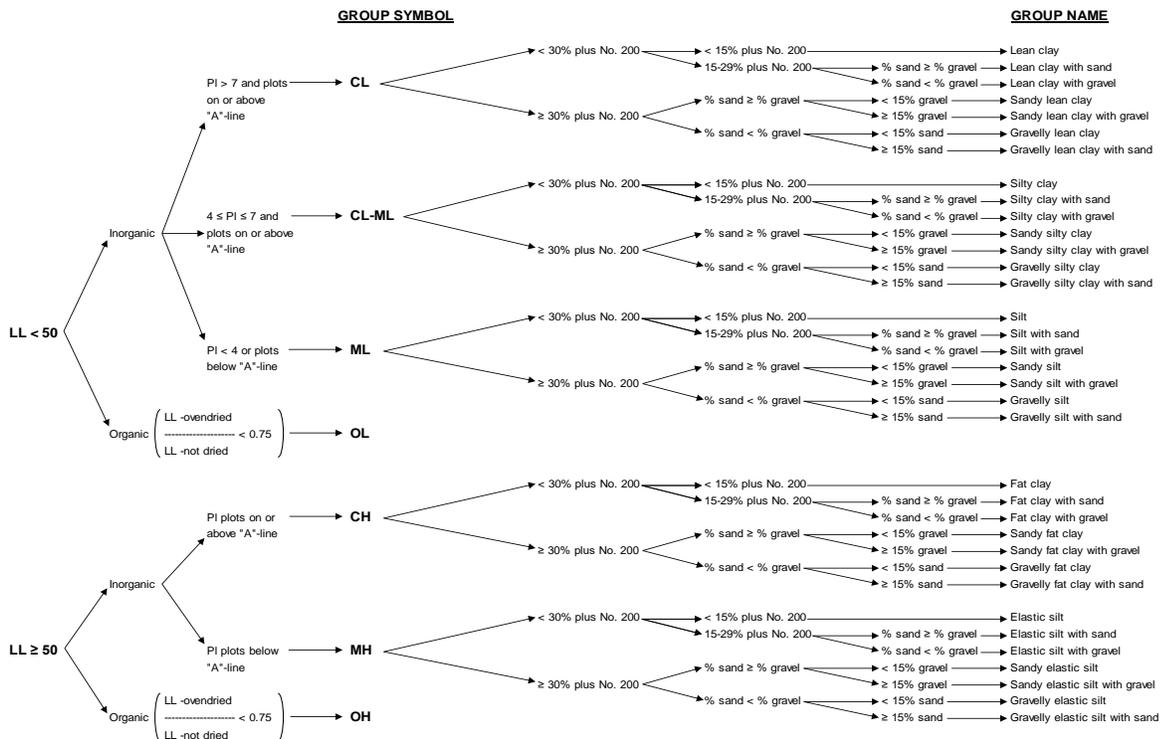
Flow Chart for Classifying Fine-Grained Soil (50% or More Passes No. 200 Sieve)

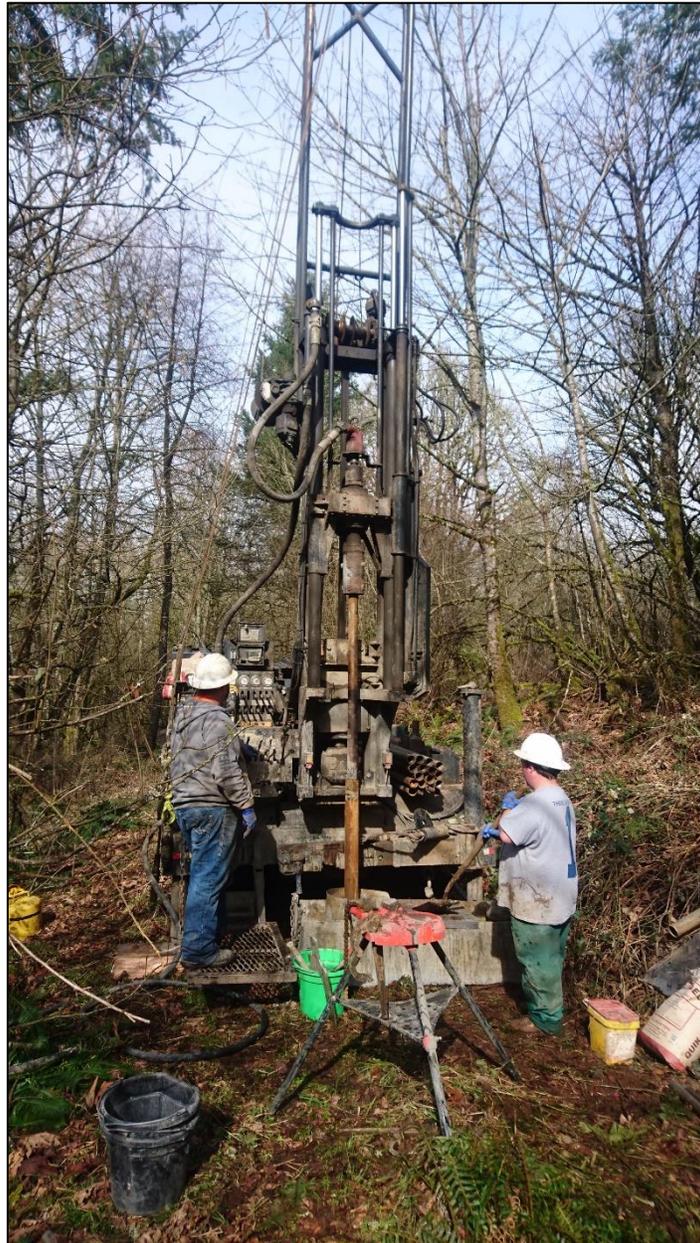
**Conducting Soil Boring Exploration (SB-2).**

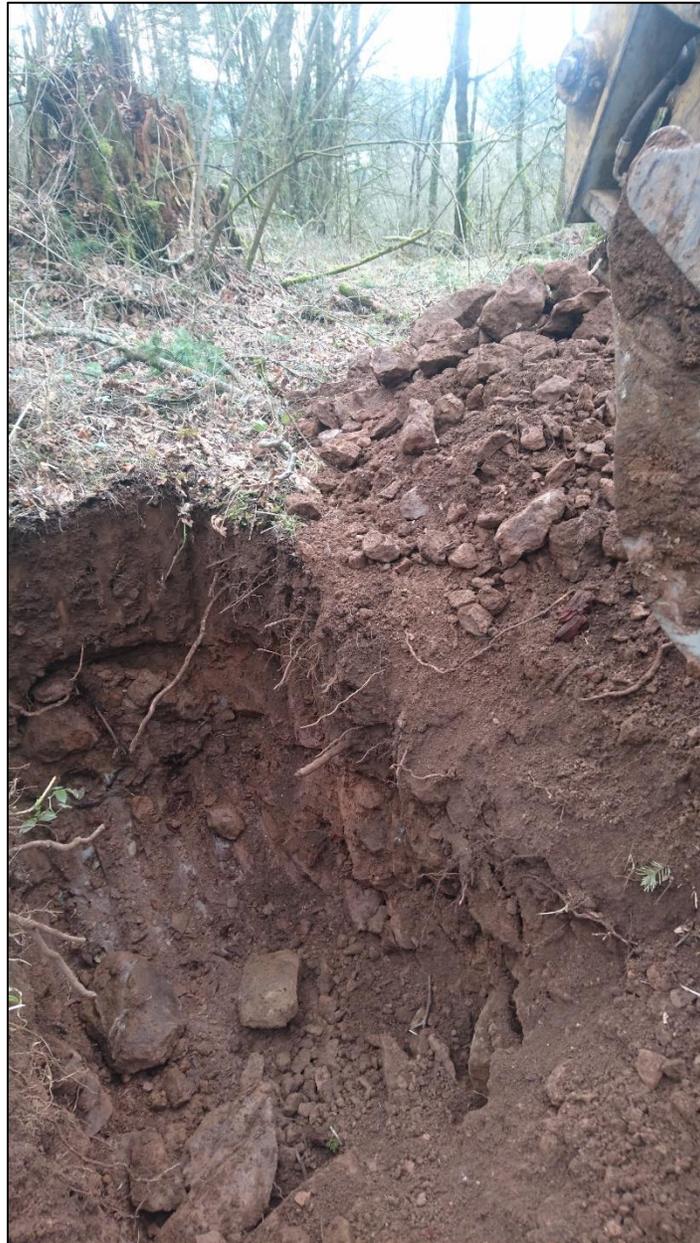
**Typical Soil Profile Observed on the Site (TP-11).**

The field investigation indicated the site is generally covered with 12 to 24-inches of topsoil and associated organic-rich root zone material at the locations observed. Underlying the topsoil layer, fine-textured silt and clay soils resembling native USDA Olympic stony clay loam were encountered. Olympic soils were generally underlain by weathered to competent basaltic andesite bedrock in locations observed. Subsurface lithology was reasonably consistent at all explored locations and may generally be described by soil types identified in the following text.

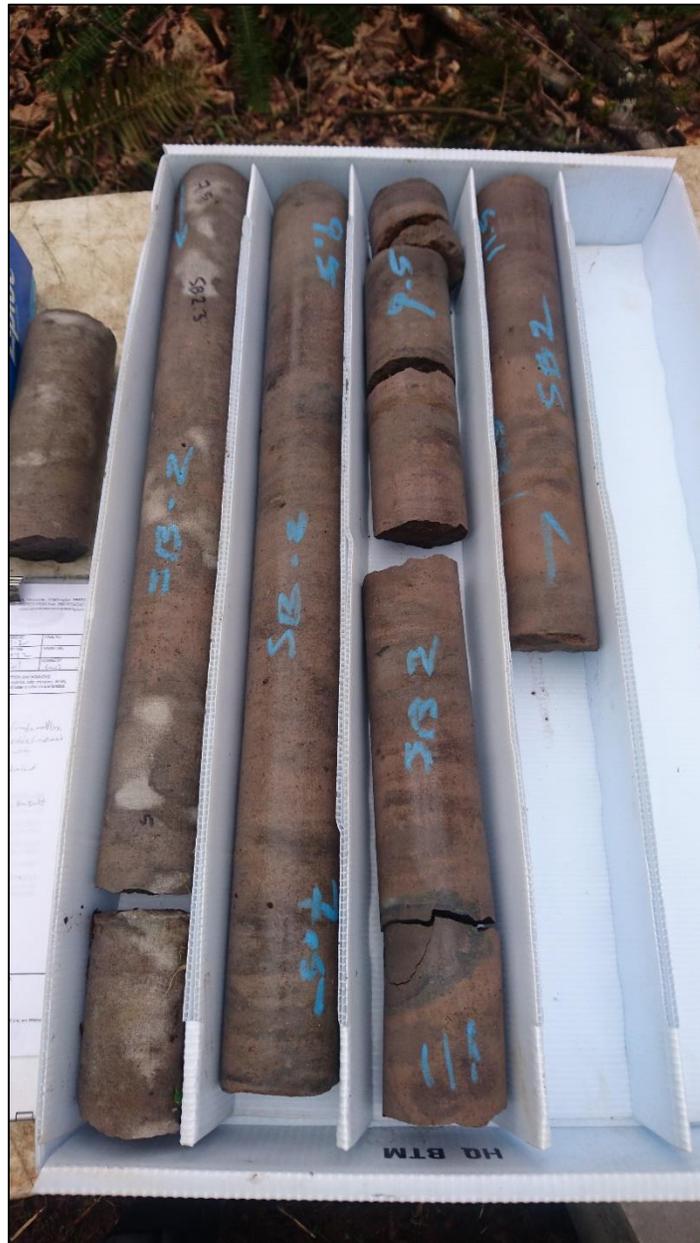
**Typical Basalt Coring Observed on the Site (SB-2, 5-15'BGS).**
